# Buffers improve water quality

Recently, the MPCA had a request asking if we could see a difference in water quality in streams from sites where there are buffers compared to sites without buffers.

# Buffers and stream health

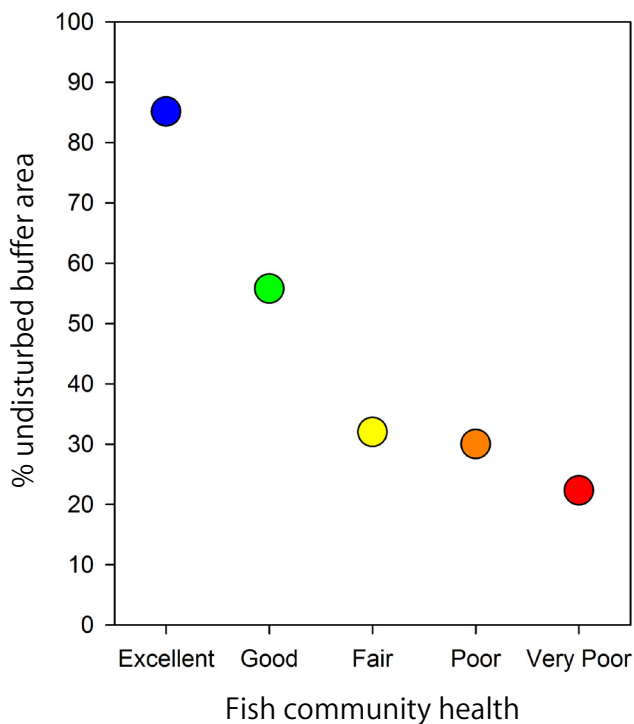
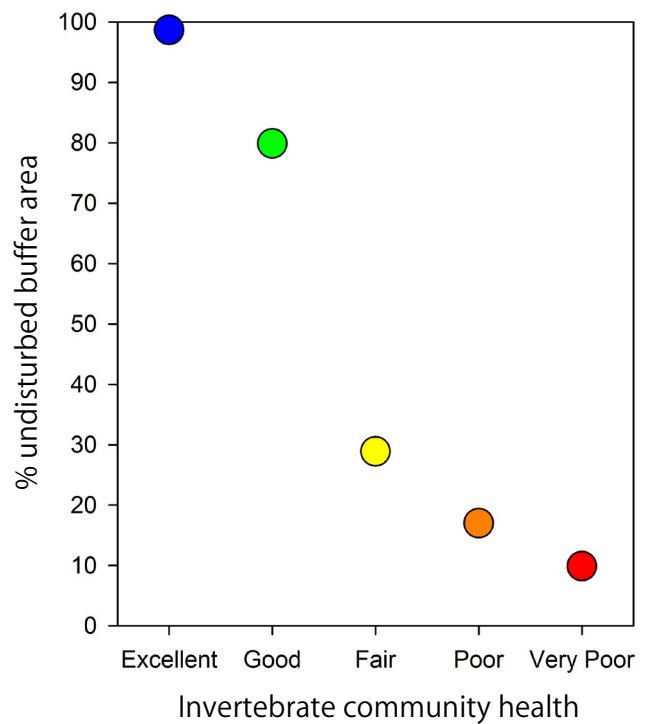
- More than 85% intact buffers have excellent aquatic life
- About 50% – 85% intact buffers have good aquatic life
- Between 25% – 50% intact buffers have fair aquatic life
- Less than 25% intact buffers have poor or very poor aquatic life.

Then we compared the buffer quality to the health of the fish and invertebrate communities at each site. The sites were grouped into “excellent,” “good,” “fair,” “poor,” and “very poor” categories based on the health of the biological community (see graphs).

Watersheds with missing or disturbed buffers have less healthy fish and bug (invertebrate) communities.

We looked at the quality of the buffers next to and upstream of more than 3,500 fish monitoring sites and 3,000 invertebrate monitoring sites across Minnesota.

Buffer quality was measured by calculating the percentage of the buffer area that was undisturbed by human activities.

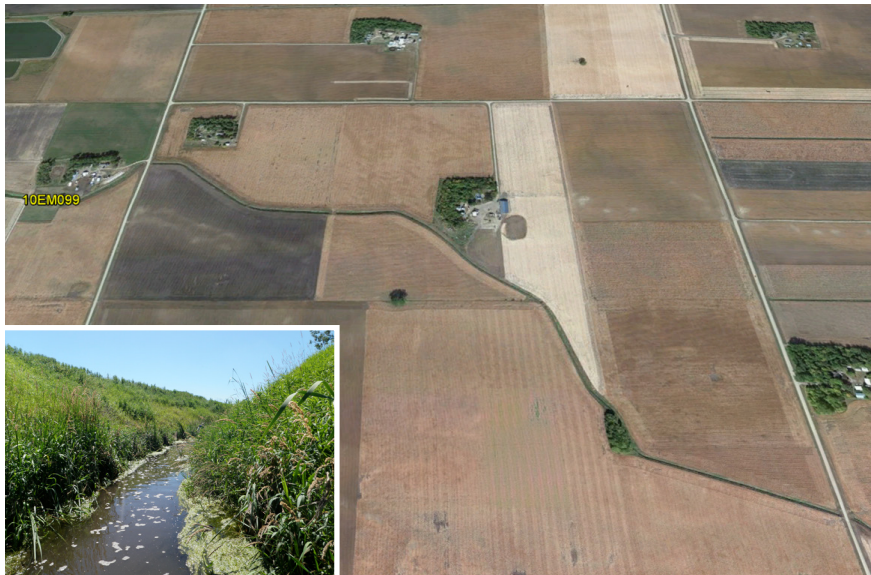
# Lower Minnesota River Watershed, County Ditch 13A (channelized stream)

County Ditch 13A is a headwater, channelized tributary to the South Branch of the Rush River in Sibley County. The buffer zone of this stream is in poor condition and dominated by row-crop agriculture. The fish and invertebrate community as well as the in-stream habitat are all severely degraded.

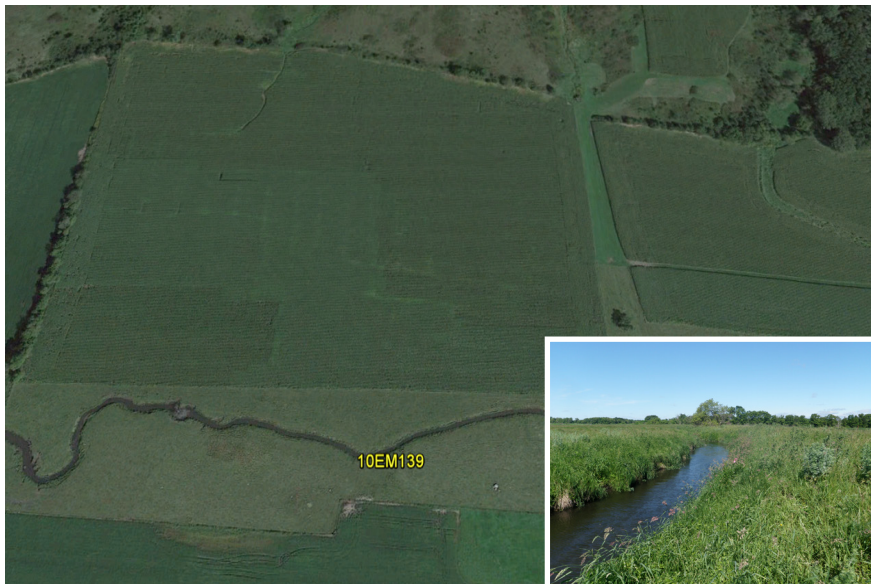
# Zumbro River Watershed, North Fork of Zumbro River (channelized stream)

The North Fork of the Zumbro River is a channelized tributary to the Zumbro River in Rice County. The buffer zones of streams in this watershed are generally in poor condition, but the buffer zone around and immediately upstream of the monitoring site is more intact. The fish and invertebrate community reflect the somewhat better habitat conditions at the site.

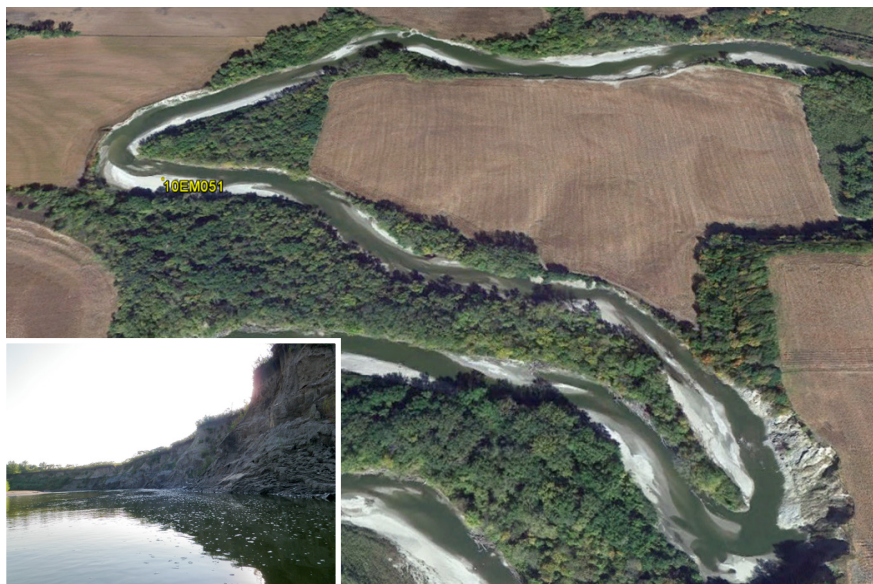
## Blue Earth River Watershed, Blue Earth River (natural stream)

The Blue Earth River is a large, direct tributary to the Minnesota River. The buffer zone of this stream's watershed is often encroached upon by row-crop agriculture. At this monitoring location, the buffer zone around and immediately upstream of the site is somewhat intact, but cropland encroaches on the stream banks in several places and may be contributing to bank erosion along some outside bends. Note the erosion evident in the lower right corner of the air photo and site picture above.

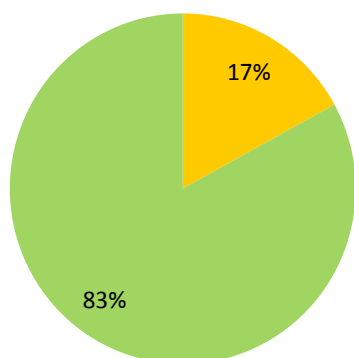
Land use in the buffer zone

- Cultivated Crops
- Forest and Shrubland

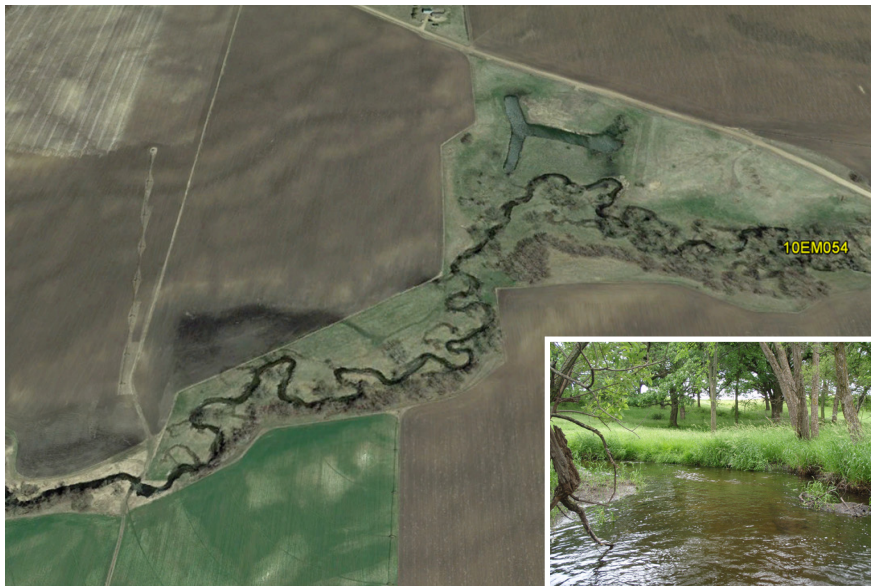
## Sauk River Watershed, Silver Creek (natural stream)

Silver Creek is a tributary to the Sauk River in Todd County. The buffer zone at the monitoring site is composed of perennial grasses that may be grazed at times. The stream has good channel development and a stream bottom composed of coarse substrates that are not covered by fine sediments. The intact buffer at this site may somewhat mitigate the impact on the biology of land use practices in the upstream watershed.
