UNIVERSITY OF MINNESOTA
ST. ANTHONY FALLS LABORATORY
Engineering, Environmental, Biological, and Geophysical Fluid Dynamics

Project Report No. 501

The development and application of a four-level rain garden assessment methodology

Prepared for
Twin Cities Metropolitan Council
and
Minnesota Pollution Control Agency
November 2007
Minneapolis, Minnesota

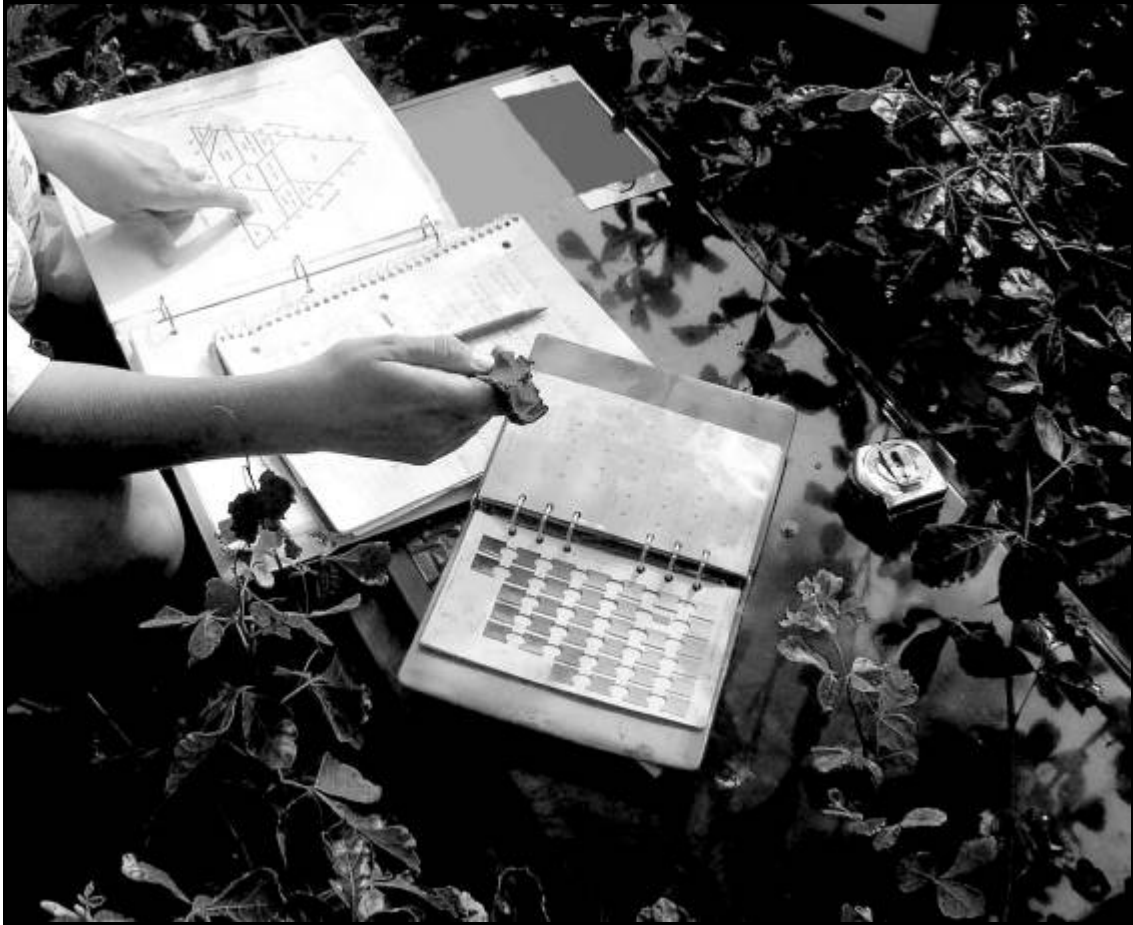
Figure F.2. Texturing and coloring the soil.

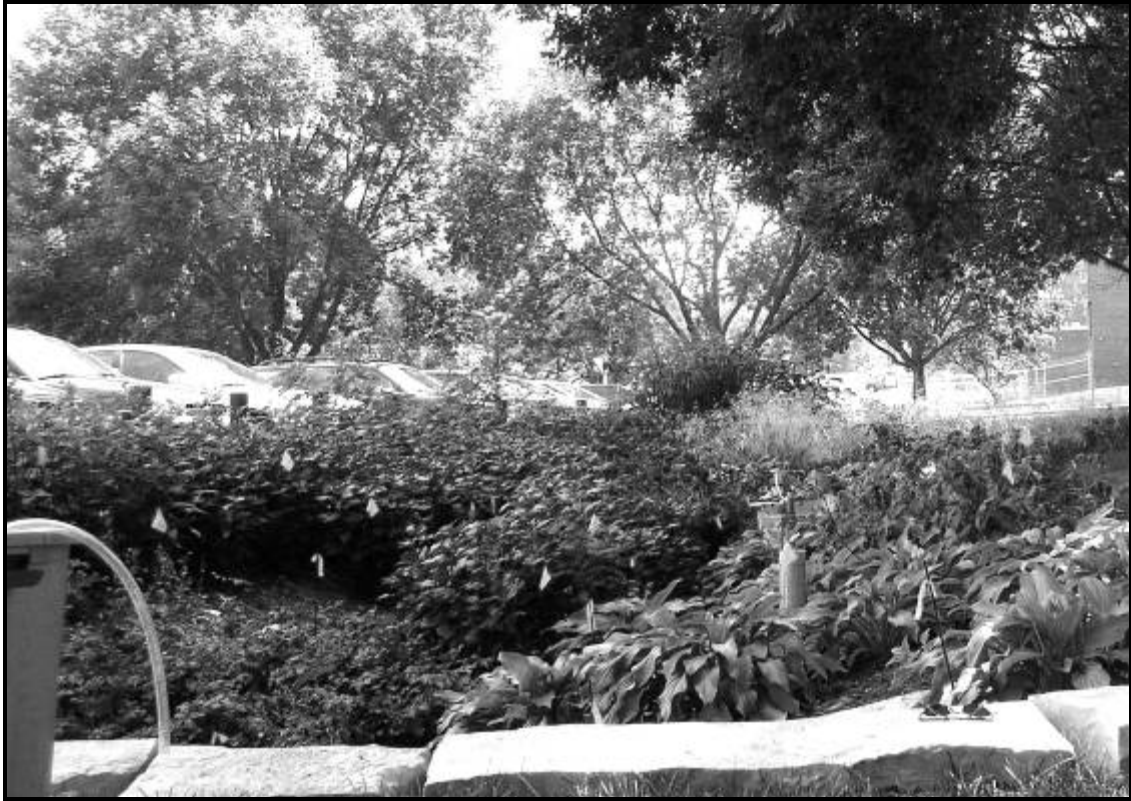
The permeability of the soil was measured to determine the rain garden's capacity for infiltrating water. At this site several devices were used to measure the saturated hydraulic conductivity (K_{sat}) of the soil in order to establish the technique. The three devices used to measure K_{sat} were the double-ring infiltrometer, Minidisk infiltrometer, and the Modified Philip-Dunne infiltrometer. Locations where point measurements of K_{sat} were to be made were distributed evenly throughout the entire rain garden and marked using orange utility flags. These locations varied in their proximity to the vegetation but were never placed directly over the base of the plant. Additional locations were marked at the low point of the site to better represent the frequently occurring small runoff events. Figure F.3 is a photograph of the rain garden with utility flags marking test locations.

Figure F.3. Photograph of flags marking locations of permeability tests.

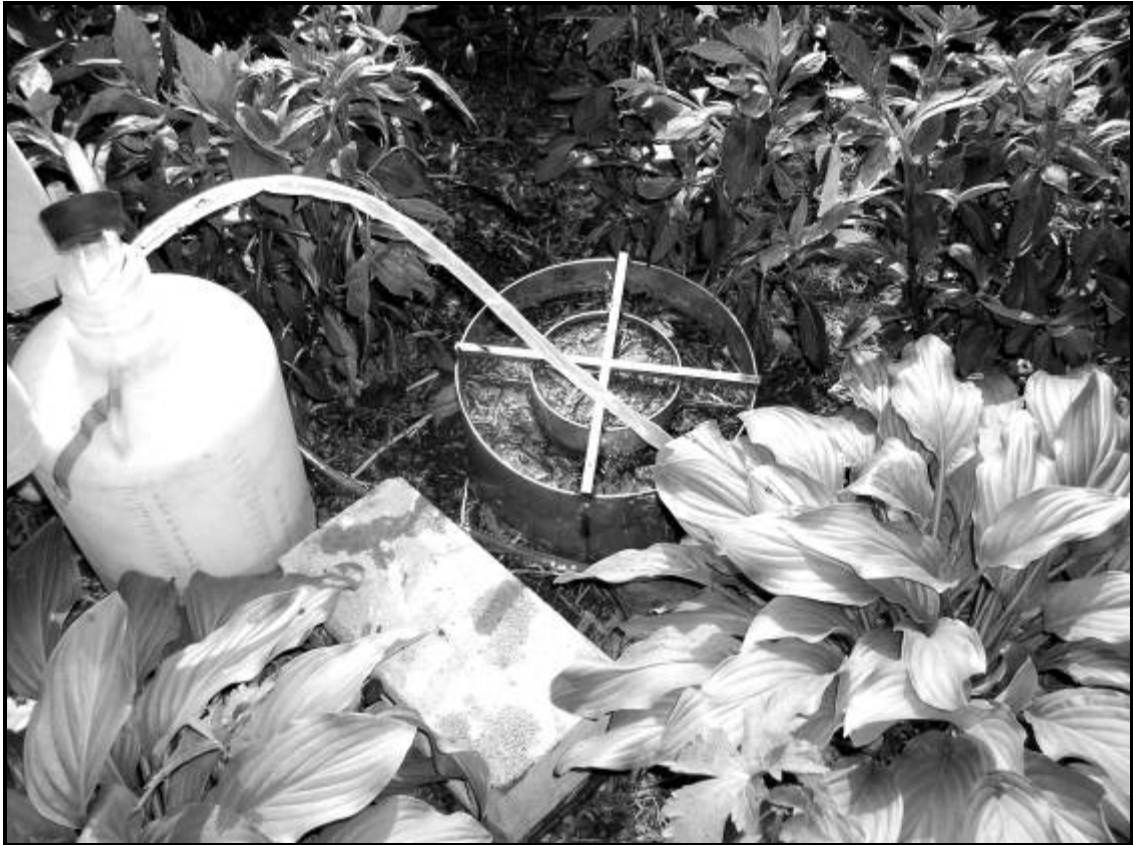
Figure F.4. Photograph of double ring infiltrometer with Mariotte system.

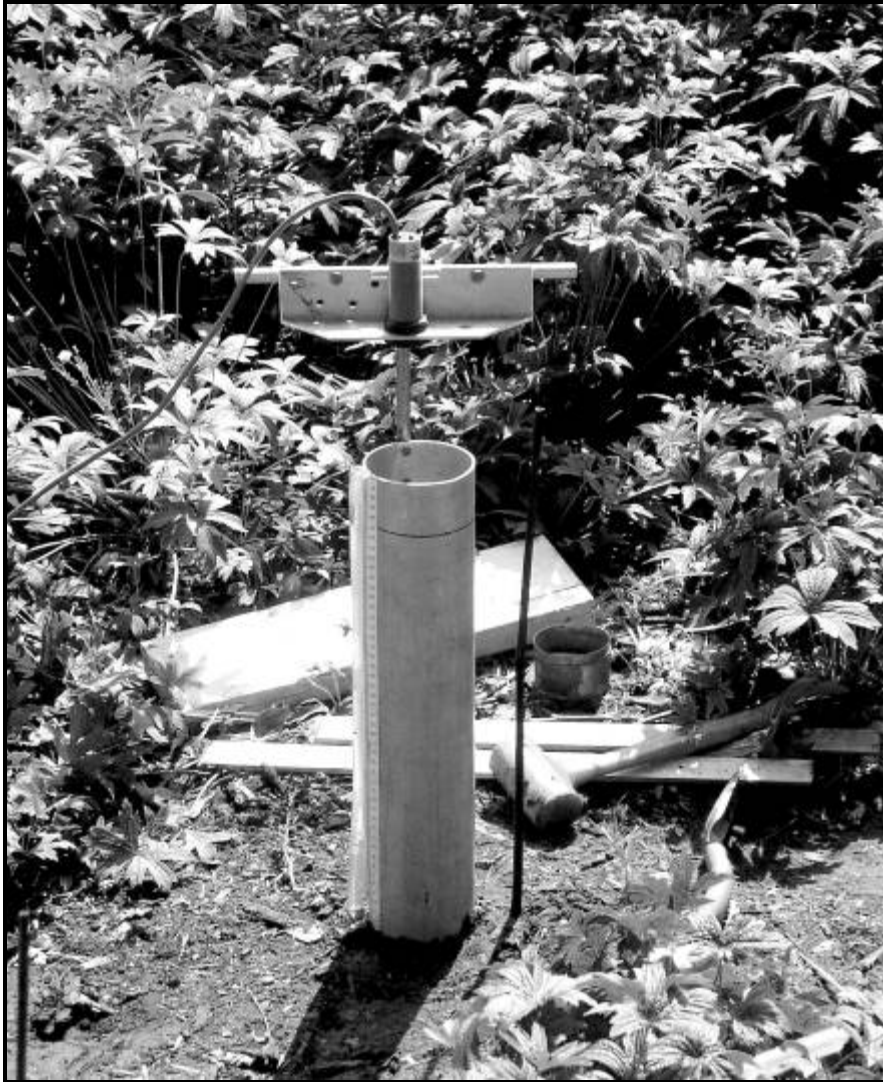
Figure F.5. Modified Philip-Dunne infiltrometer with ultrasonic sensor.
