Grand Marais Creek Watershed

Watershed approach

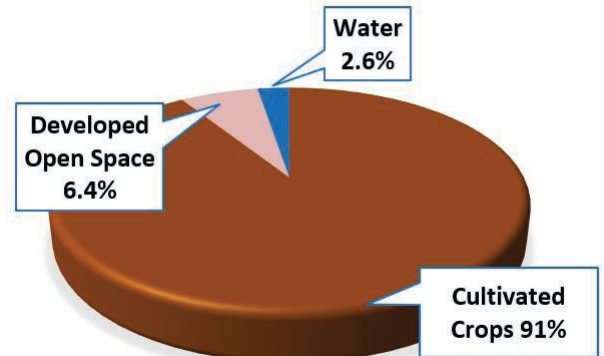
LAND USE - GRAND MARAIS CREEK WATERSHED

Cultivated crops are the dominant land use and cover more than 91% of the watershed. The next largest land use is developed open space with 6.4% of the watershed area. Spring wheat, soybeans, corn, and sugar beets are the main crops grown in the watershed.

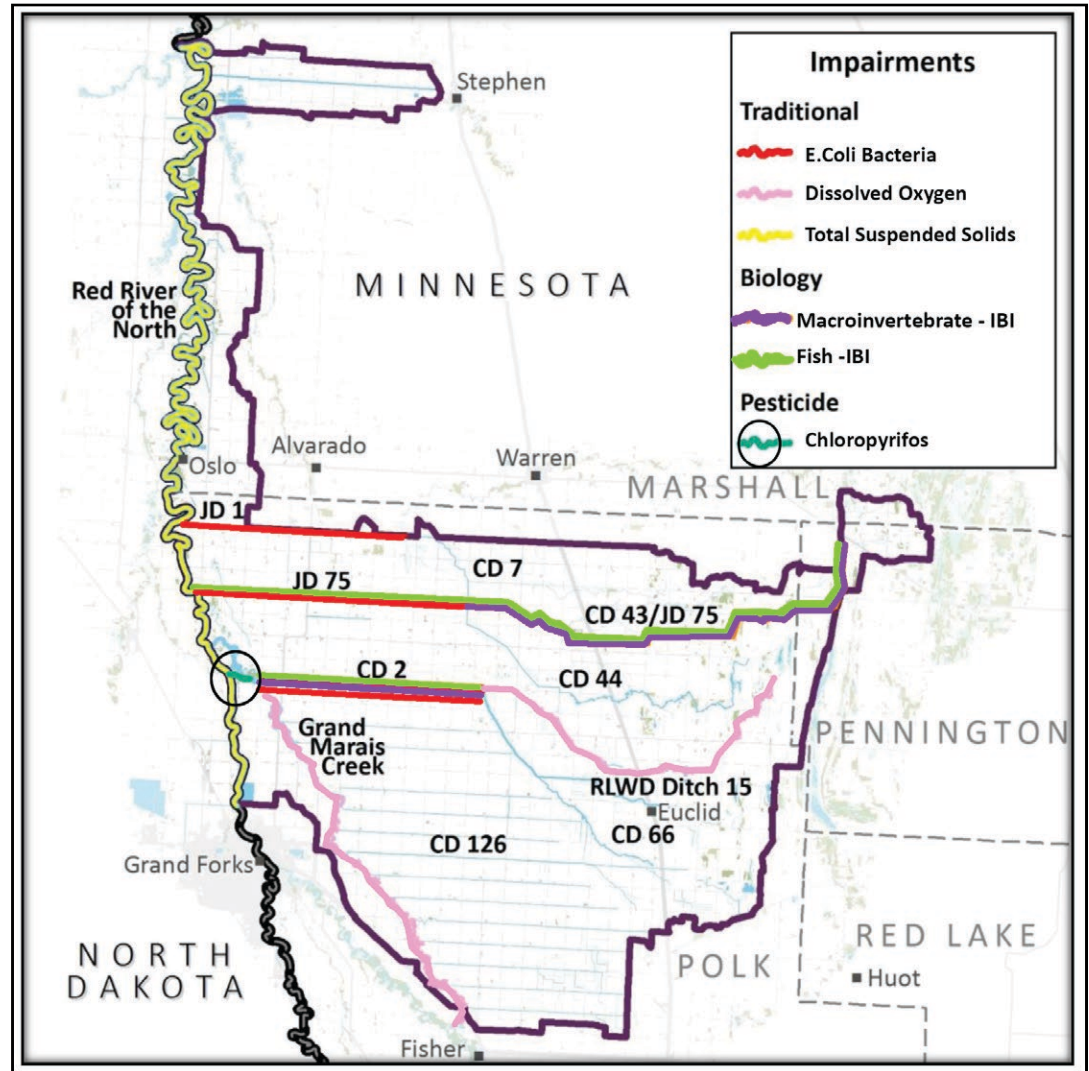
Waters are “impaired” if they fail to meet standards. This map shows the impairments in the watershed.

Using data from these sampling efforts, it was determined that three stream reaches were impaired for recreation due to excessive levels of *E.coli* bacteria and required Total Maximum Daily Load (TMDL) studies.

Impairments were also found for total suspended solids, fish and aquatic insect (macroinvertebrate) communities, low dissolved oxygen, and chloropyrifos (a pesticide). These impairments will be addressed at a later time.
