December 2020

Snake-Middle Rivers Watershed Restoration and Protection Strategy Report

Restoration and protection strategies for waterbodies in the Snake River Watershed in the Red River Basin

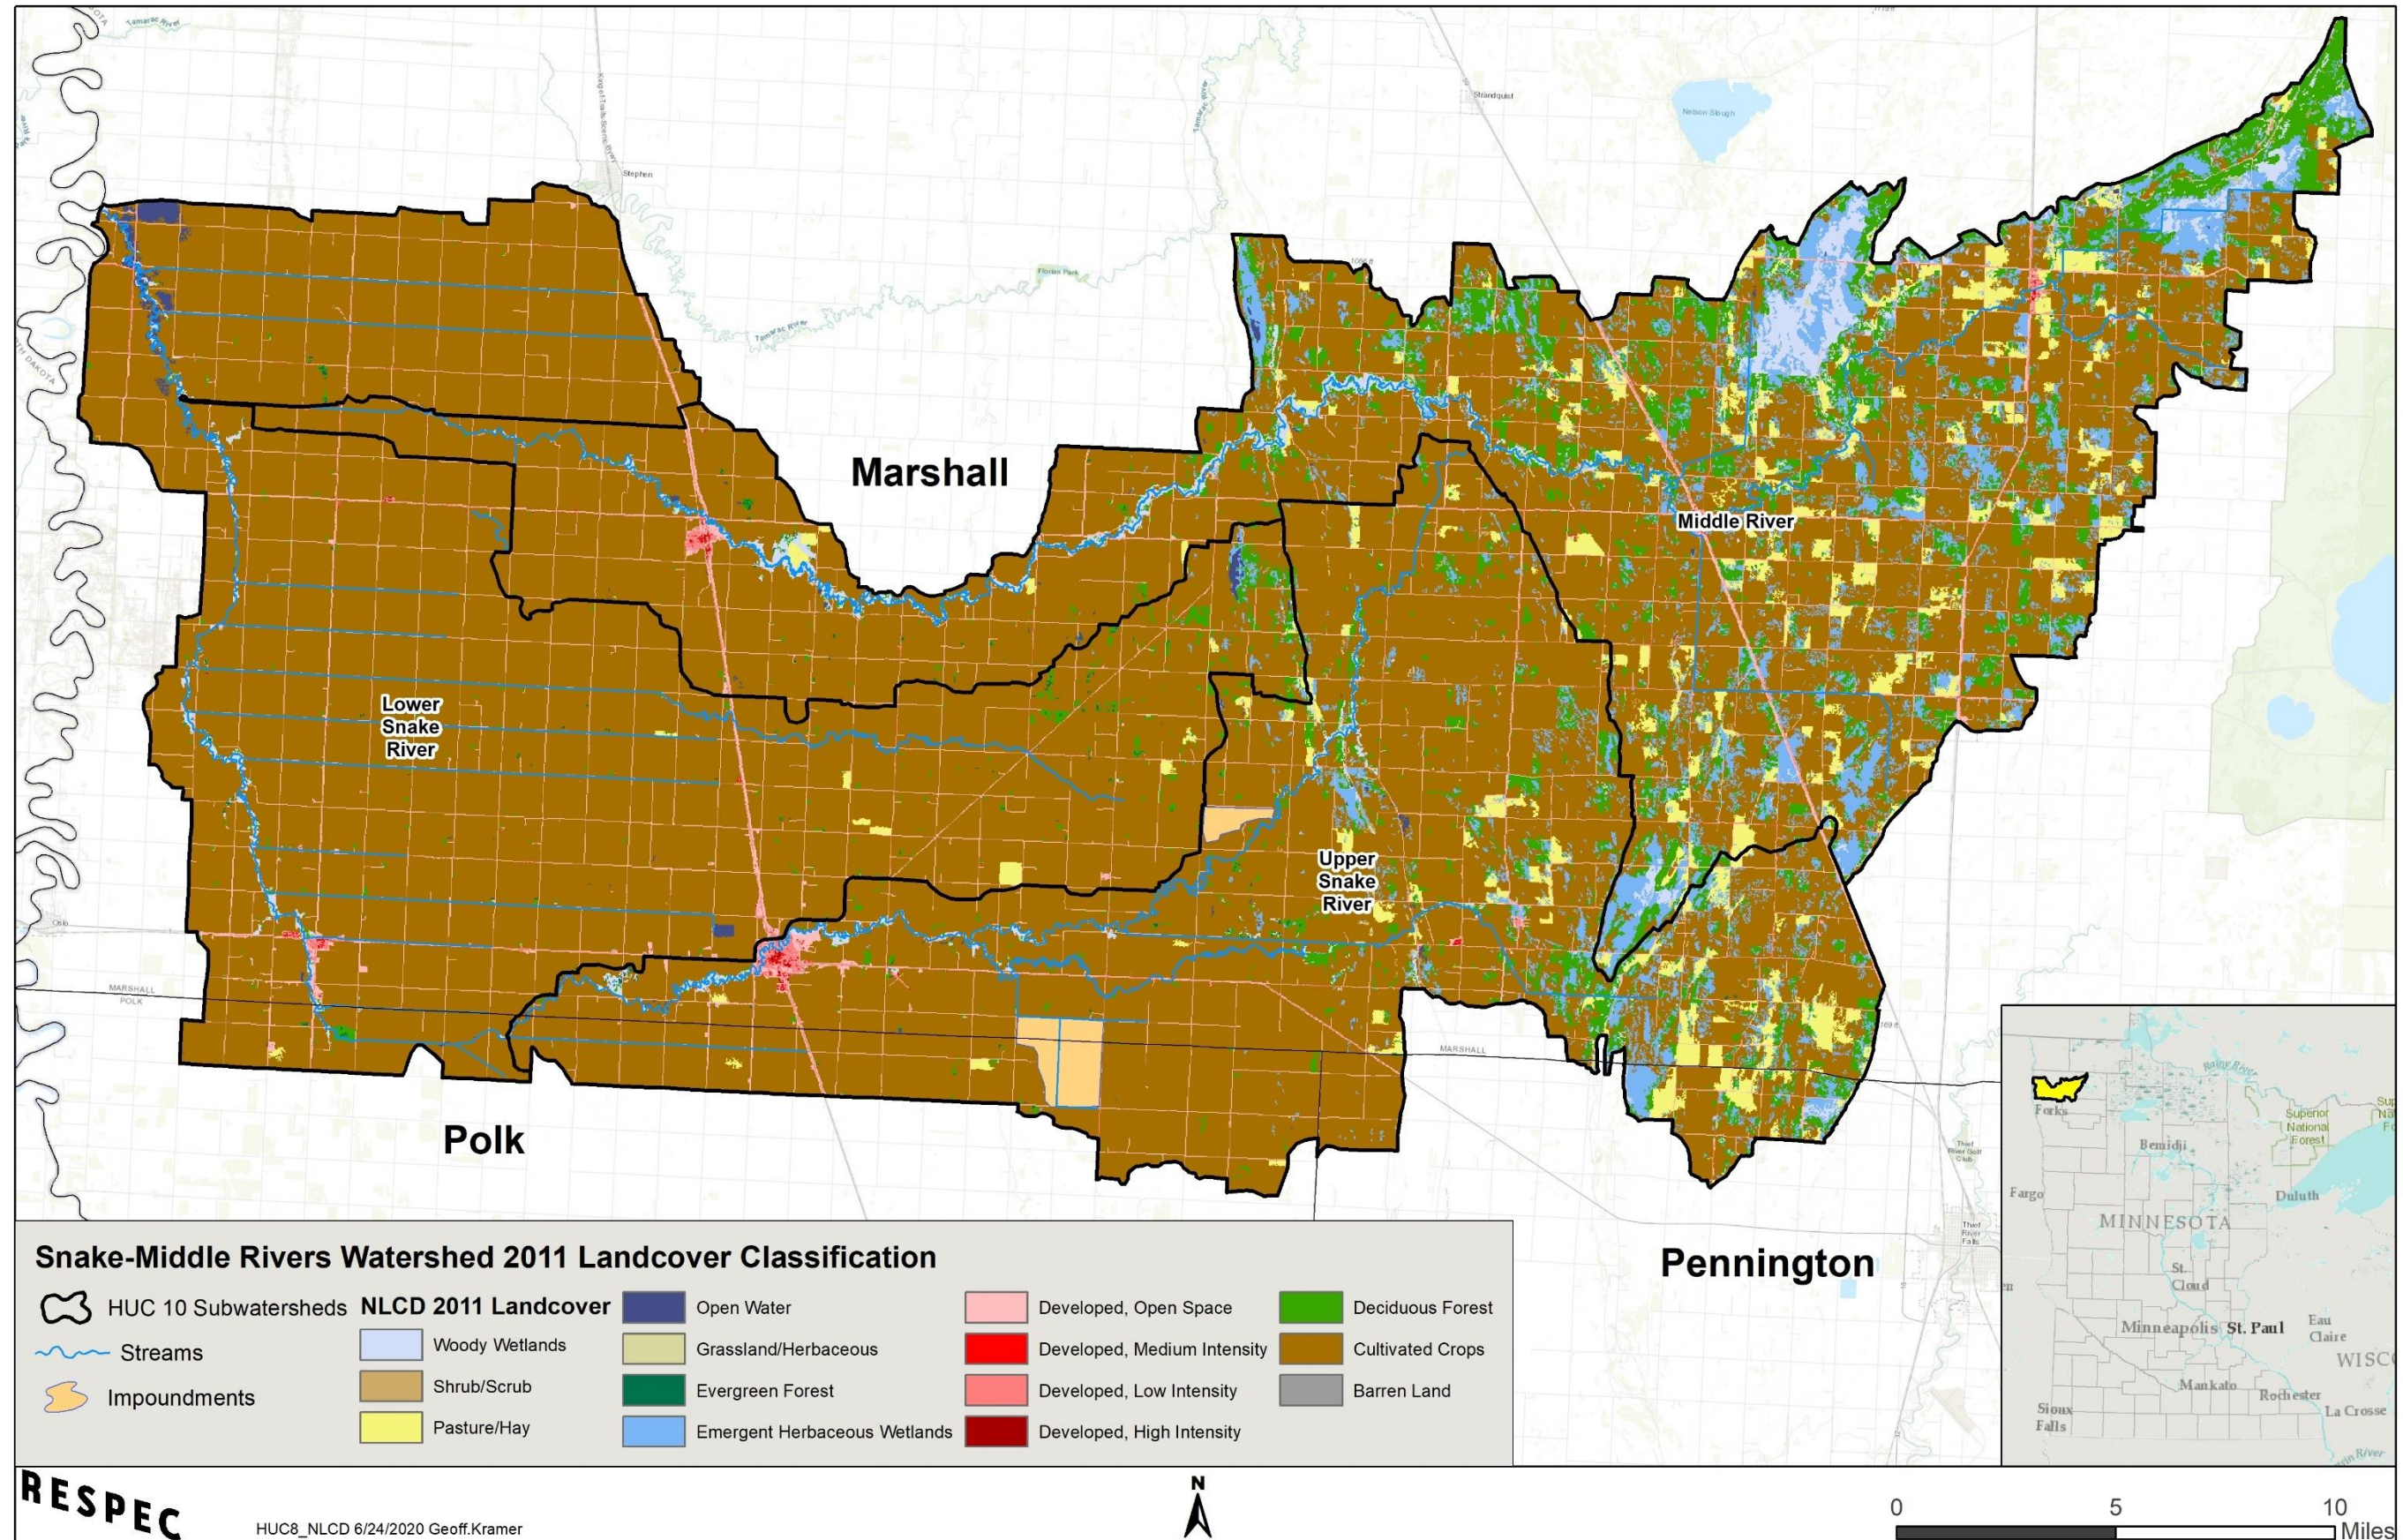
Figure 1. Snake-Middle Rivers Watershed land cover from National Land Cover Database 2011 (Homer et al. 2015).

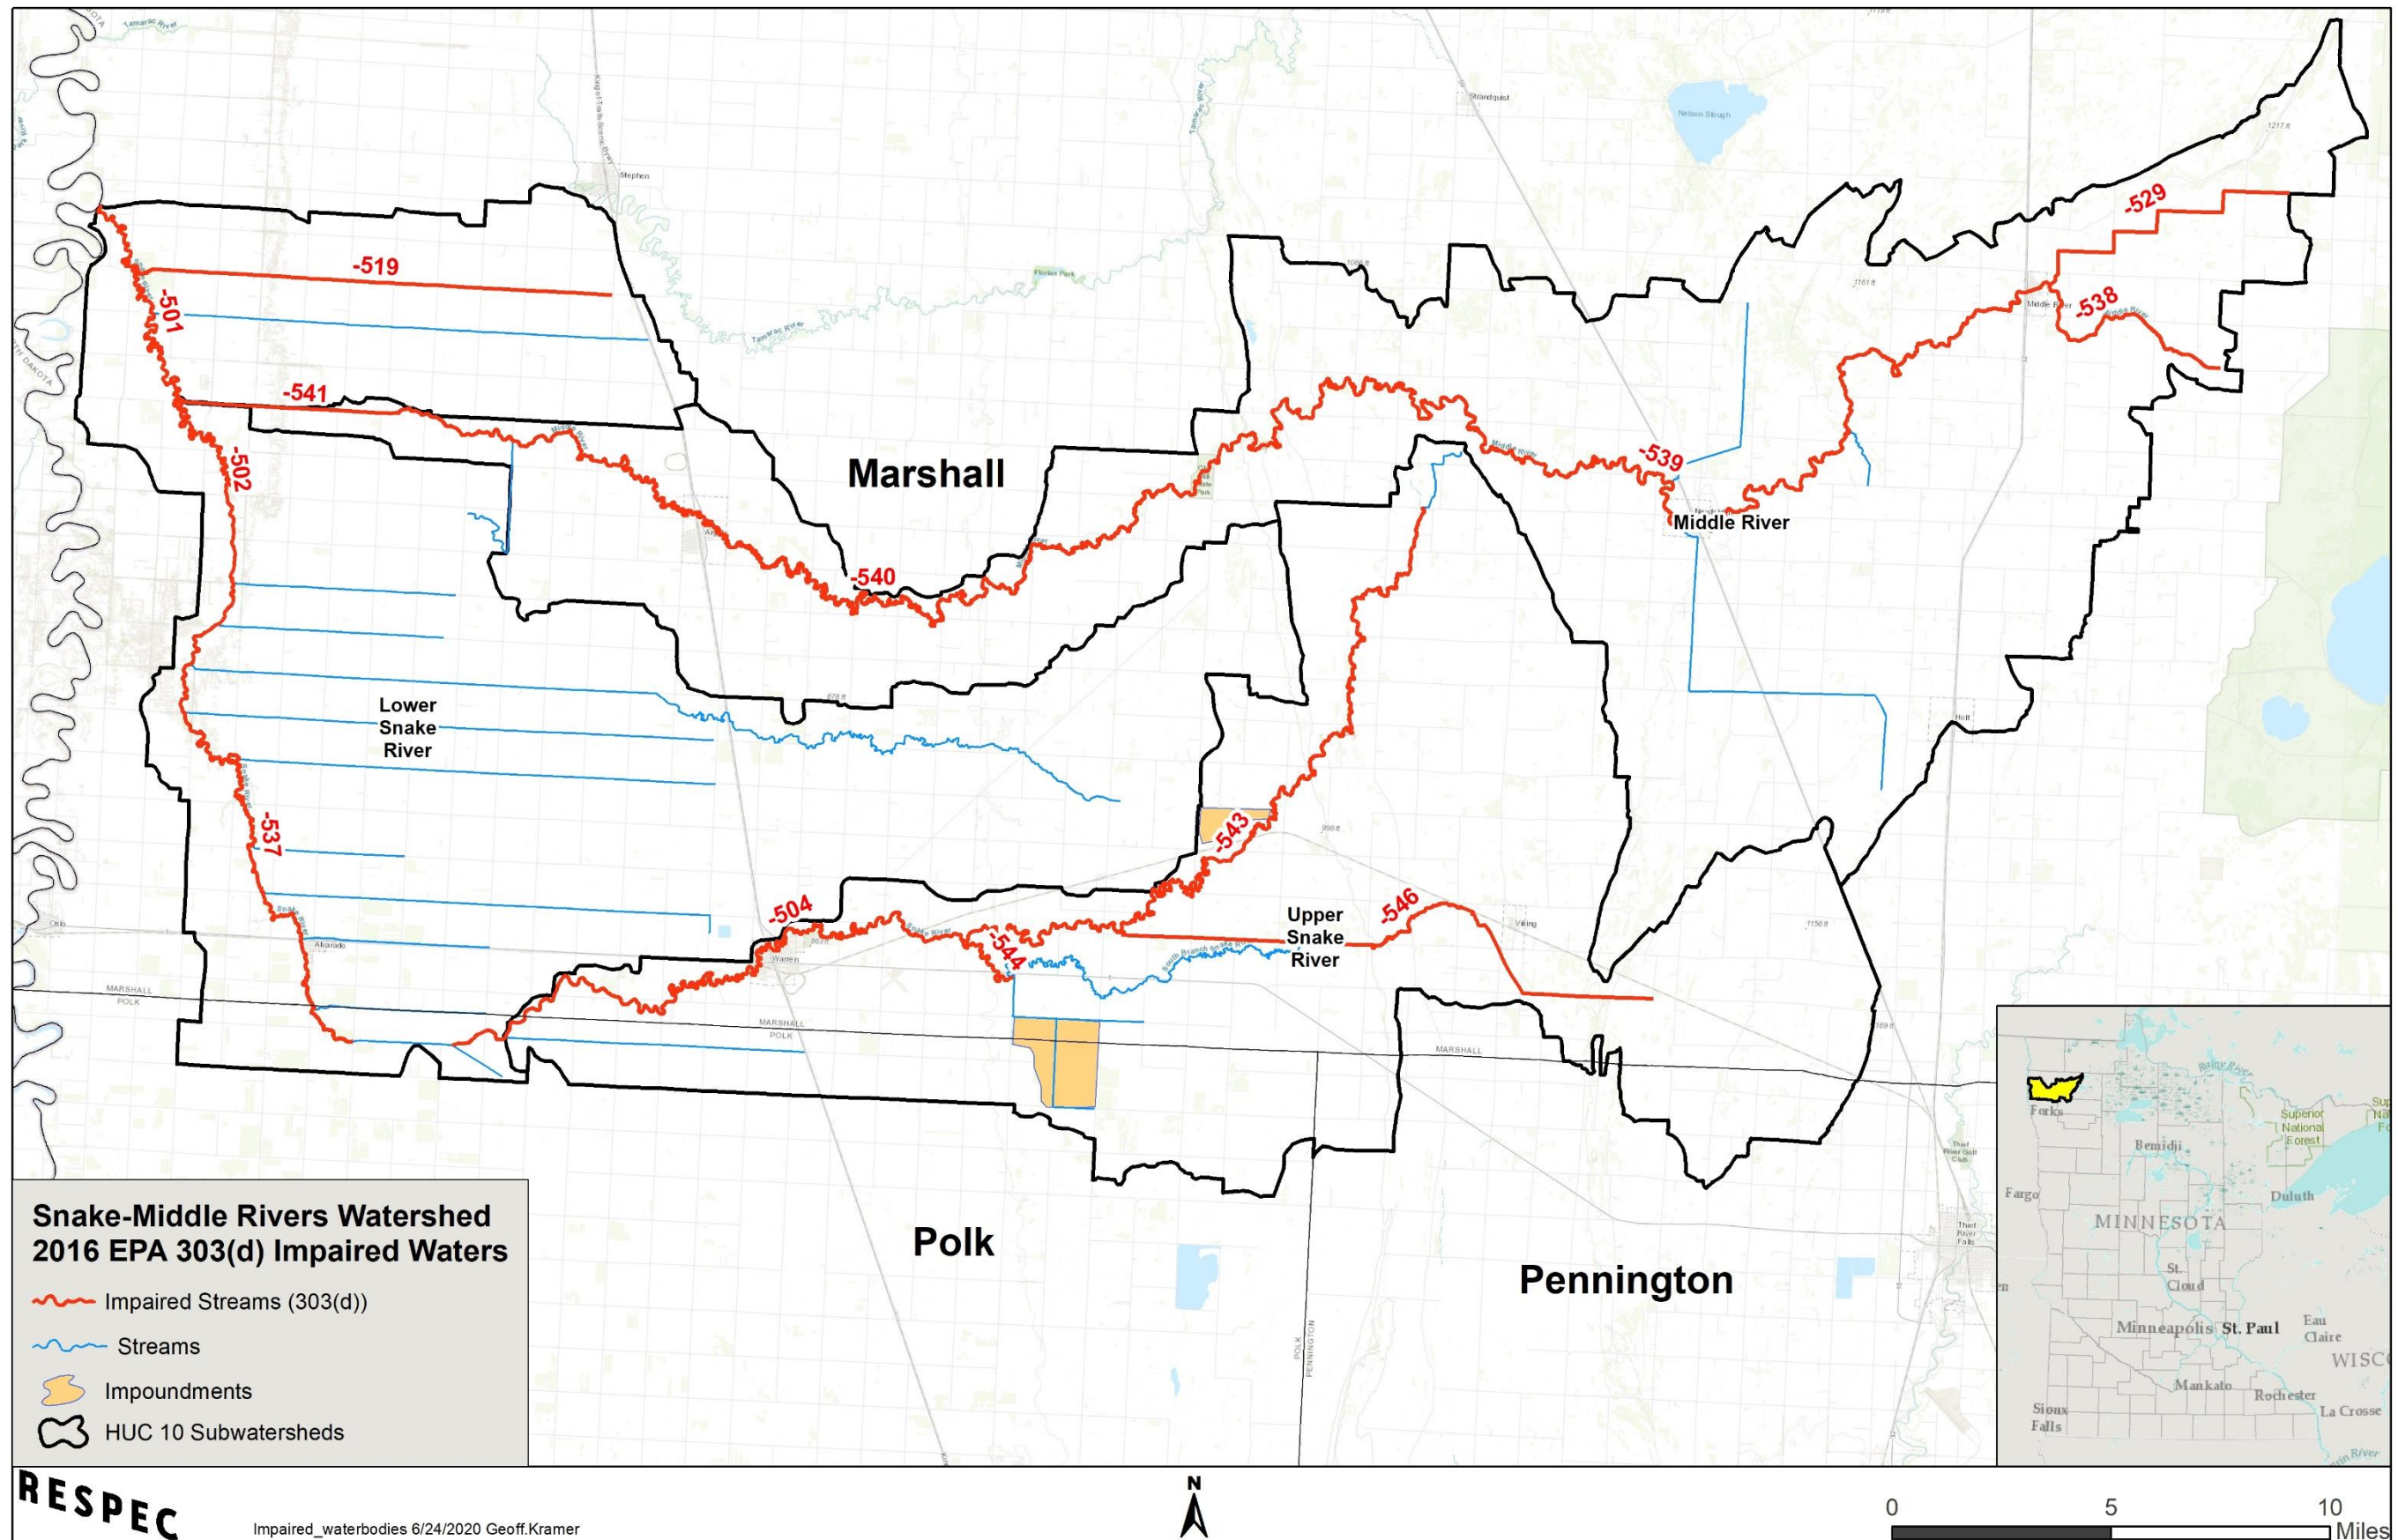
Figure 2. Impaired waterbodies in the Snake-Middle Rivers Watershed on the 2018 Impaired Waters List (MPCA 2019a).

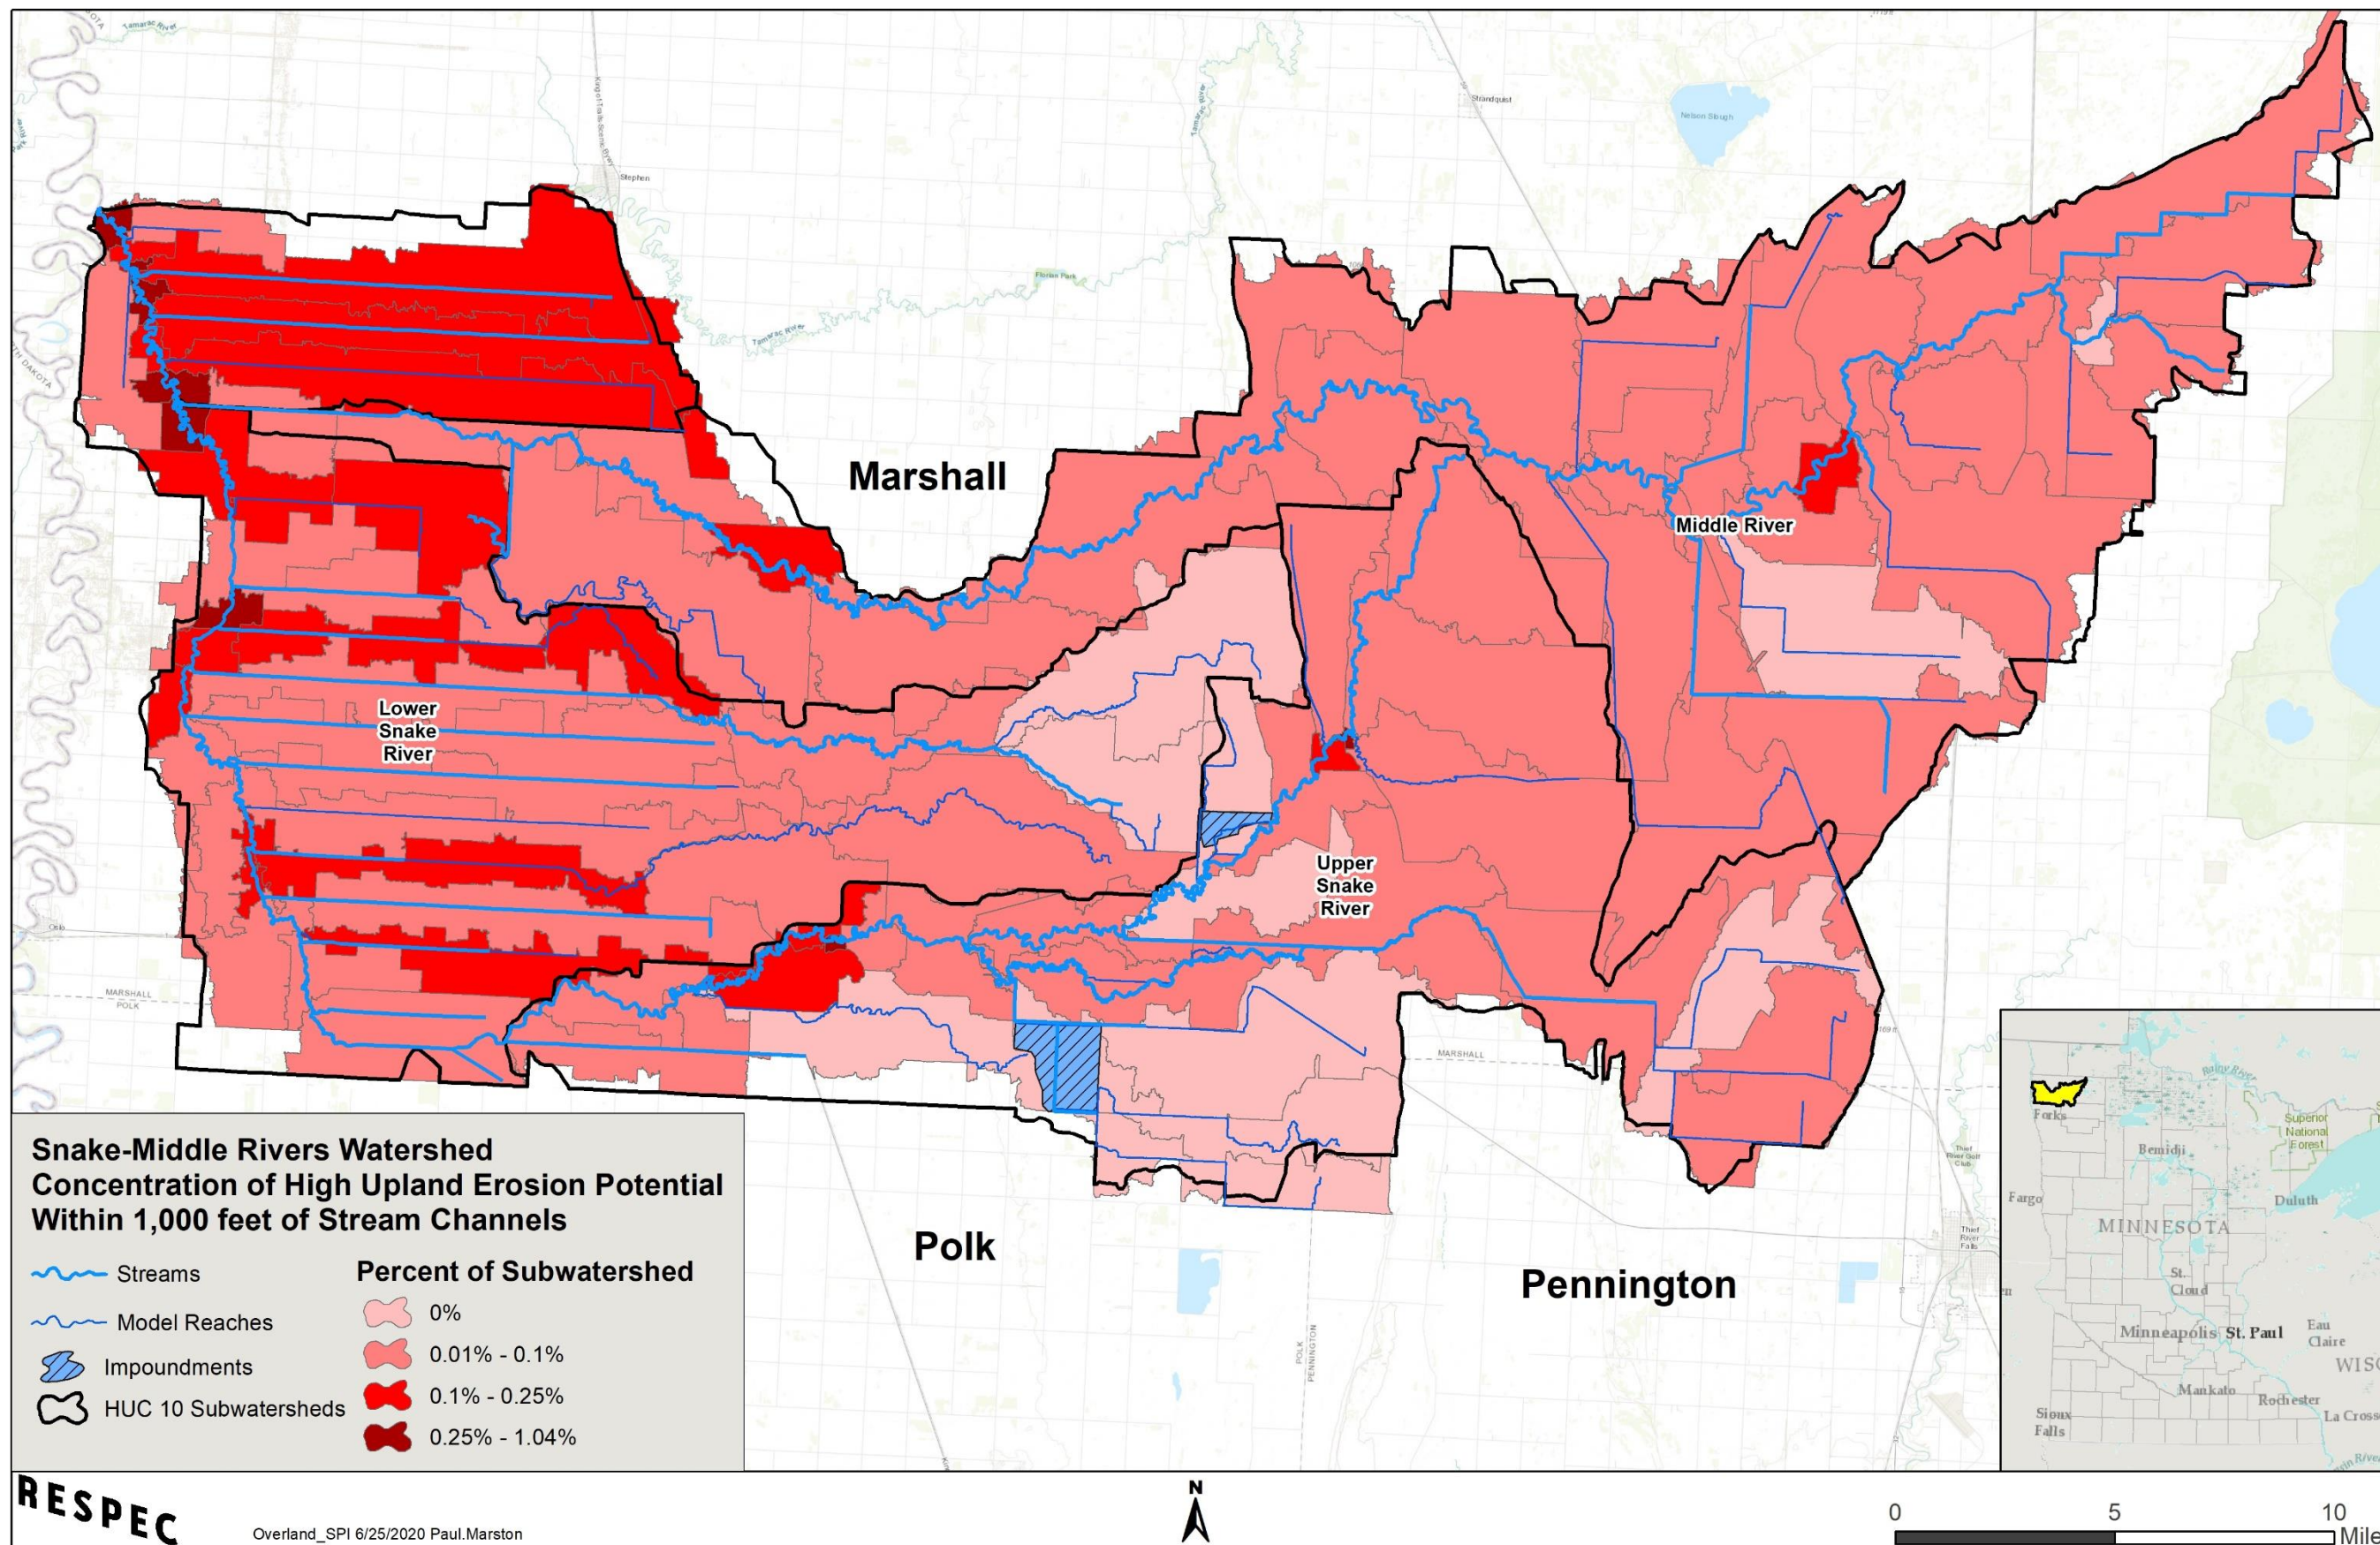
Figure 3. Concentration of high upland erosion potential areas by subwatershed in the Snake-Middle Rivers Watershed (adapted from RESPEC 2016b).

Potential treatment areas were first determined by considering only the 5% of raster values within both the SPI and CTI rasters, which identifies those areas most susceptible to erosion and most suited for surface water storage, respectively. Those areas were then overlaid with Hydrologic Soil Groups C and D, which are typically higher in clay and silt content, have a higher runoff potential (because of low infiltration rates), and are more suitable for surface storage practices like wetland restoration. Only areas within a certain distance of modeled streams and ditches were considered to identify areas of concern and opportunity that are close to stream channels. Figure 3 shows the percentage of each subwatershed having high upland erosion potential (top 5% of SPI values) and also within 1,000 feet of a stream or ditch; subwatersheds with higher concentrations may be more suitable for BMPs (e.g., Water and Sediment Control Basins [WASCOBs] or grassed waterways) that can address overland flow with high erosive potential. Figure 4 shows results of a similar analysis focused only on high erosion potential areas (top 5% of SPI values) that are also within 150 feet of a stream or ditch. Subwatersheds with higher concentrations of these areas may benefit from upland (e.g., WASCOBs or grassed waterways) or additional edge of field trapping practices such as water quality side inlets. Finally, the analysis was repeated with the CTI raster (top 5% of values) to identify areas within 1,000 feet of streams or ditches that may be suitable for upland storage (e.g., restored wetlands). Each subwatershed's concentration of these areas is shown in Figure 5.

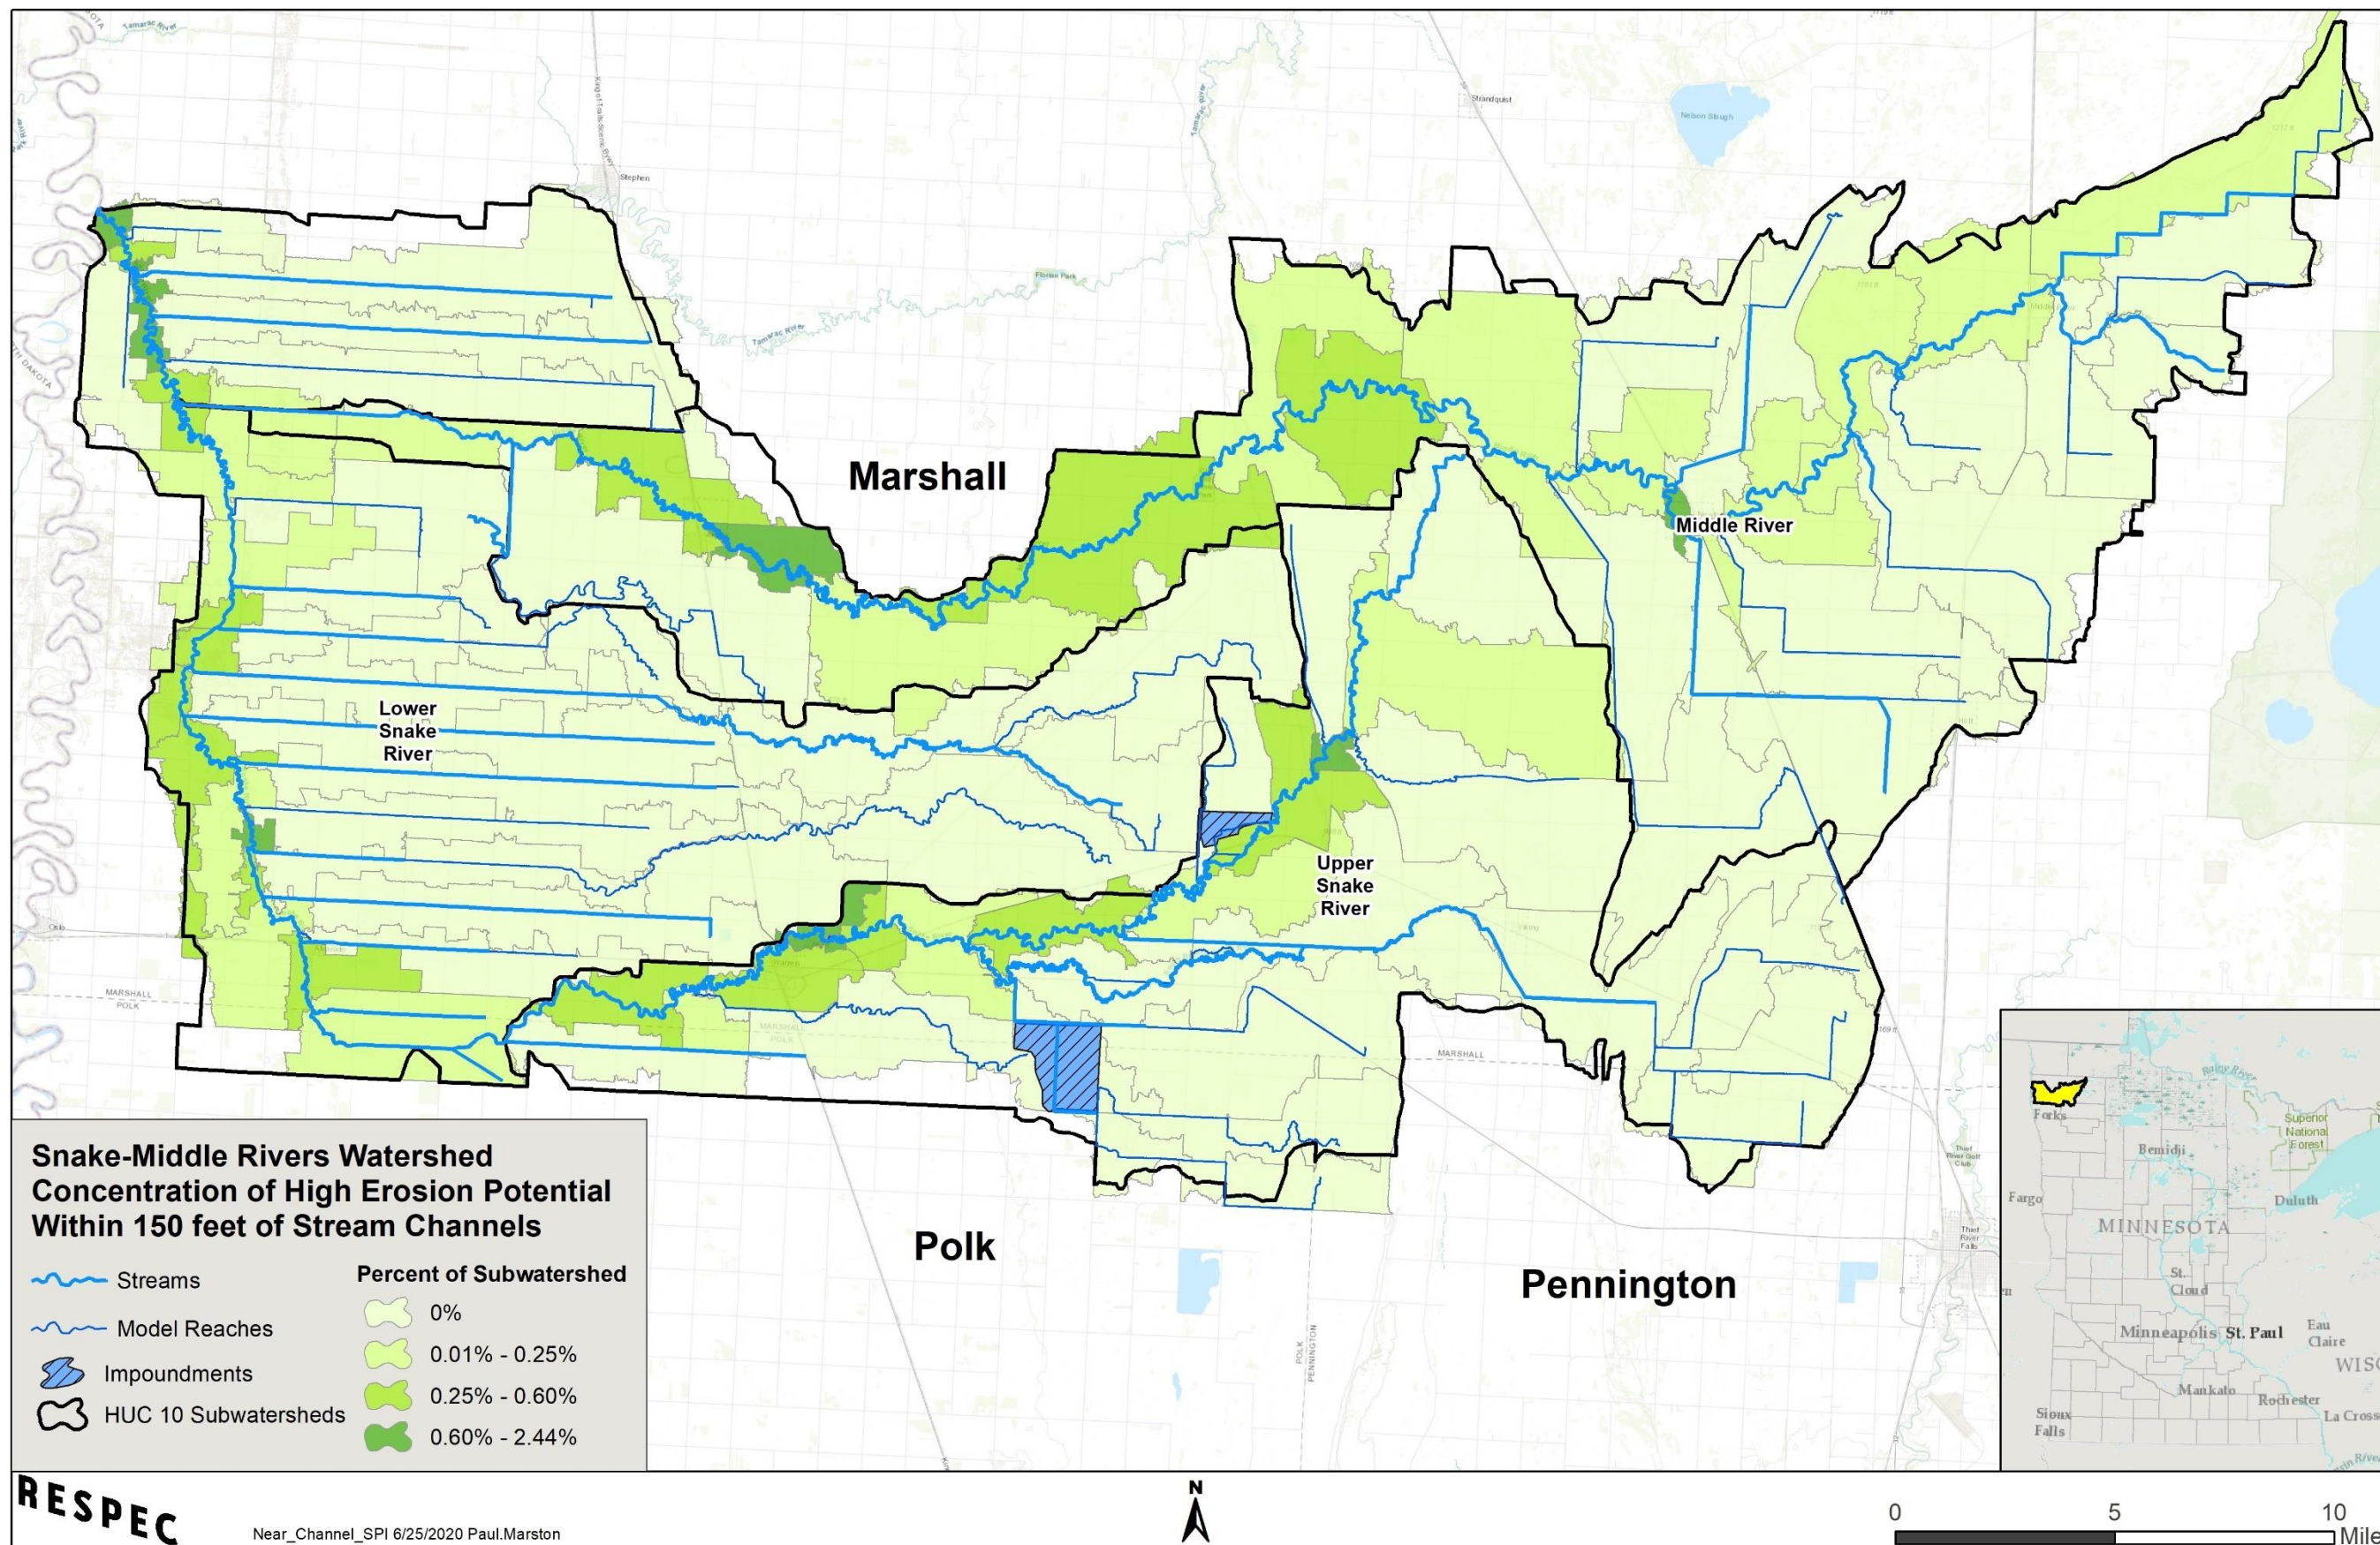
Figure 4. Concentration of high erosion potential areas within 150 feet of stream channels in the Snake-Middle Rivers Watershed (adapted from RESPEC 2016b).

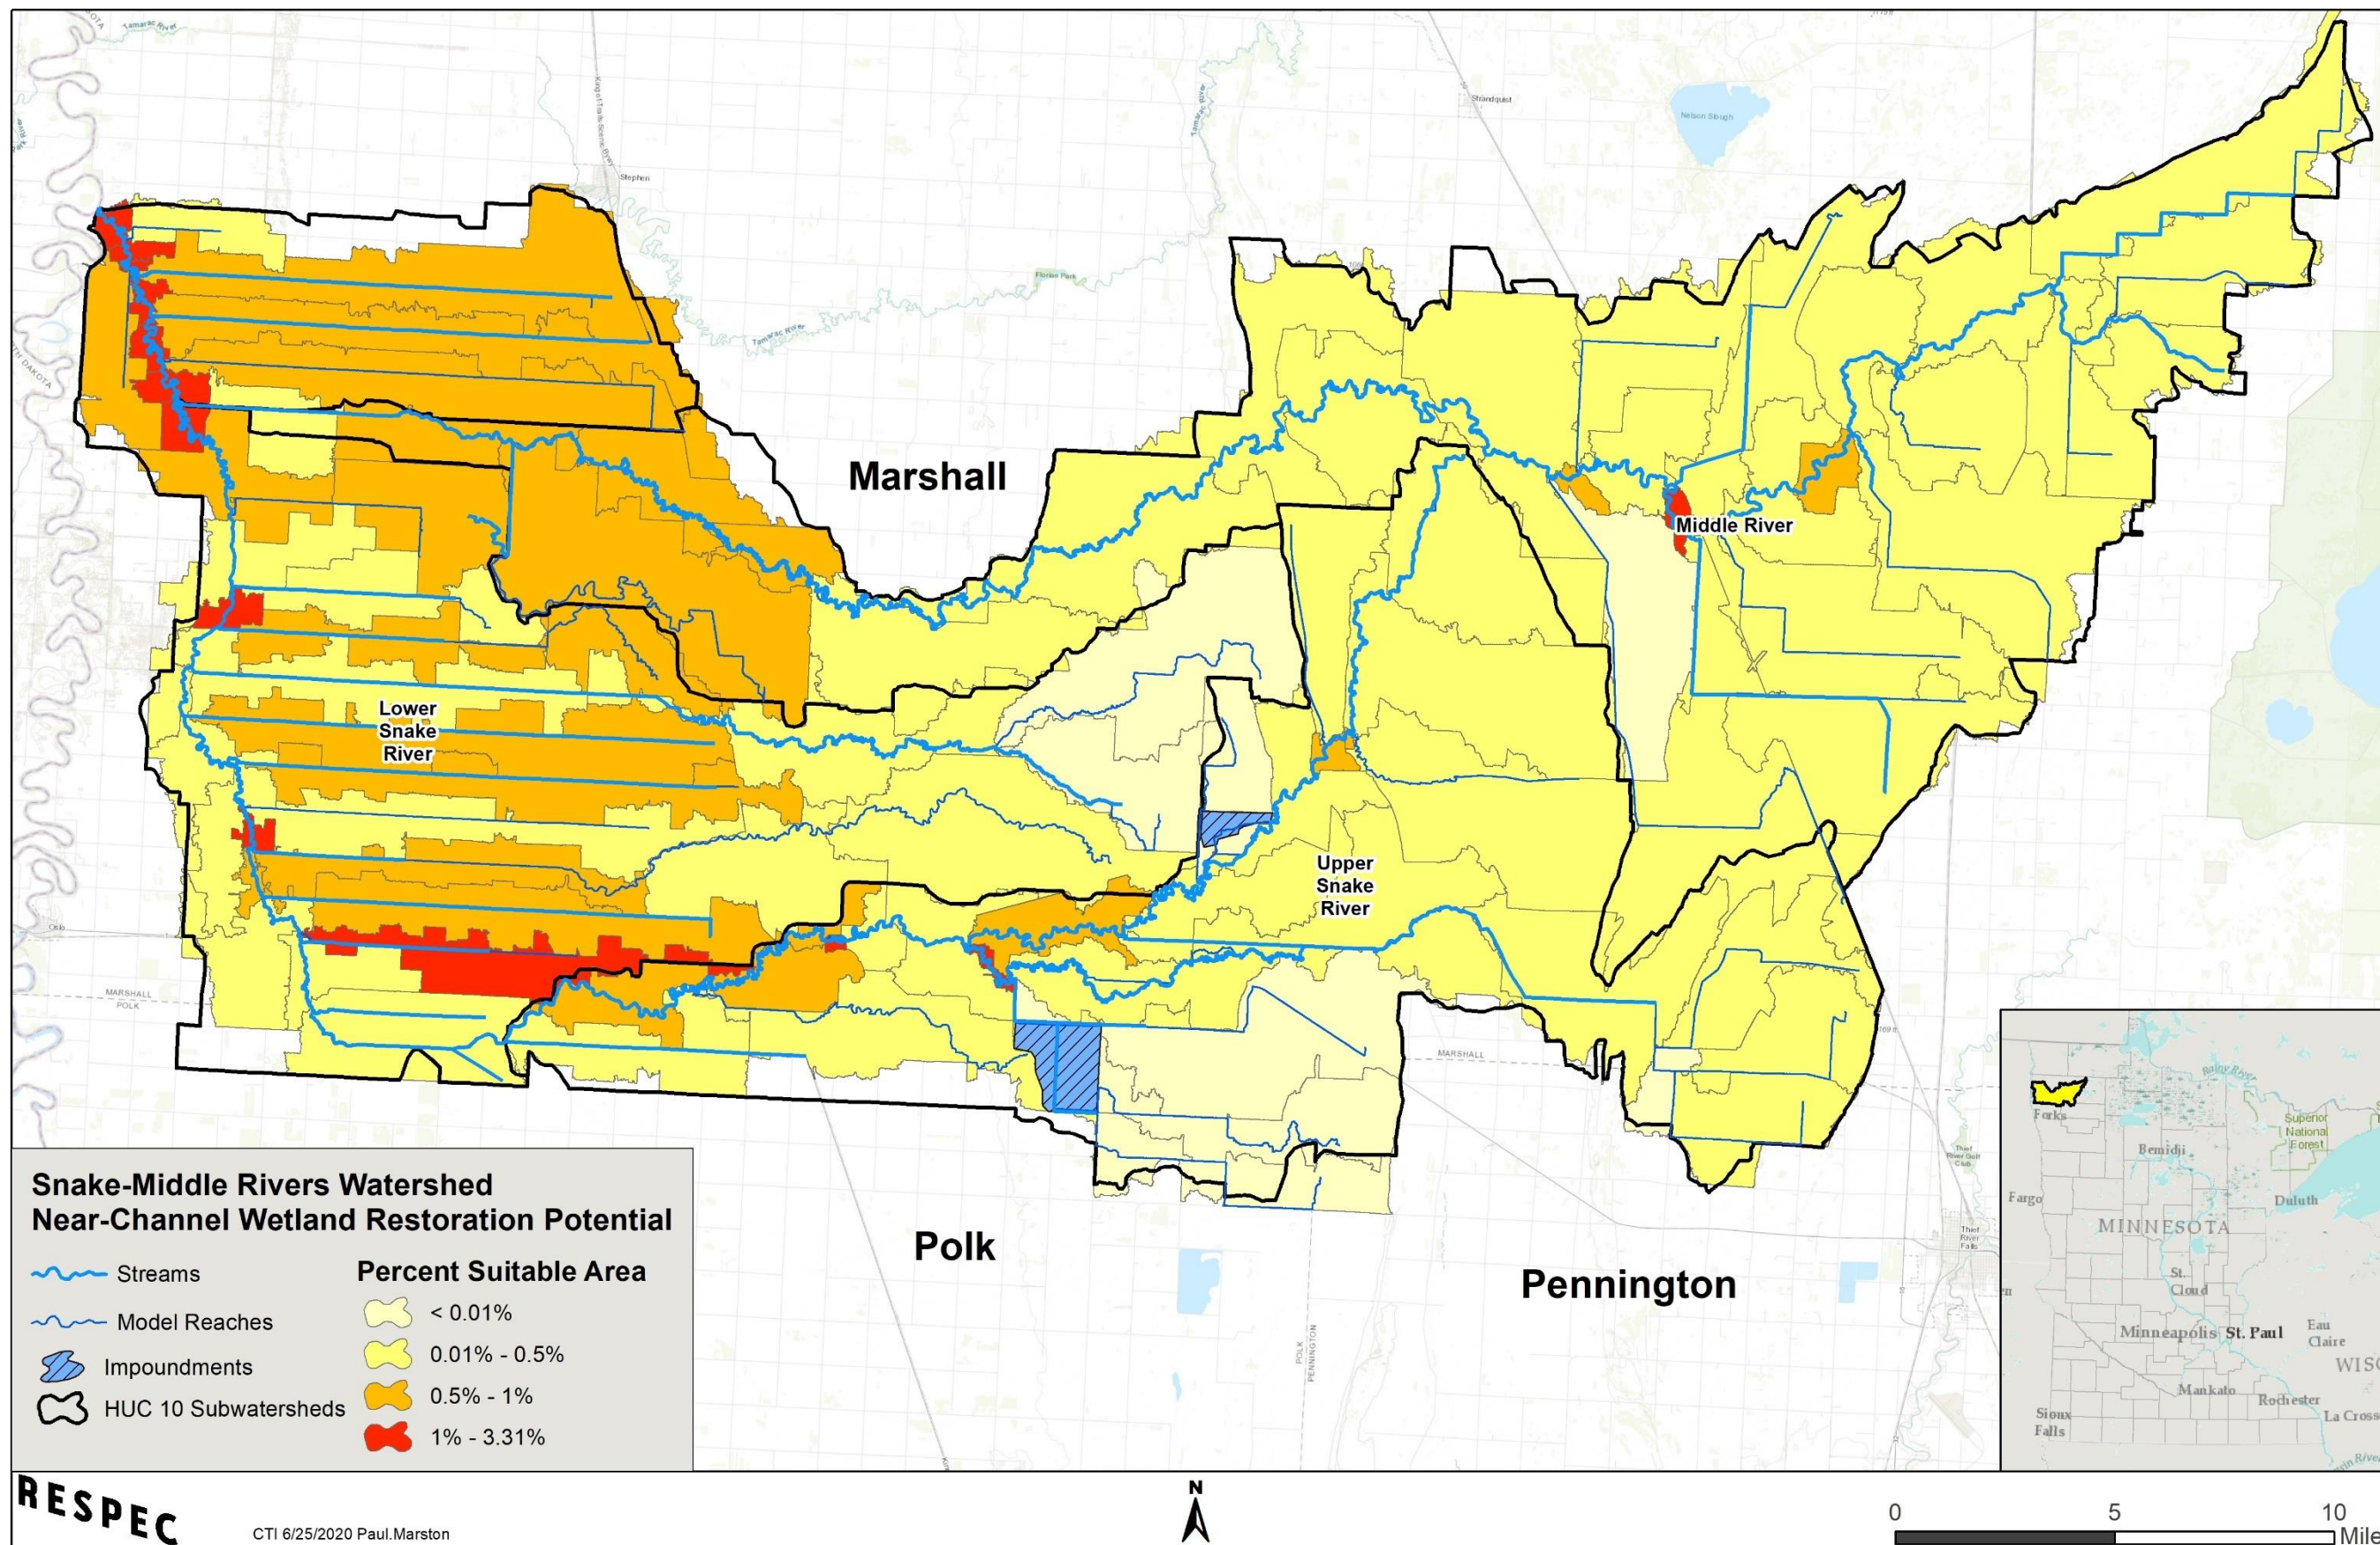
Figure 5. Wetland restoration potential in the Snake-Middle Rivers Watershed (adapted from RESPEC 2016b).

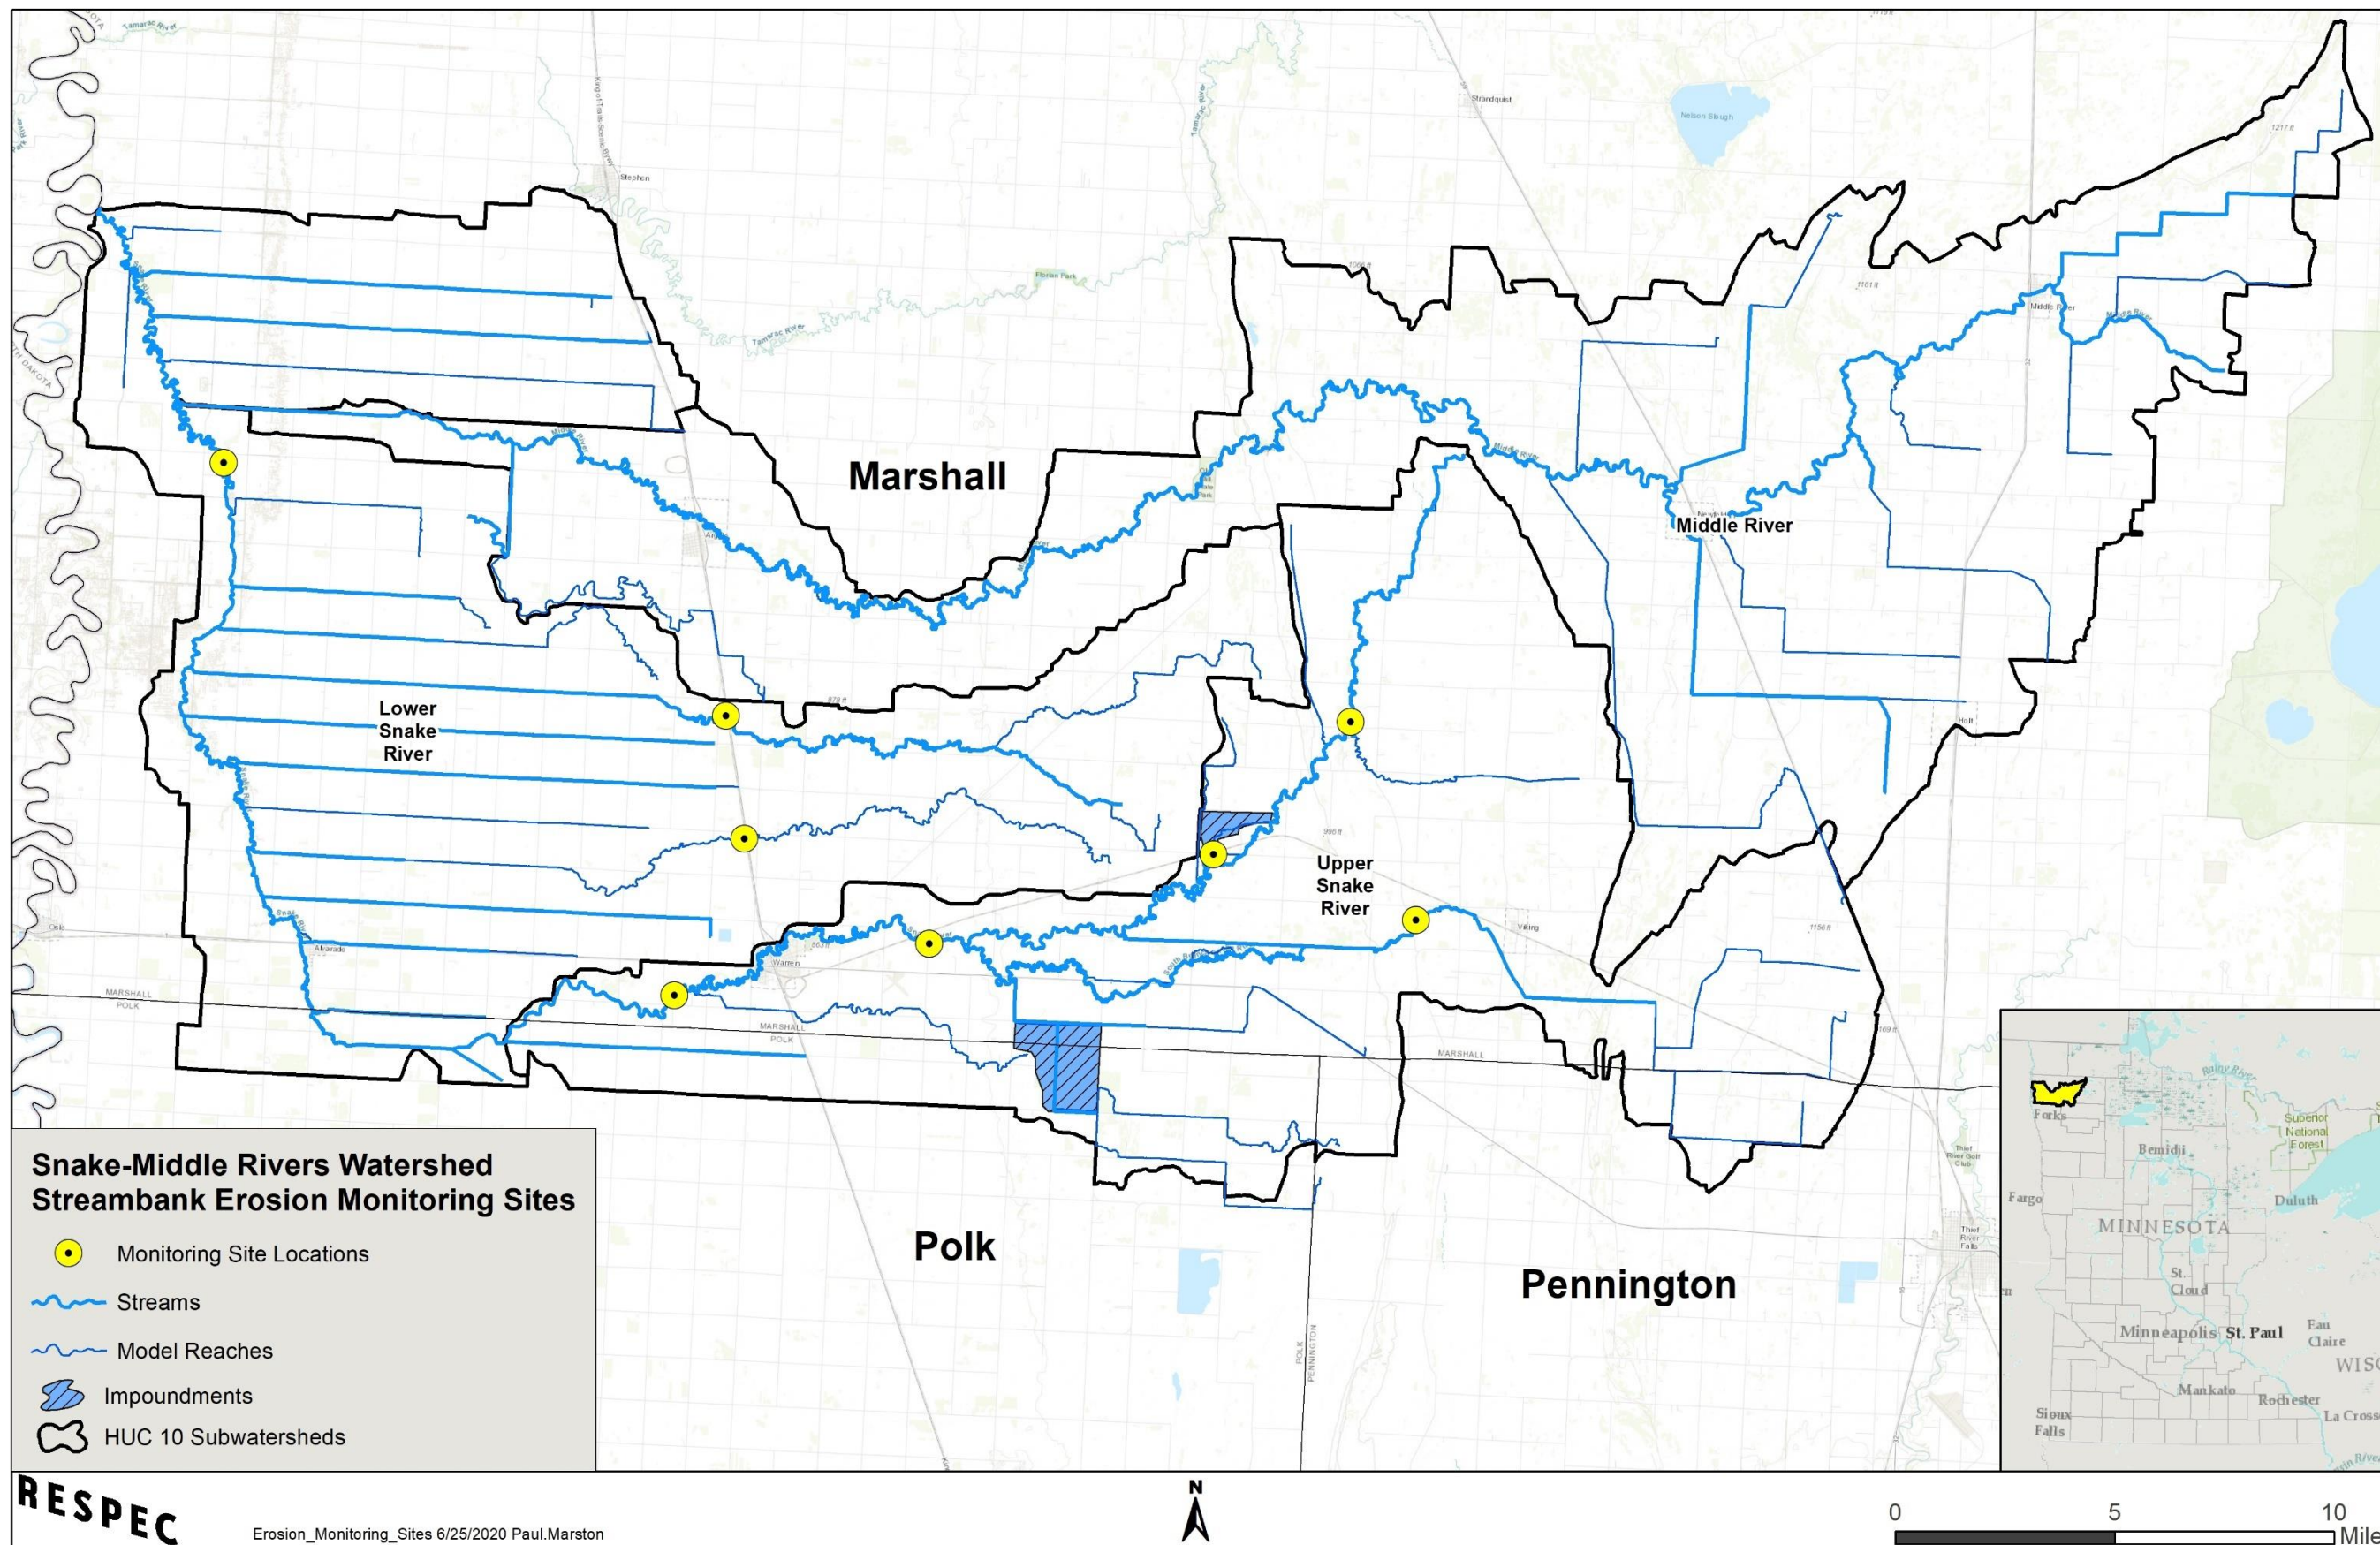
Figure 6. Snake-Middle Rivers Watershed streambank erosion monitoring sites (adapted from RESPEC 2016b).
