December 2020

Snake-Middle Rivers Watershed Restoration and Protection Strategy Report

Restoration and protection strategies for waterbodies in the Snake River Watershed in the Red River Basin

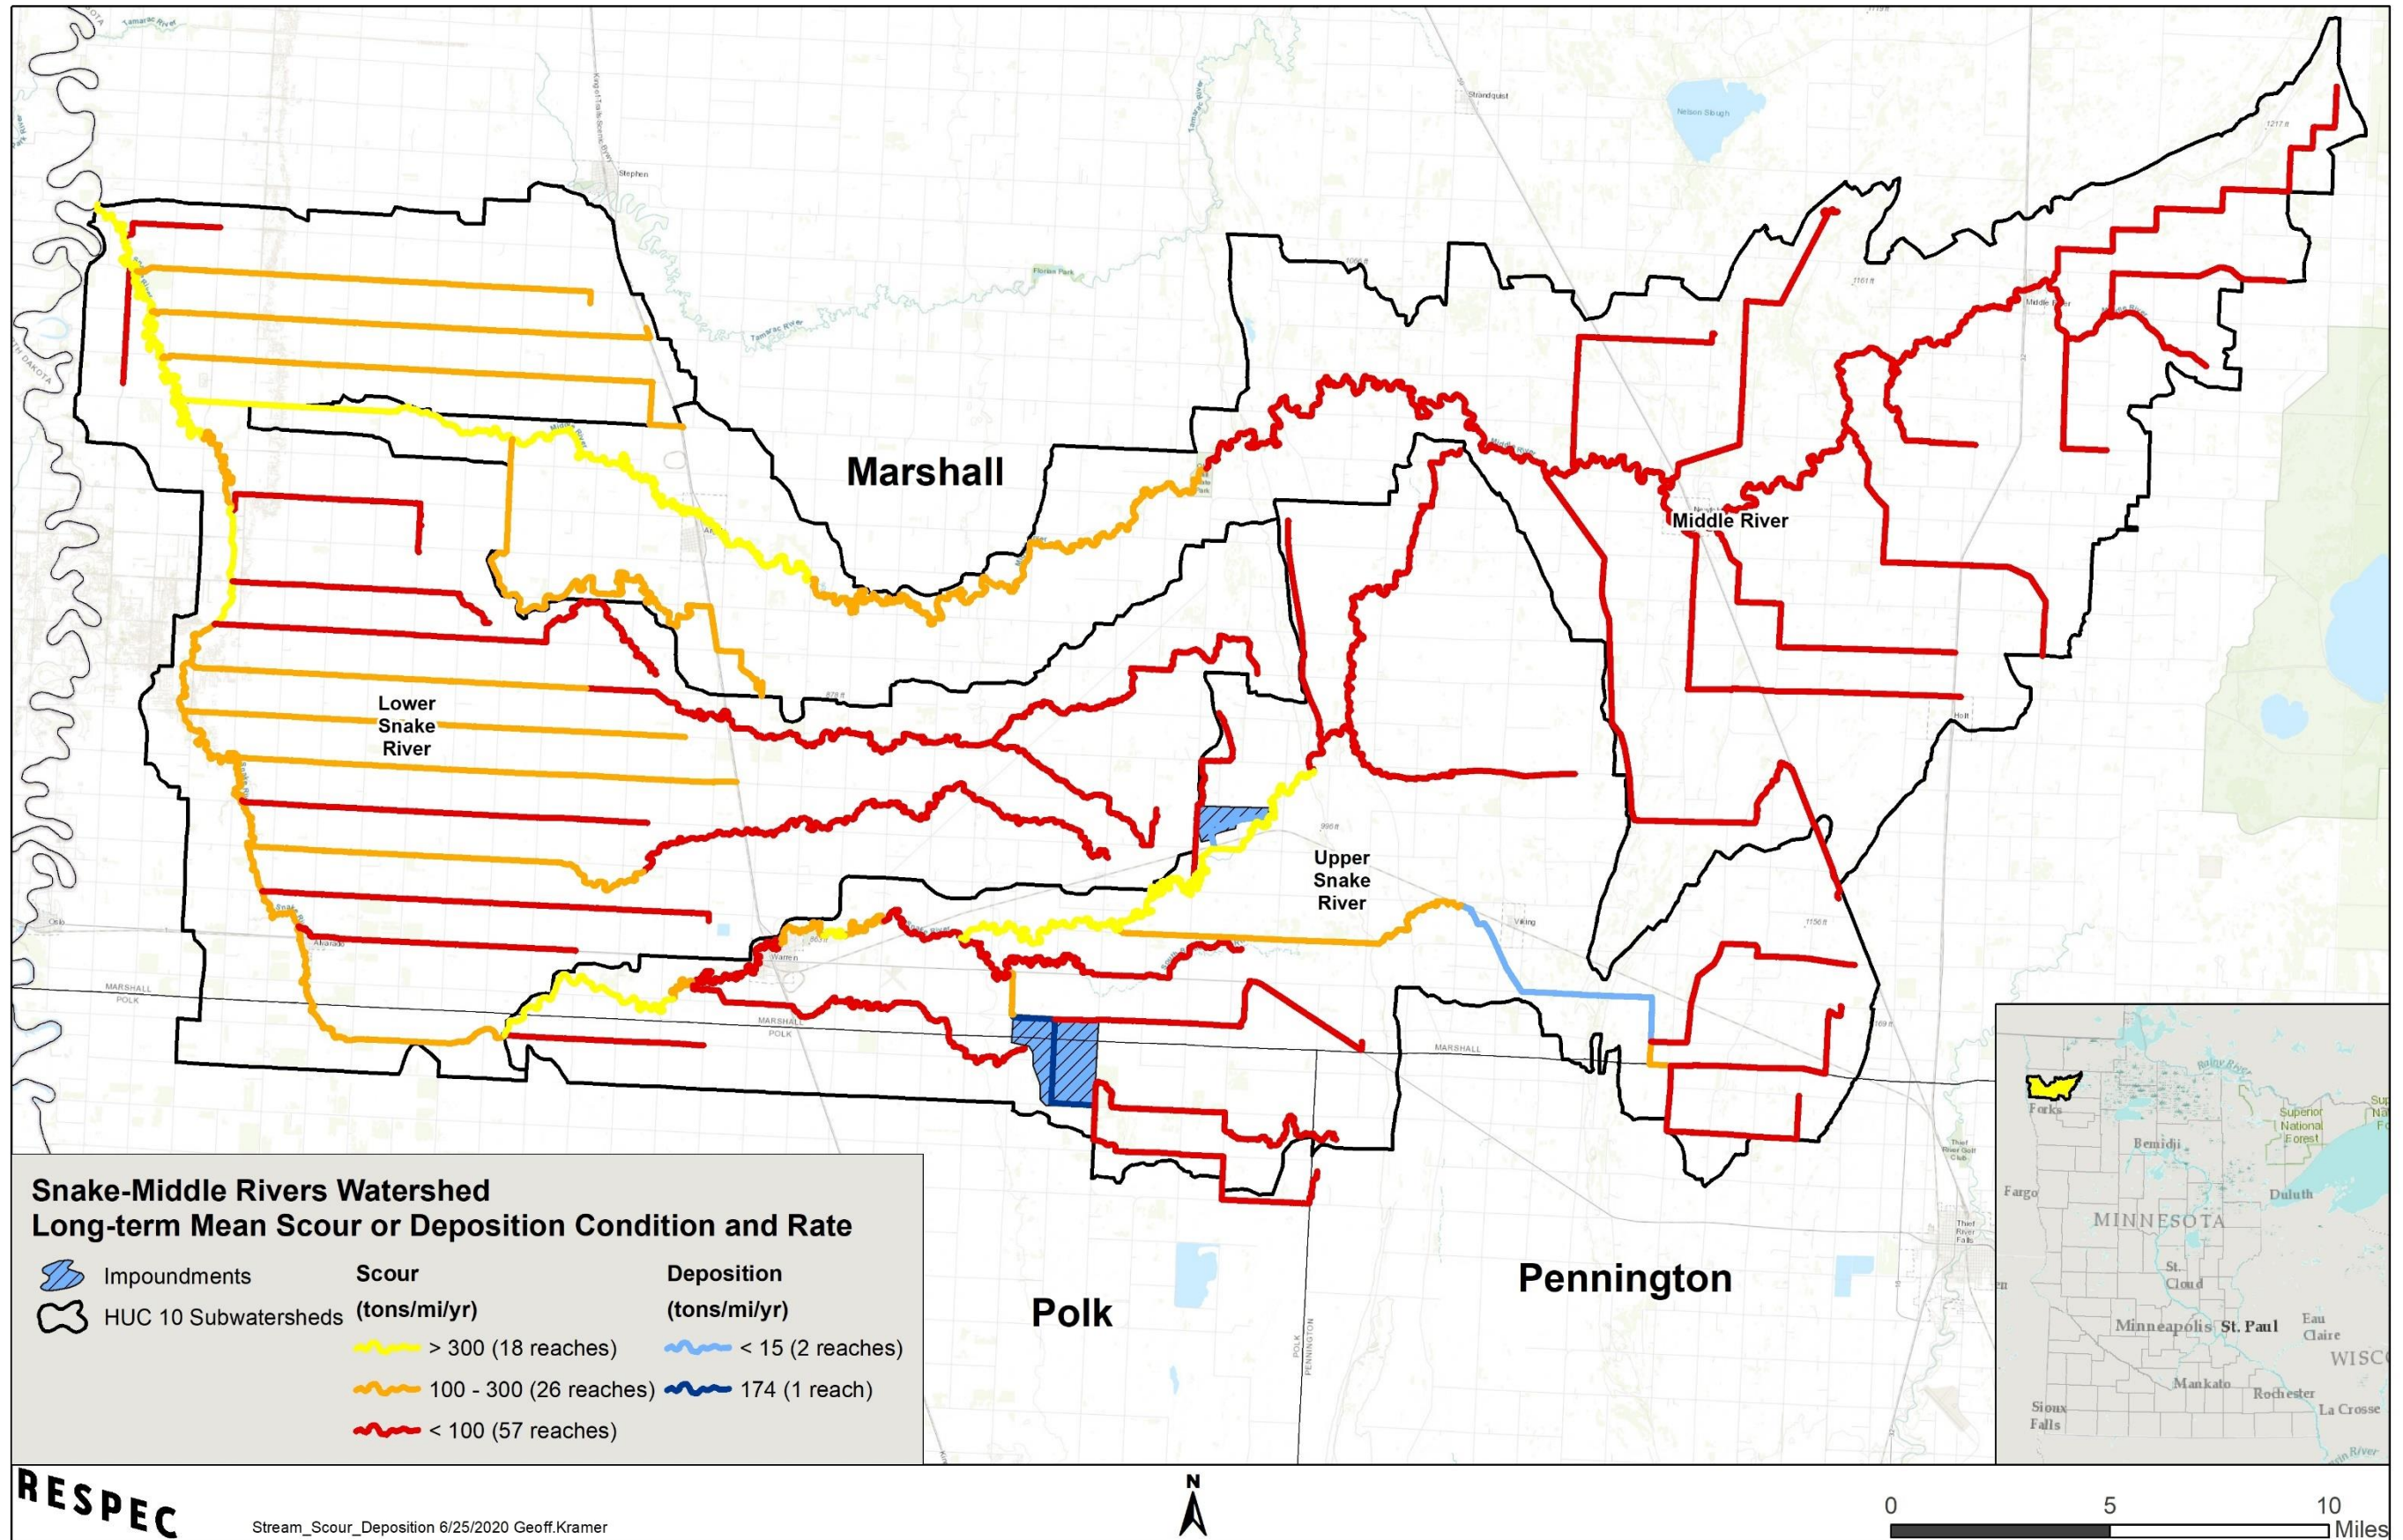
Figure 7. Long-term stream scour or deposition condition in the Snake-Middle Rivers Watershed (adapted from RESPEC 2016b).

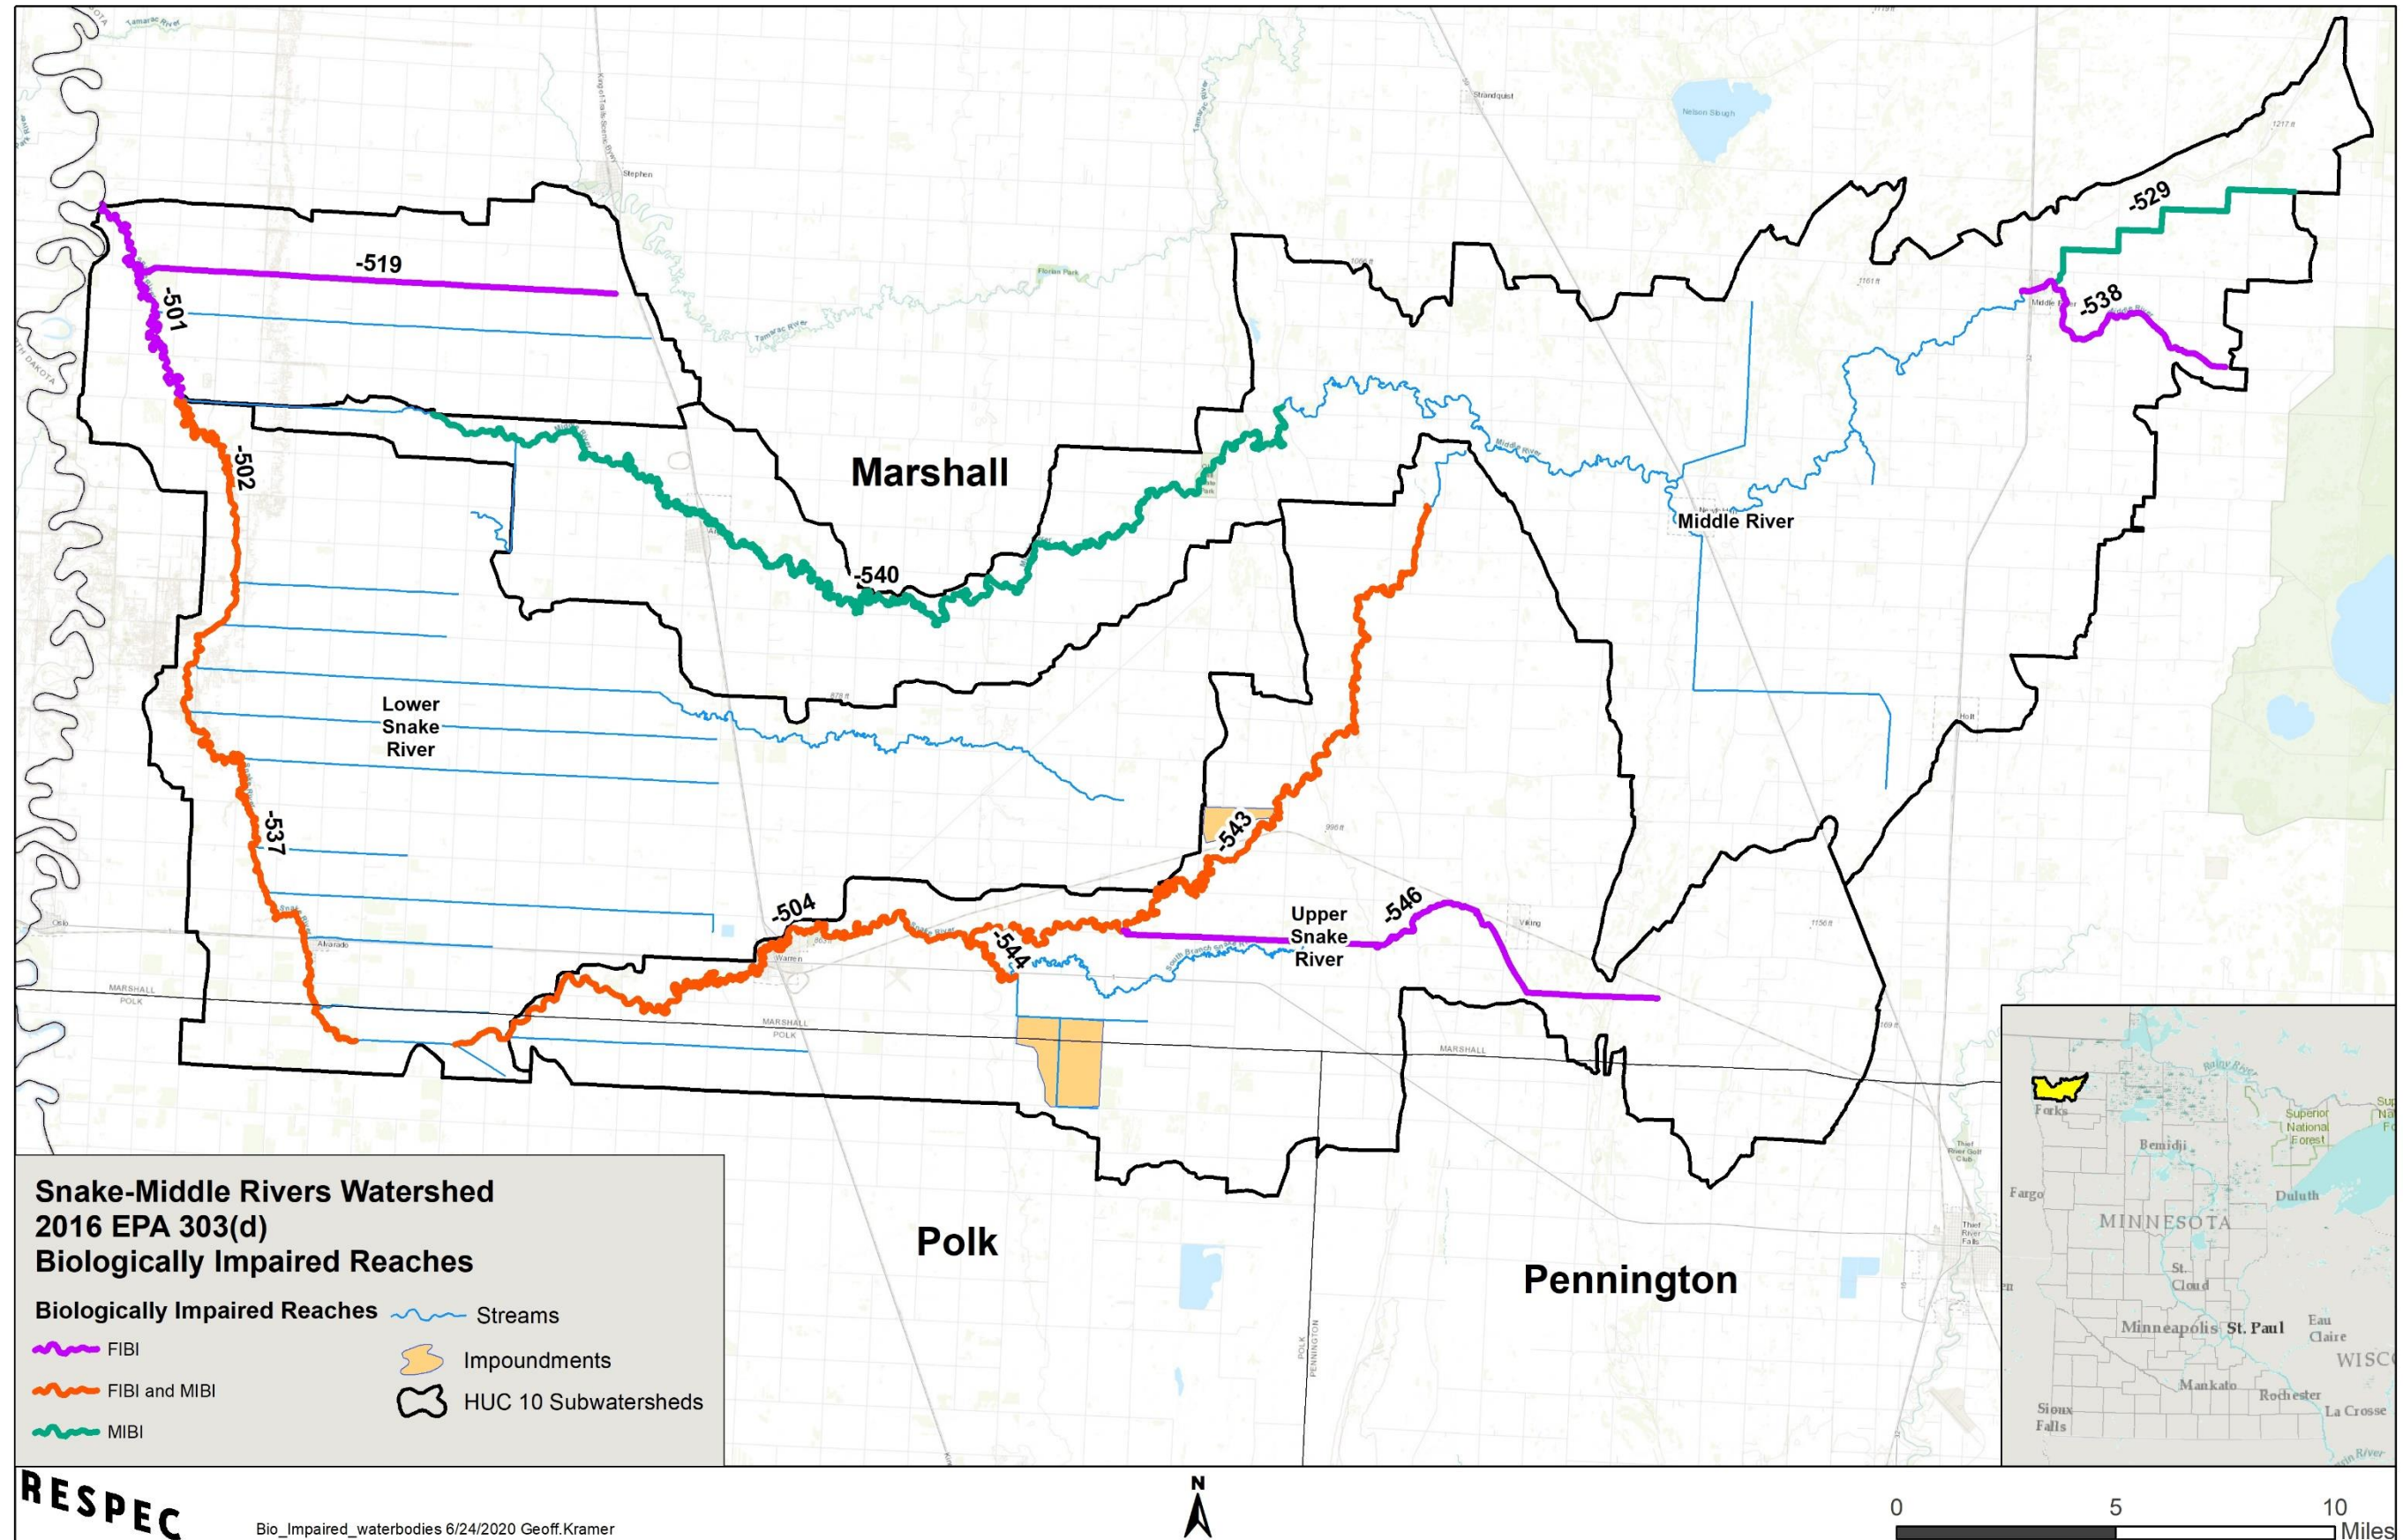
Figure 8. Biologically impaired reaches addressed in the SID report.

The [Snake River Watershed SID Report](#) (MPCA 2017) documents the efforts that were taken to identify the causes and, to some degree, the source(s) of impairments of aquatic biological communities in the SMRW. Eleven AUID reaches (Table 7) were evaluated during the SID process because they had one or both of the sampled biological communities scoring below the impairment thresholds per the [Watershed Monitoring and Assessment Report](#) (MPCA 2016). The locations of the biologically impaired reaches assessed in the SID process are shown in Figure 8.

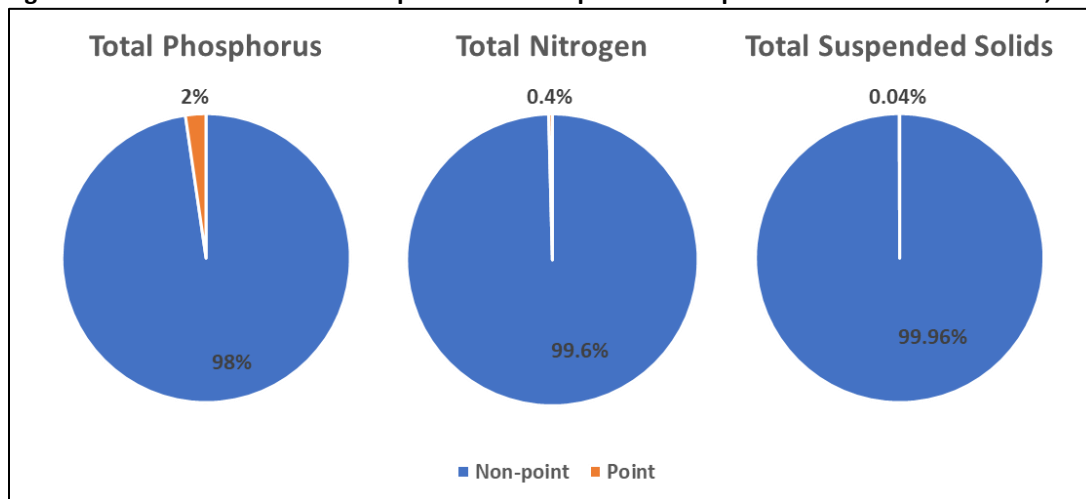
Figure 9. Overall breakdown of nonpoint source vs. point source pollution in the SMRW for TP, TN, and TSS.

This section summarizes the sources of pollutants (e.g., phosphorus, bacteria, or sediment) to surface waters in the SMRW, including point sources (such as wastewater treatment plants [WWTPs]) or nonpoint sources (e.g., runoff from the land). By using the calibrated HSPF model, loading from all of the nonpoint sources was compared to loading from point sources for TP, total nitrogen (TN), and TSS, which indicates that nonpoint source pollution is the major concern in the SMRW (Figure 9).

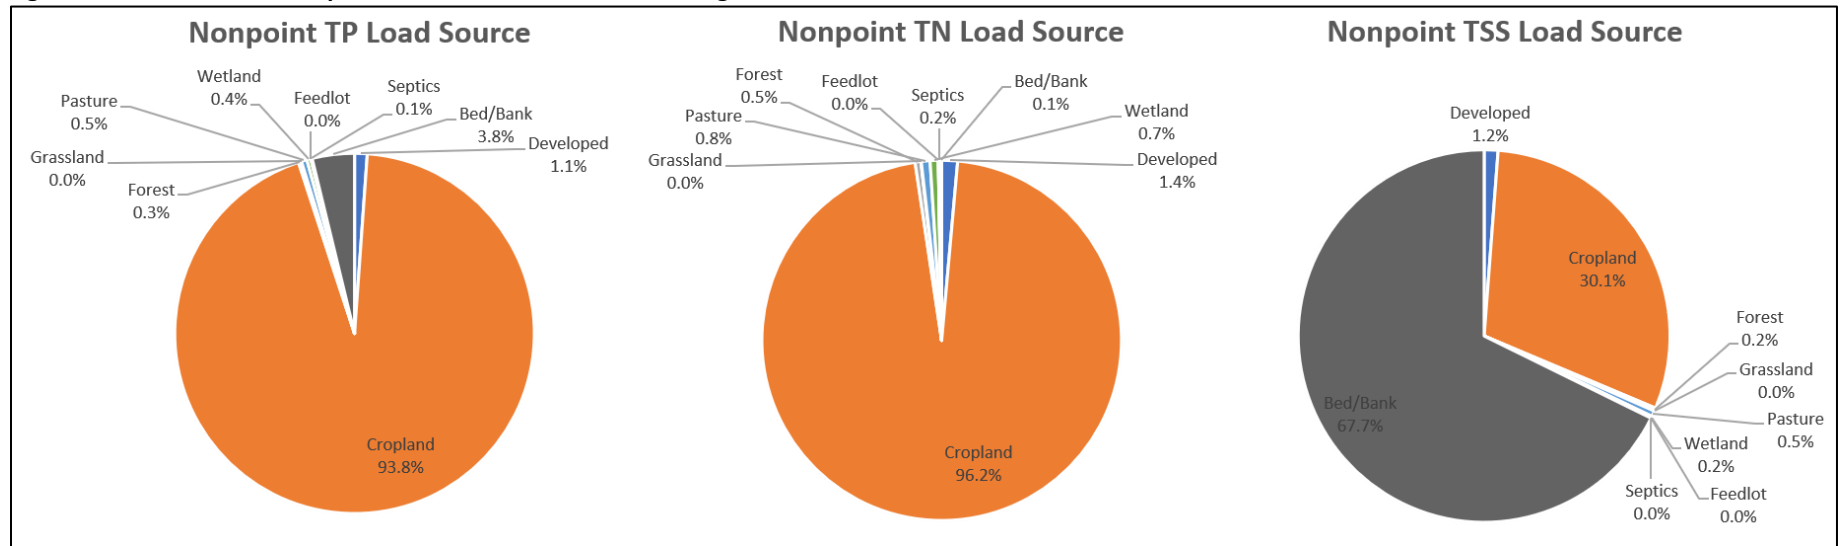
Figure 10. Breakdown of nonpoint source TP, TN, and TSS loading in the Snake-Middle Rivers Watershed.

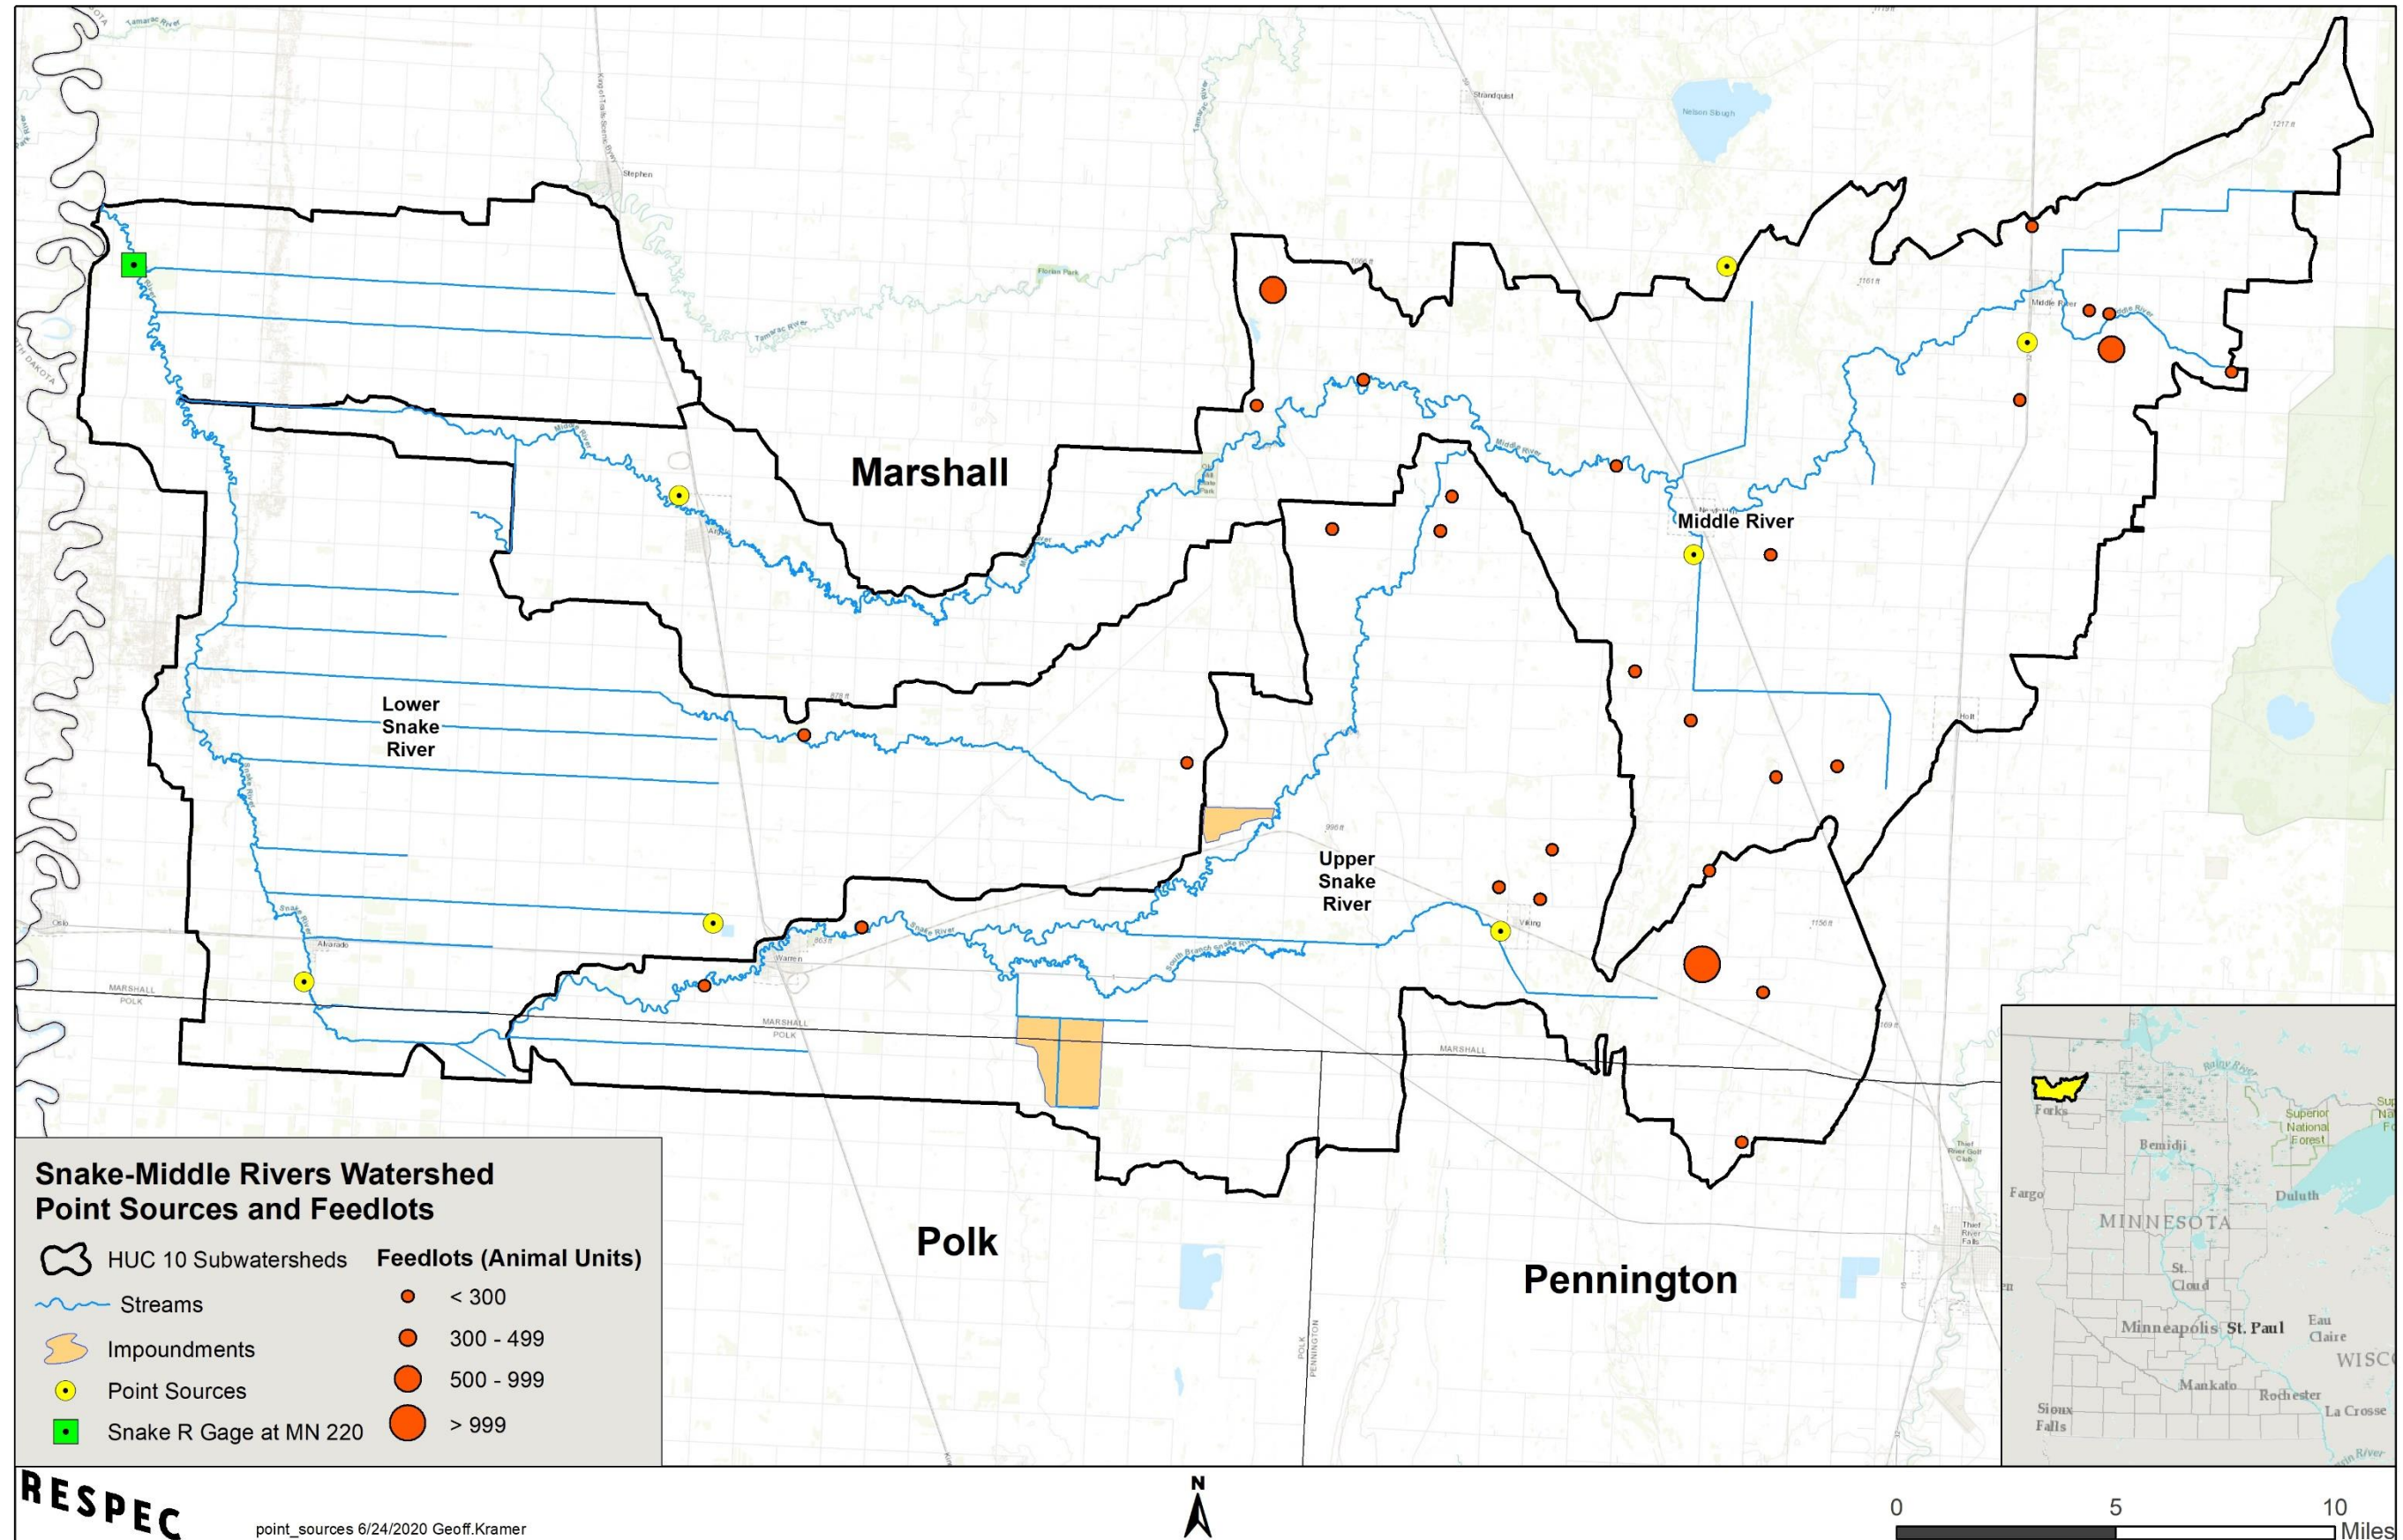
Figure 11. Point sources and animal feedlots (MPCA 2020c) in the Snake-Middle Rivers Watershed.

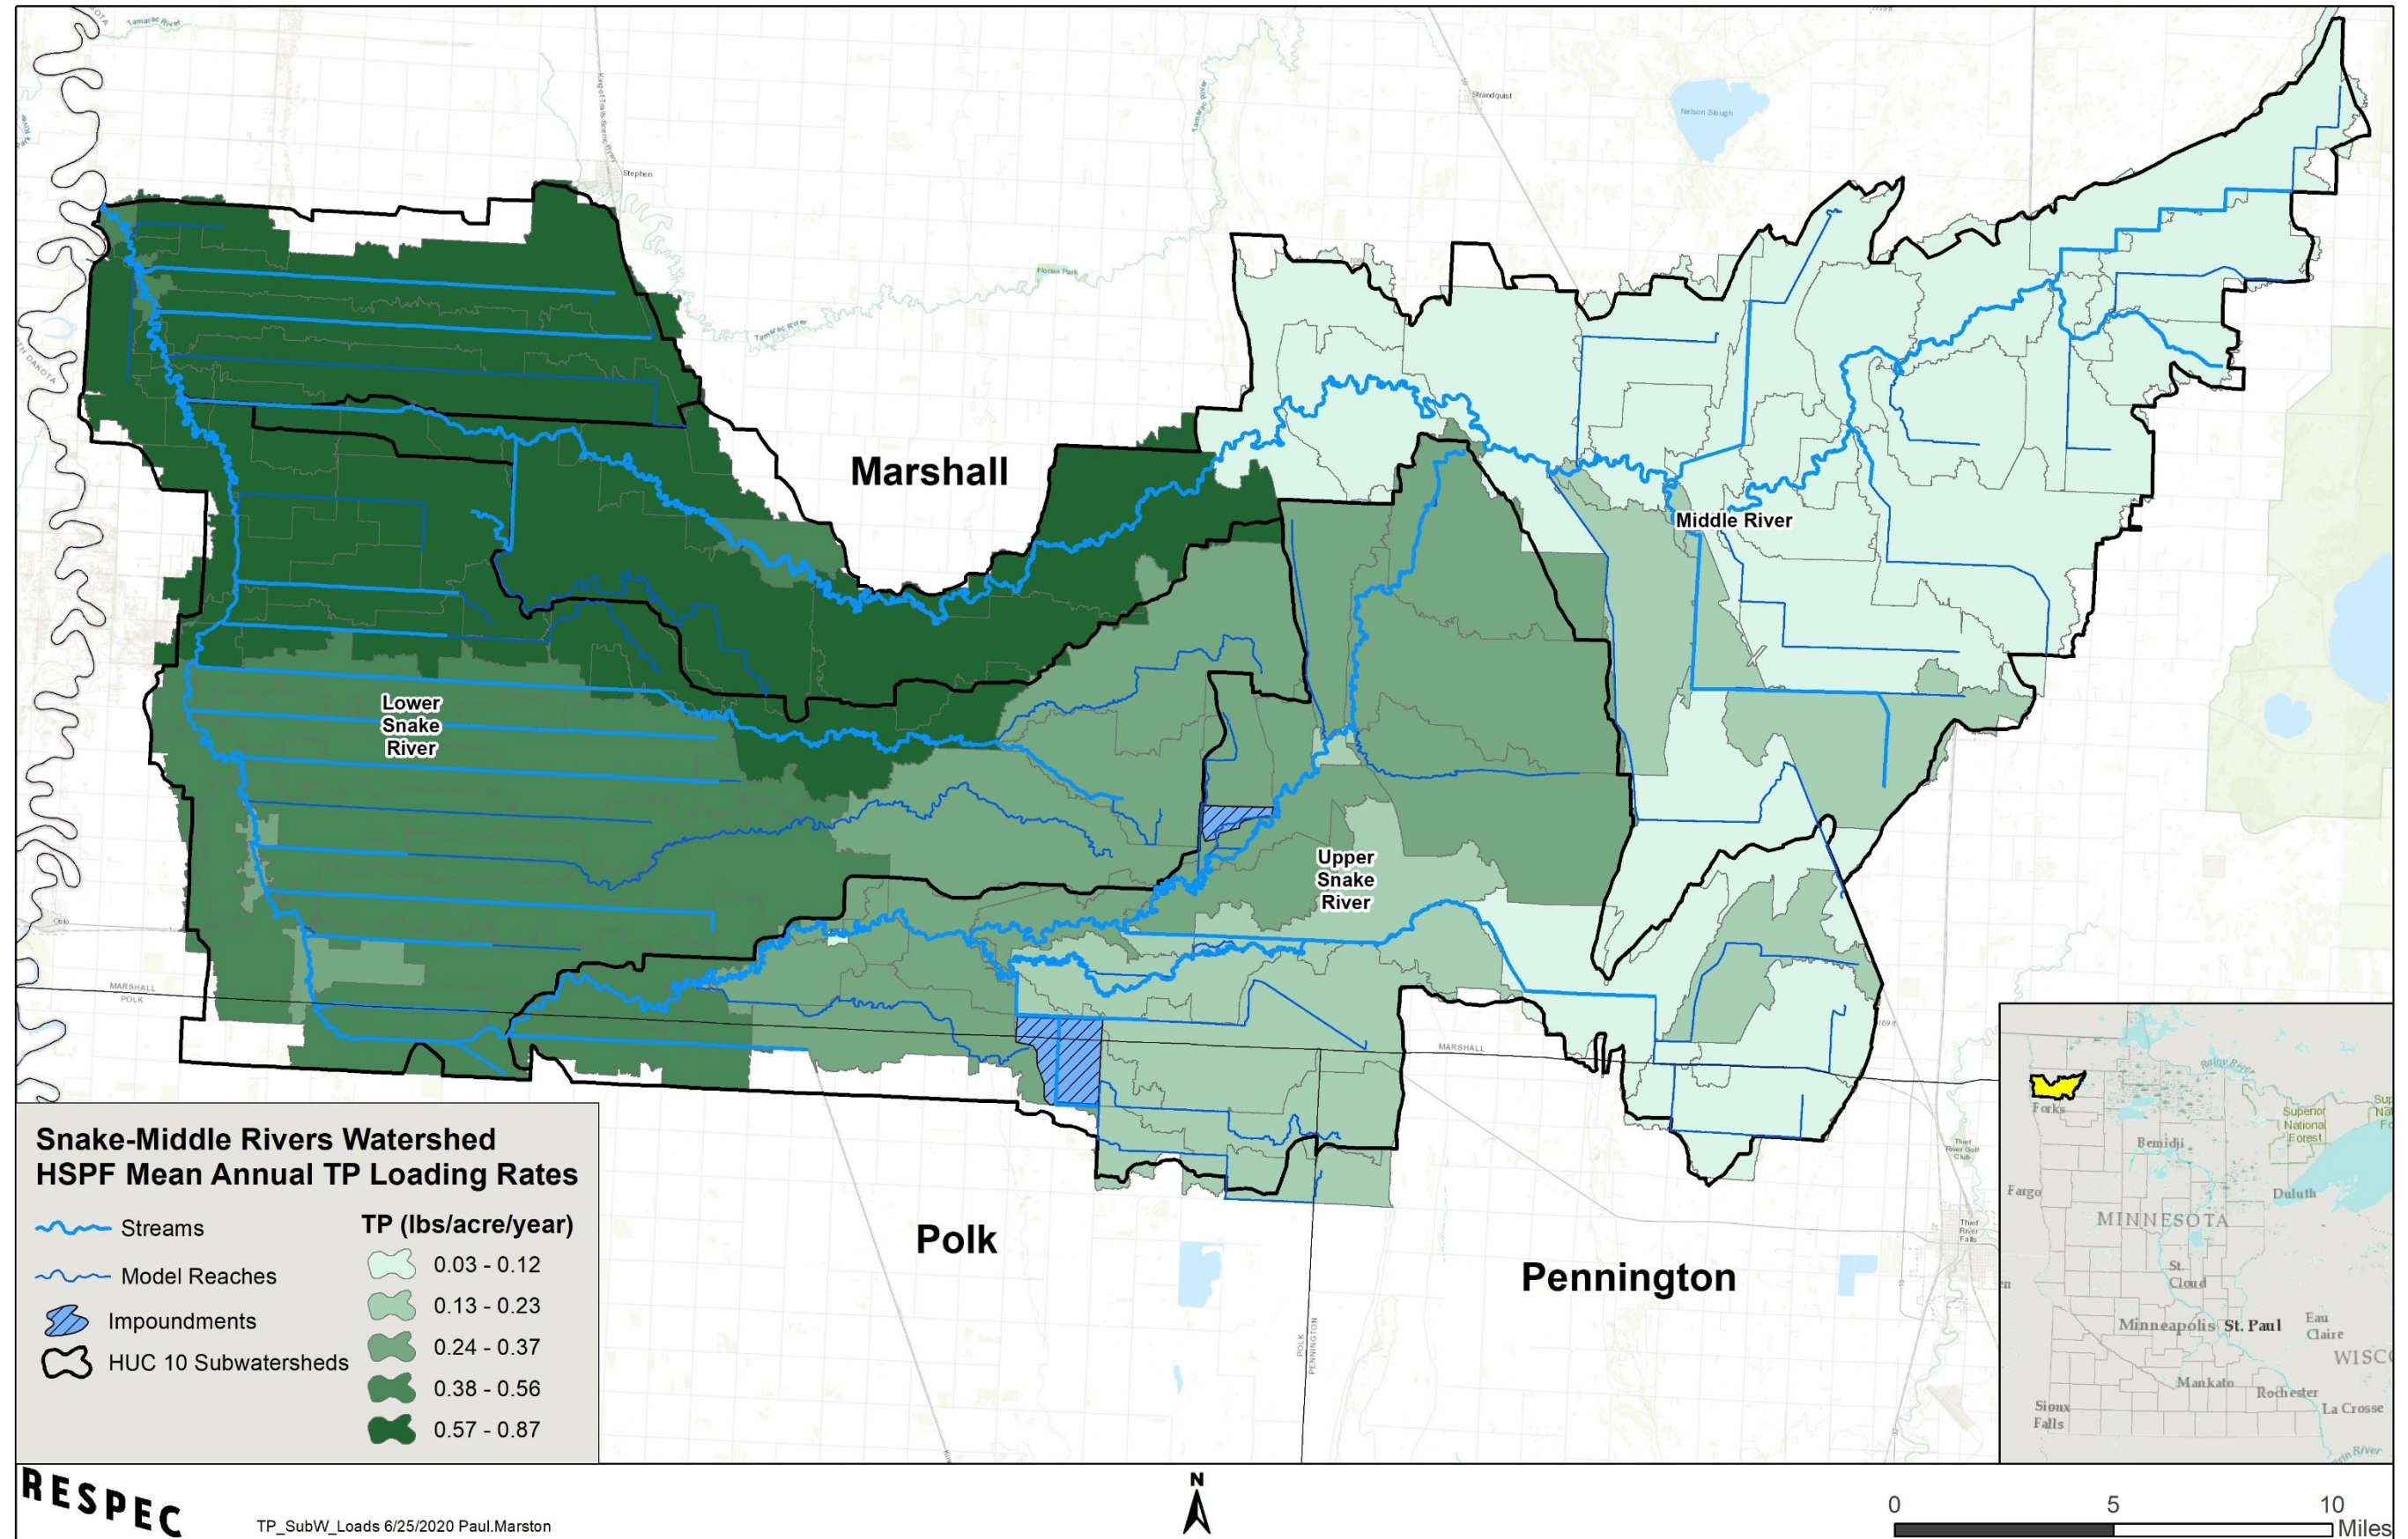
Figure 12. Mean annual total phosphorus loading rates by subwatershed in the Snake-Middle Rivers Watershed.

by land cover type in the SMRW. The loading rates for these pollutants are shown in Figure 12 (phosphorus), Figure 13 (nitrogen), and Figure 14 (TSS). Nutrient loading from cropland is delivered to streams and transported downstream. Flashy hydrographs caused by altered hydrology (tile drainage, ditching, and land cover change) create large sediment loads associated with bank erosion.

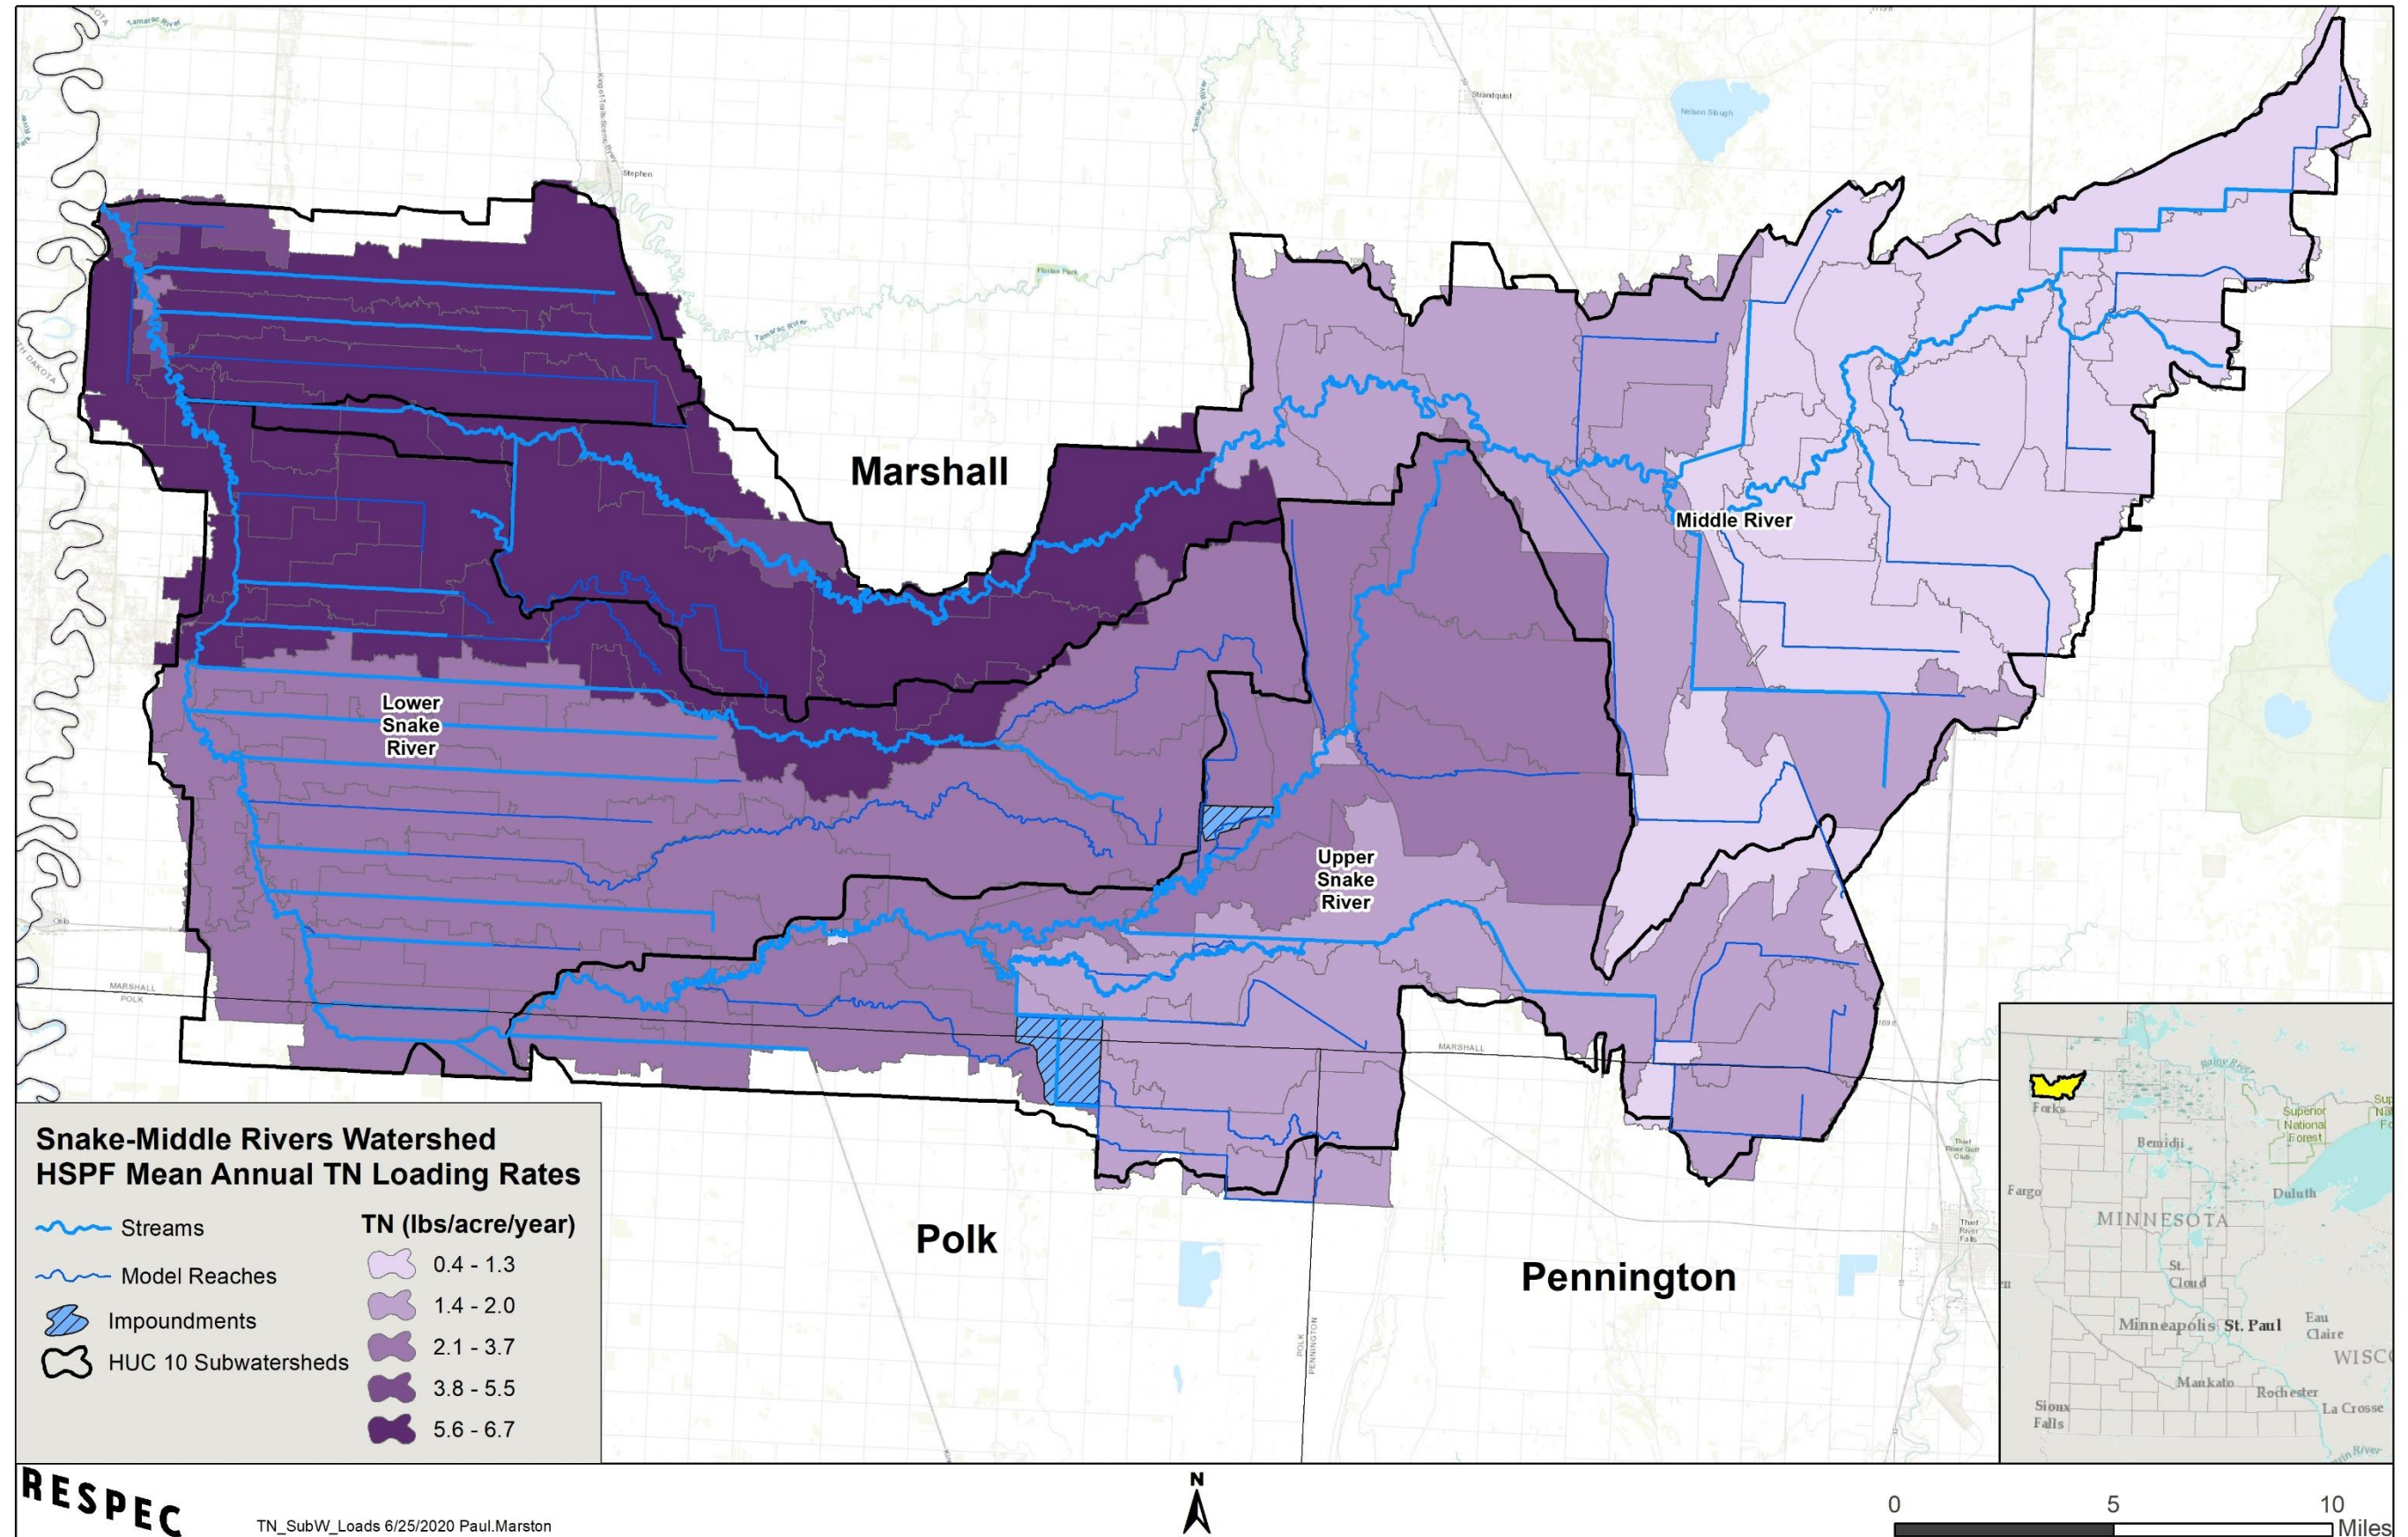
Figure 13. Mean annual total nitrogen loading rates by subwatershed in the Snake-Middle Rivers Watershed.
