December 2020

Snake-Middle Rivers Watershed Restoration and Protection Strategy Report

Restoration and protection strategies for waterbodies in the Snake River Watershed in the Red River Basin

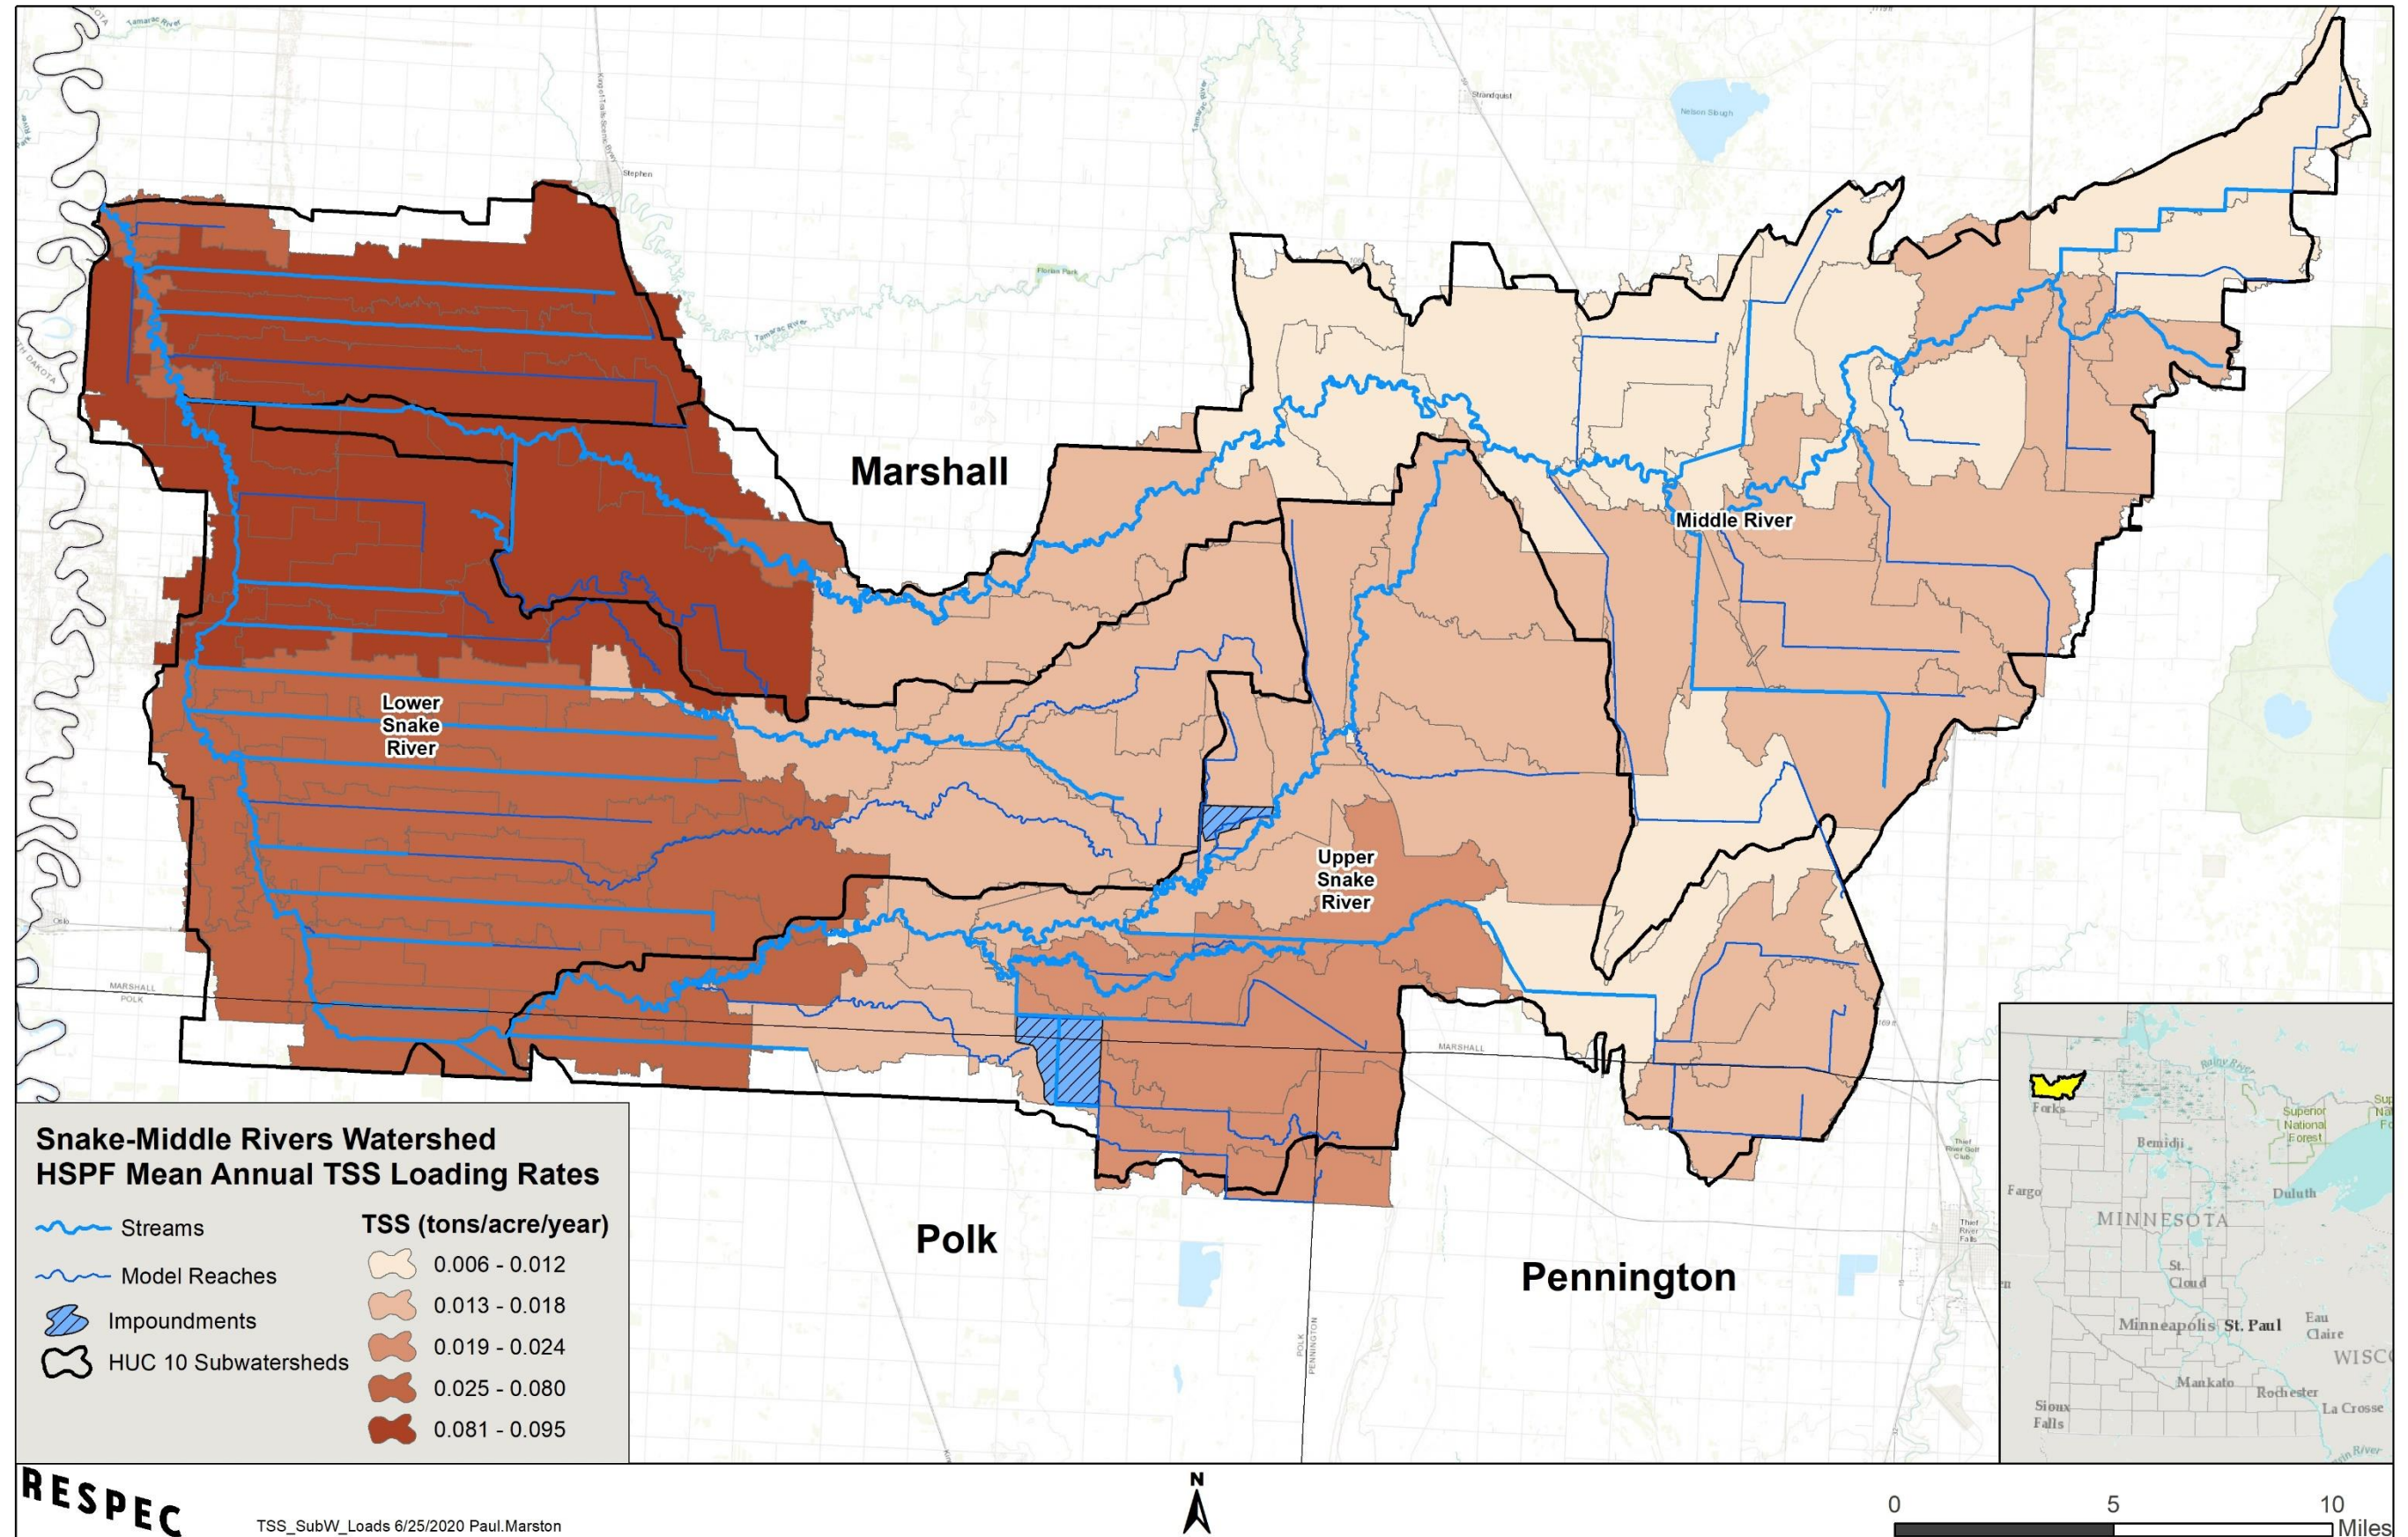
Figure 14. Mean annual total suspended solids loading rates by subwatershed in the Snake-Middle Rivers Watershed.

by land cover type in the SMRW. The loading rates for these pollutants are shown in Figure 12 (phosphorus), Figure 13 (nitrogen), and Figure 14 (TSS). Nutrient loading from cropland is delivered to streams and transported downstream. Flashy hydrographs caused by altered hydrology (tile drainage, ditching, and land cover change) create large sediment loads associated with bank erosion.

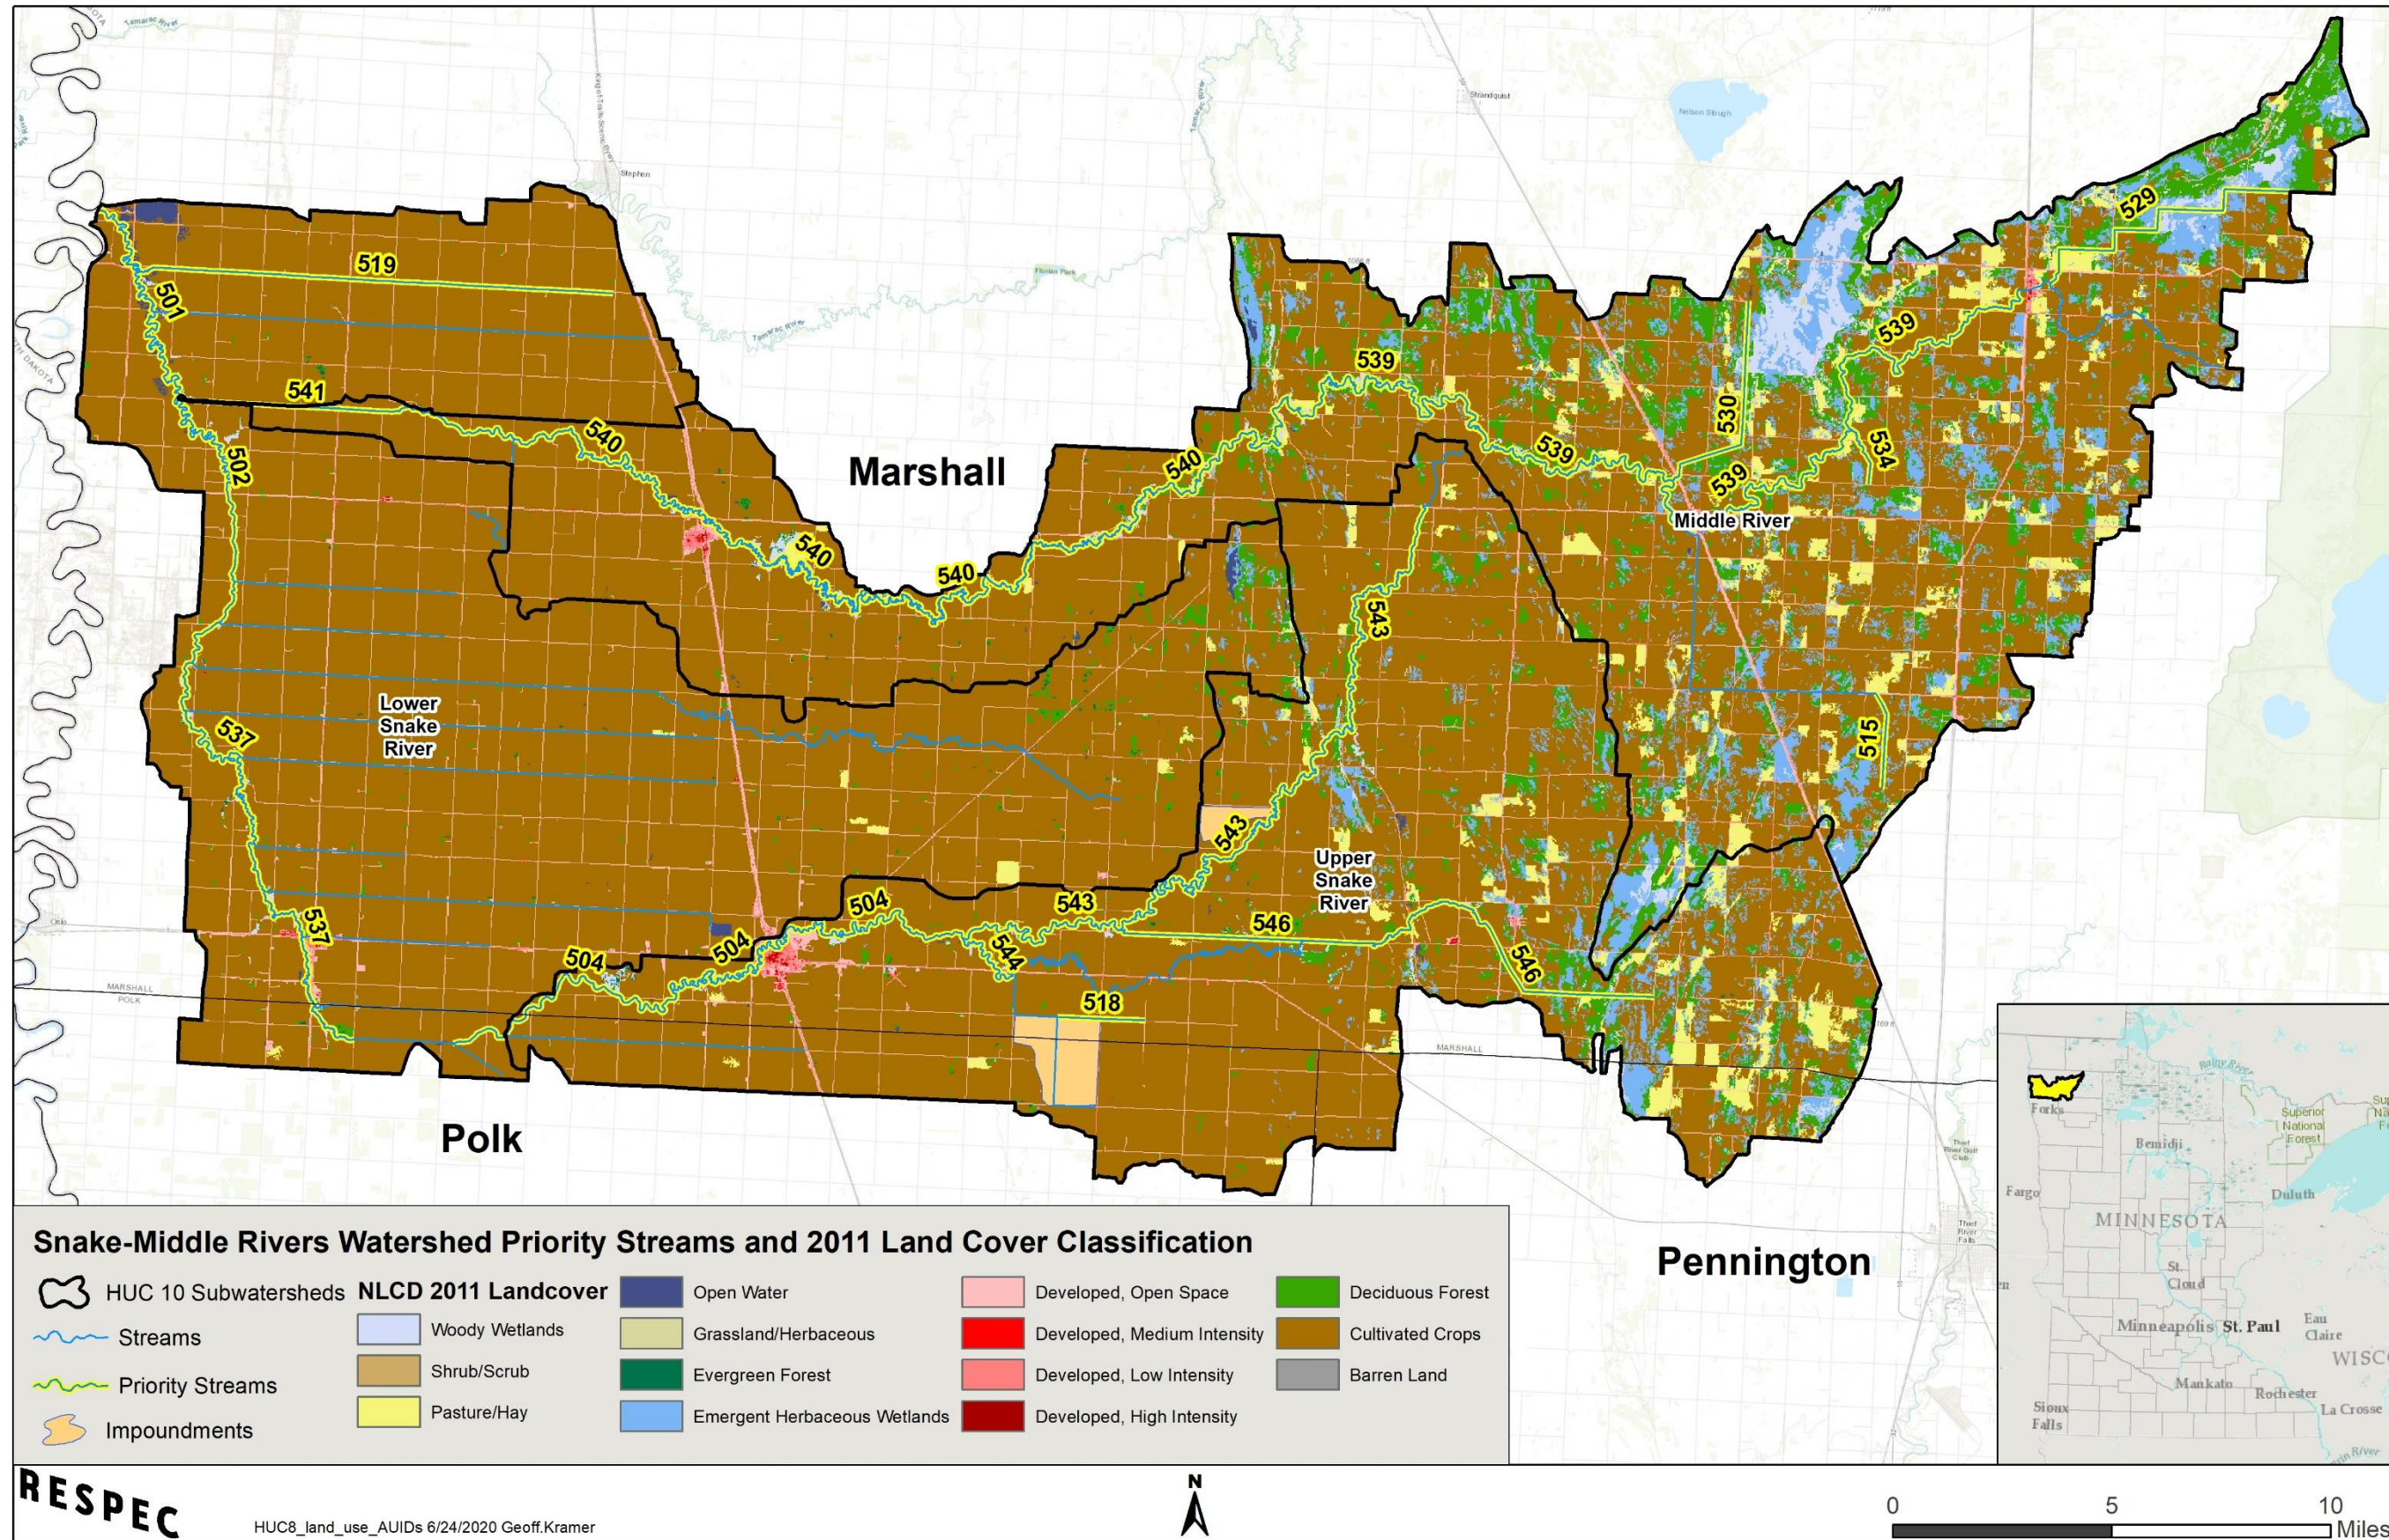
Figure 15. Snake-Middle Rivers Watershed land cover and priority streams.

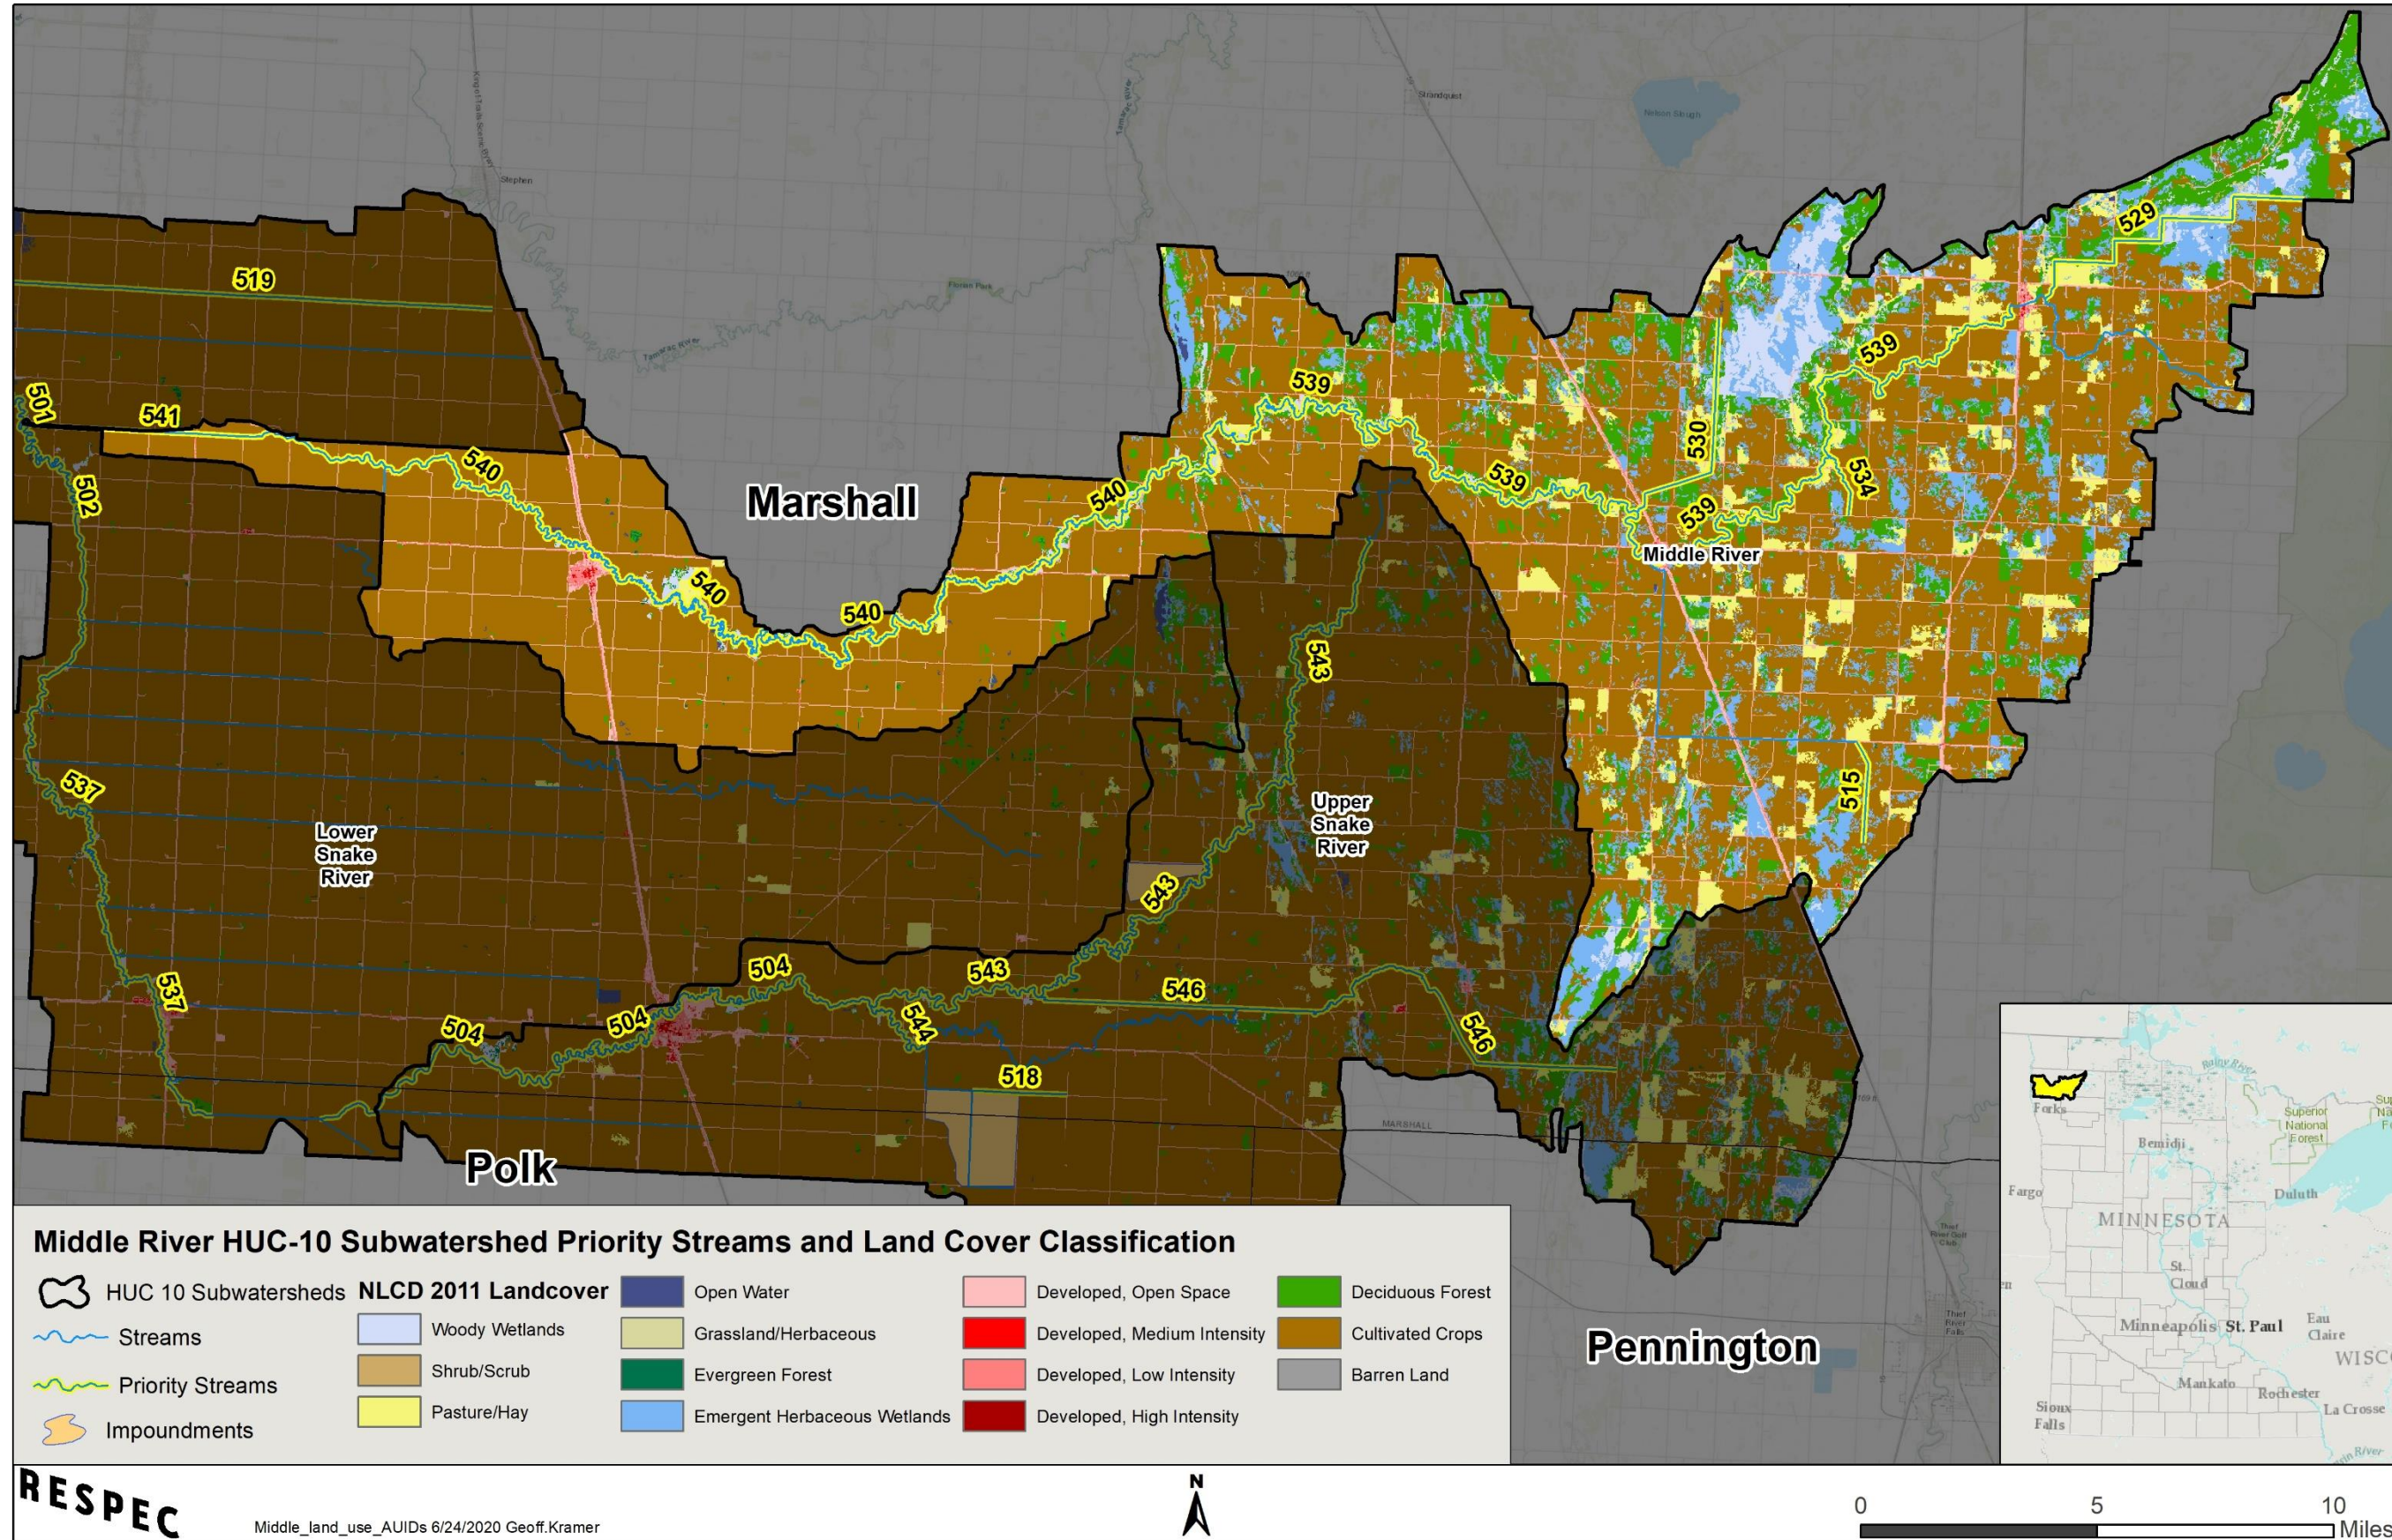
Figure 16: Middle River HUC-10 Subwatershed land cover and priority streams.

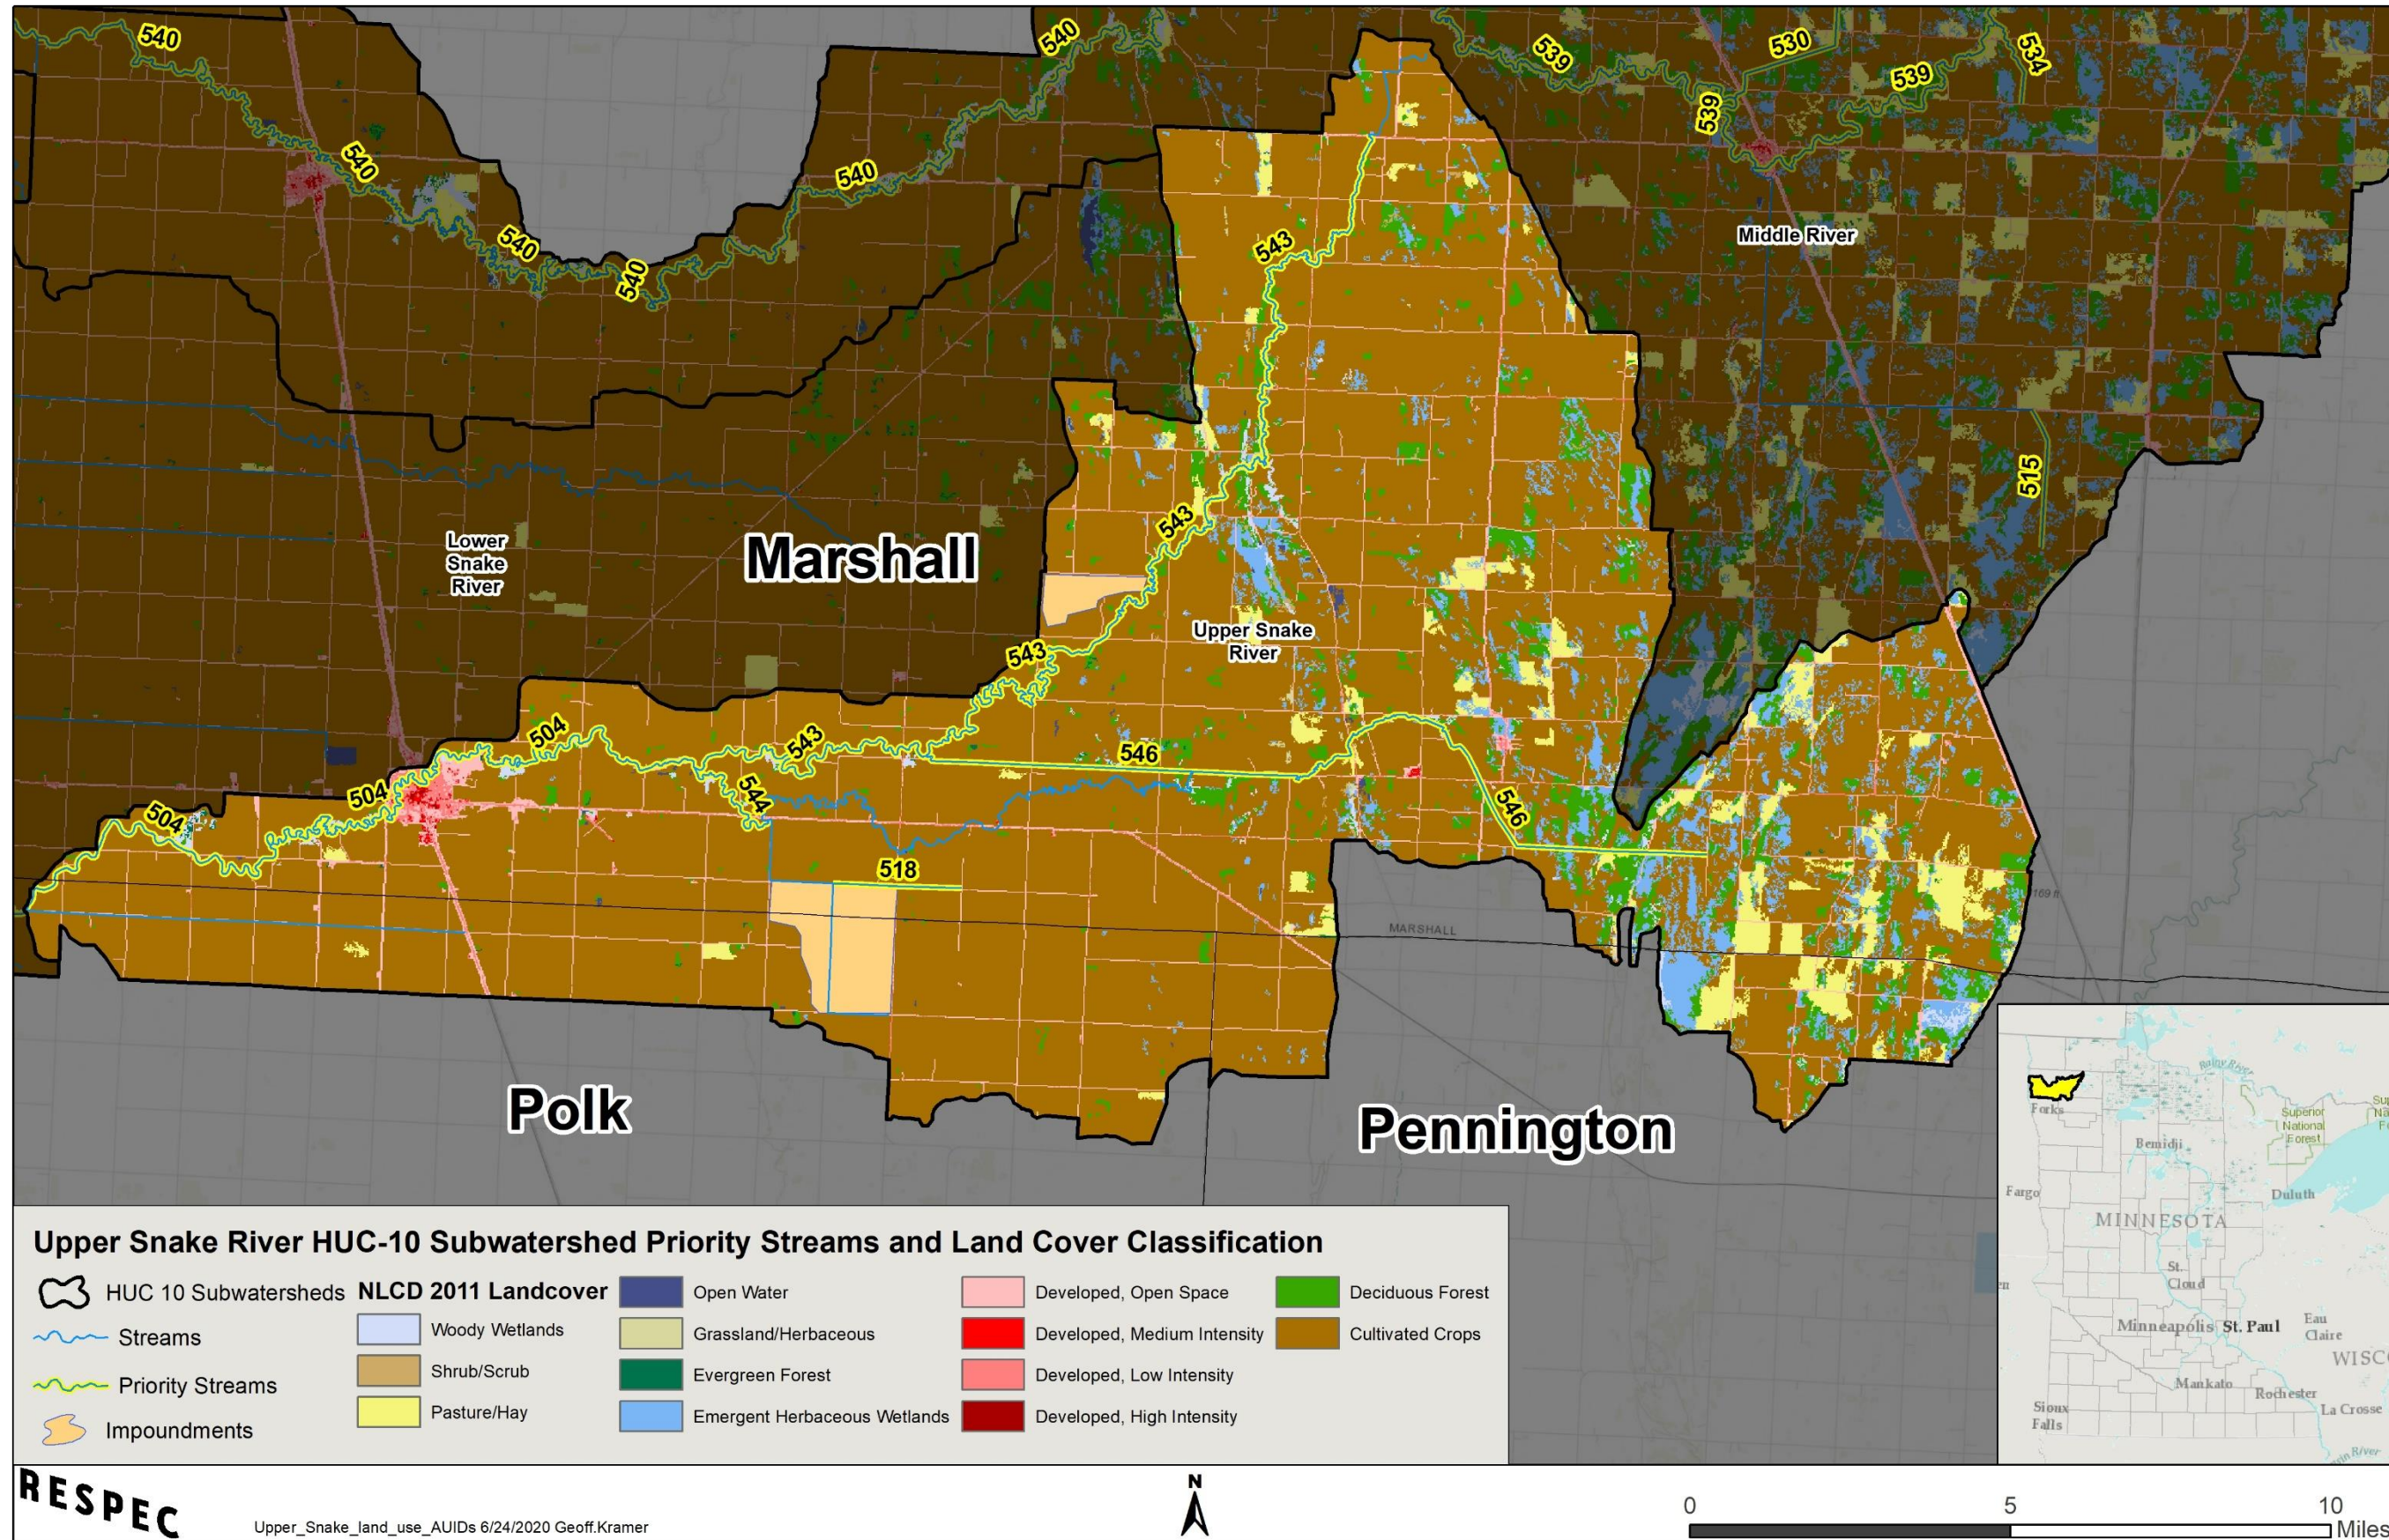
Figure 17: Upper Snake River HUC-10 Subwatershed land cover and priority streams.

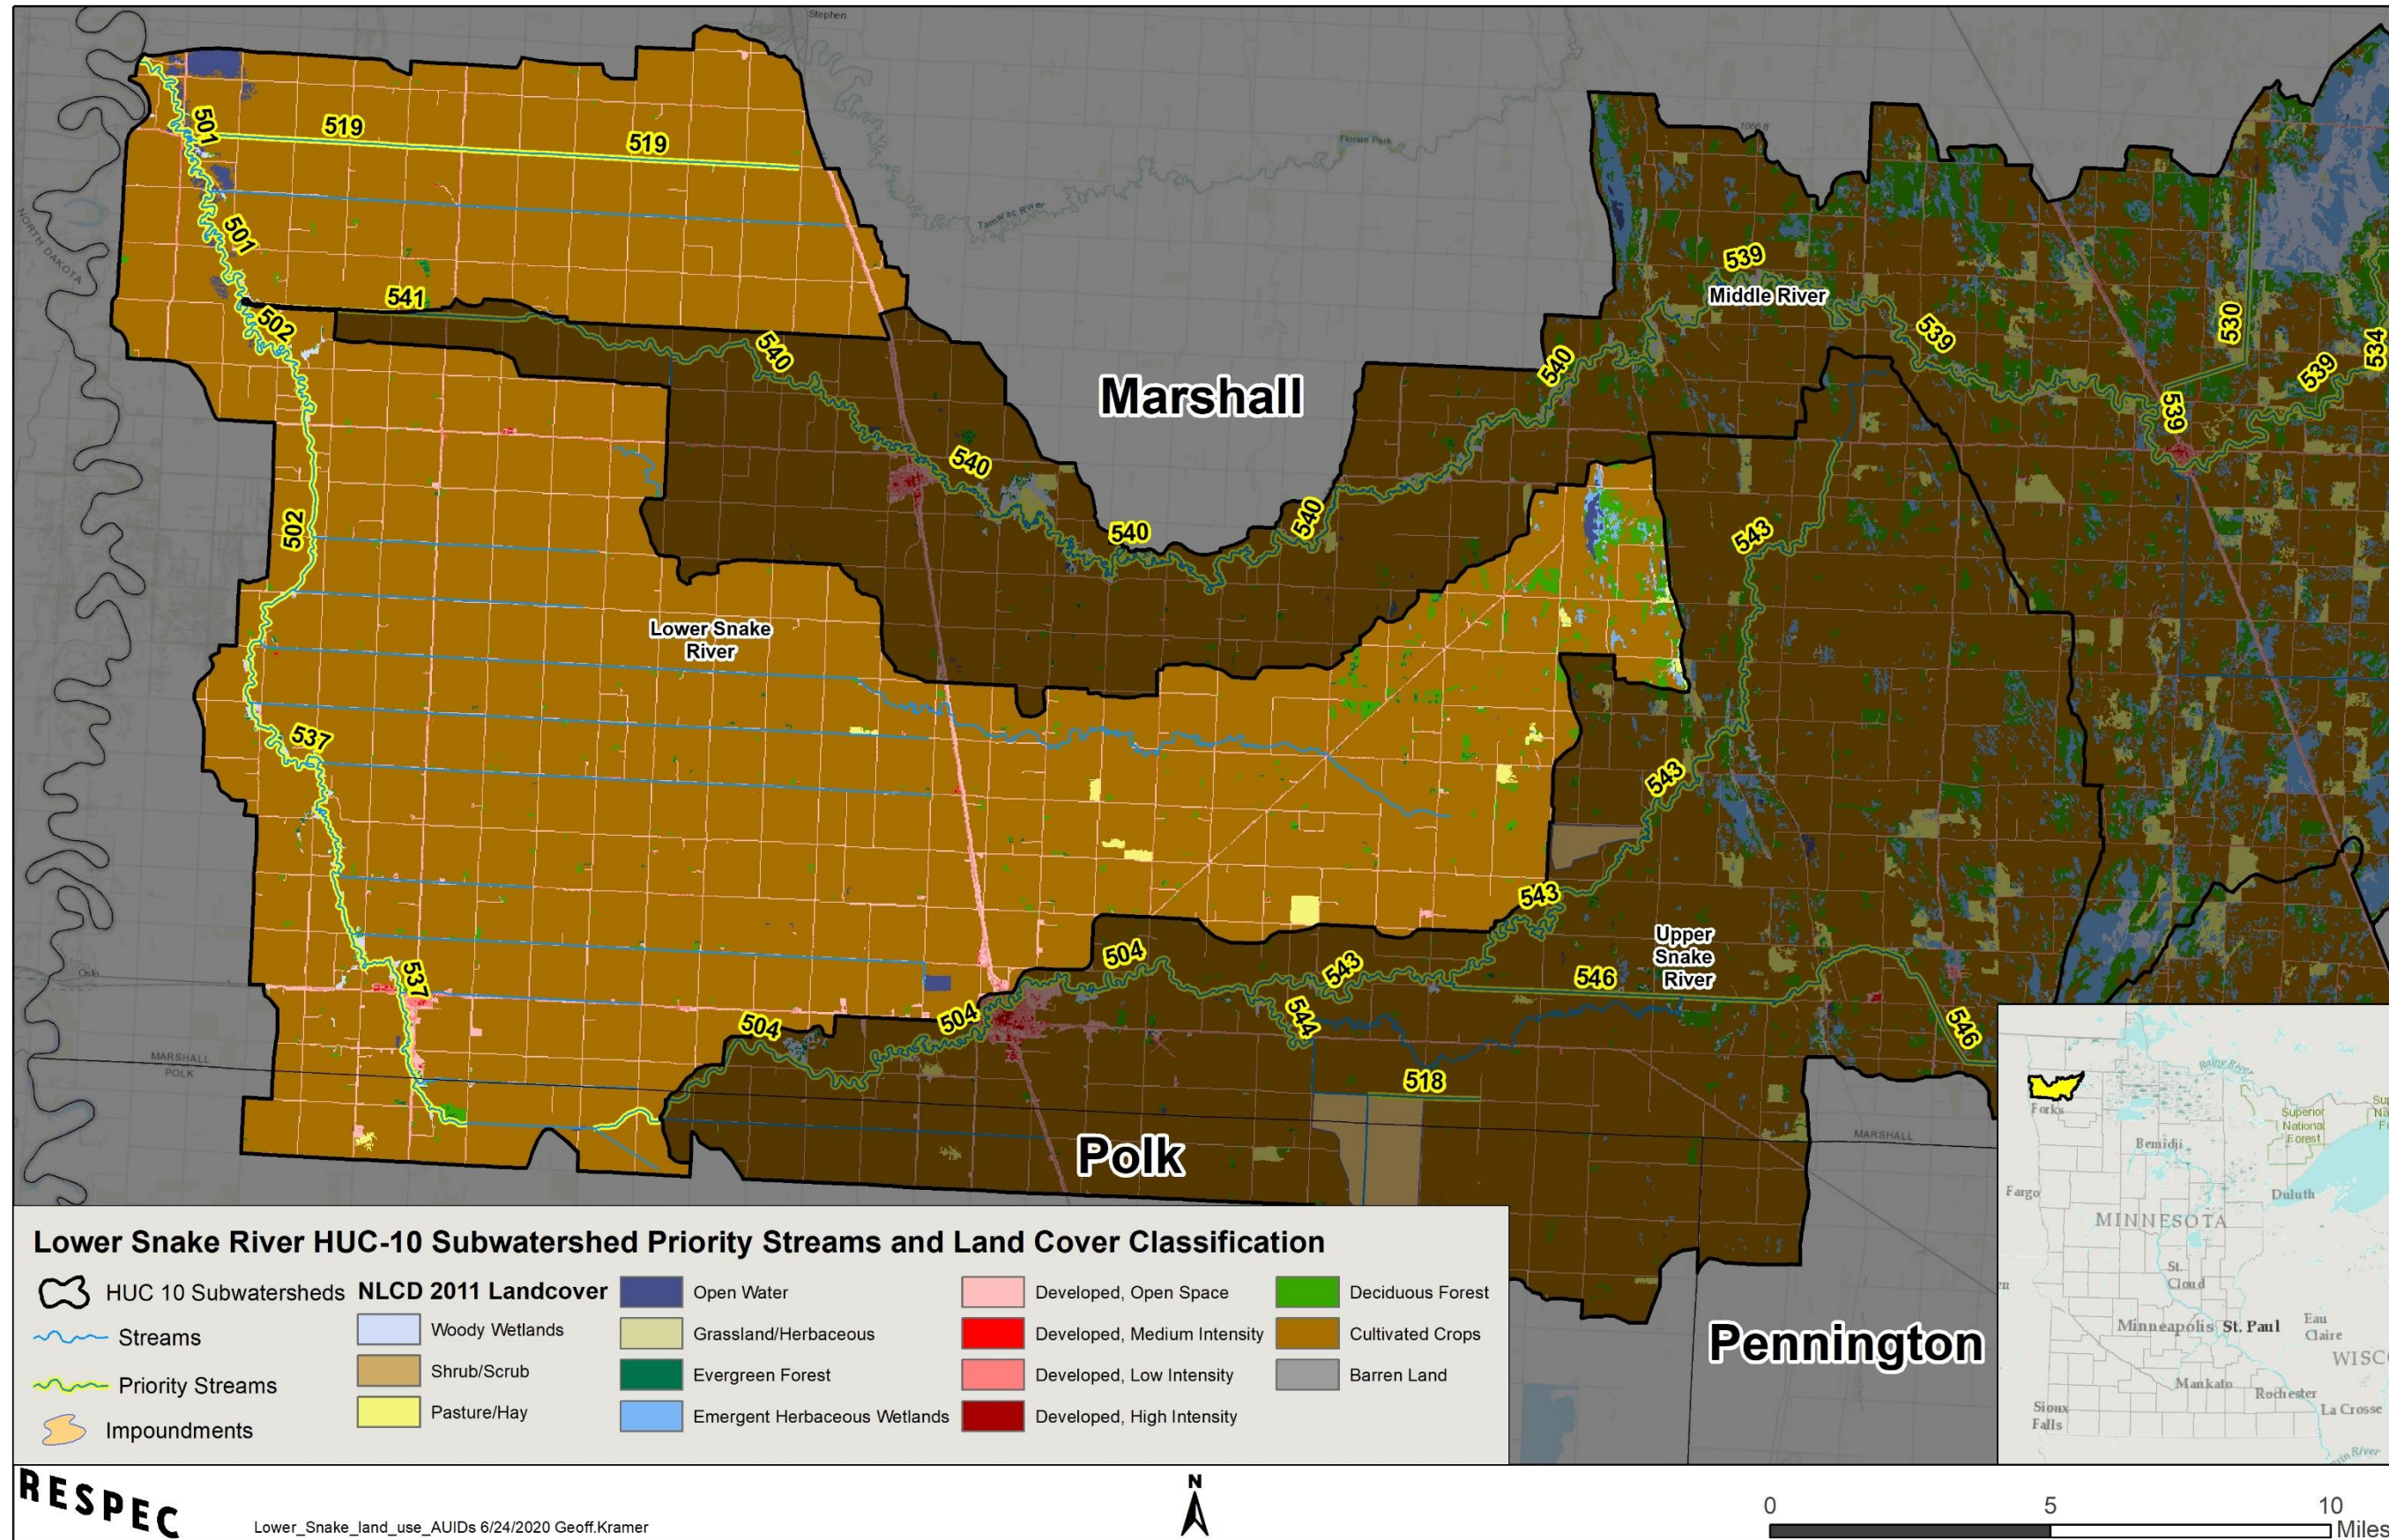
Figure 18: Lower Snake River HUC-10 Subwatershed land cover and priority streams.
