**FIVE-YEAR REVIEW REPORT FOR
GENERAL MILLS/HENKEL CORP SUPERFUND SITE
MINNEAPOLIS, MINNESOTA**

June 2021

**Minnesota Pollution Control Agency
Site Remediation and Redevelopment Section**

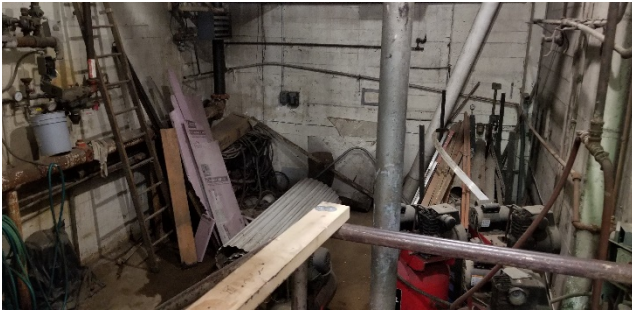
Photo 3 Basement of Building 10.

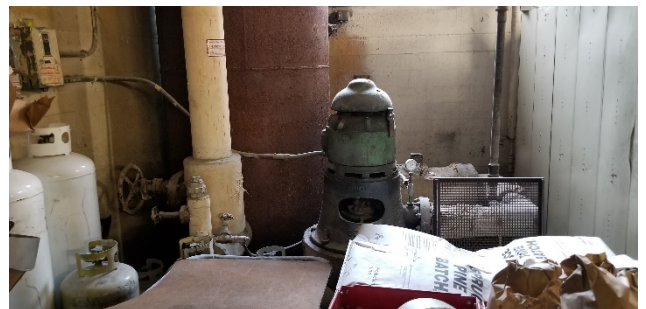
Photo 6 Henkel well in Building 10.

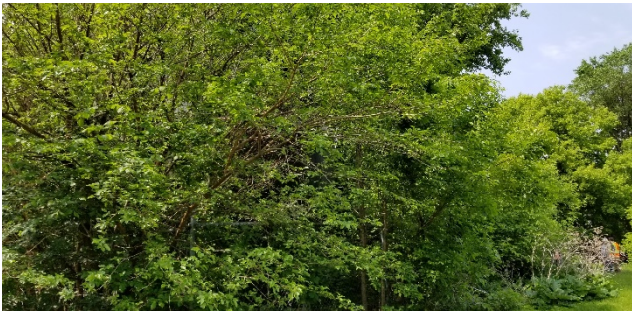
Photo 15- Bushes and trees growing into power lines.

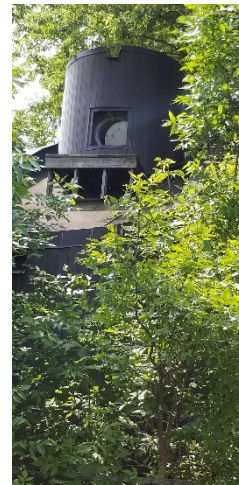
Photo 16- inactive water treatment building.

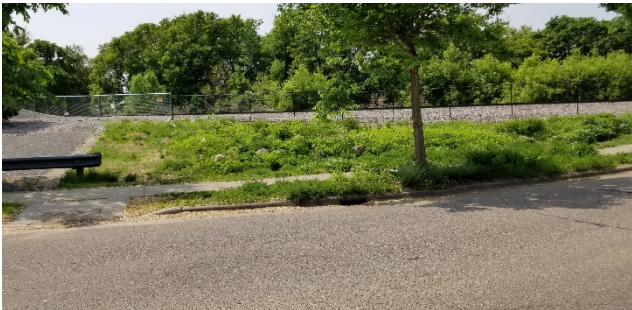
Photo 21 Community Garden.

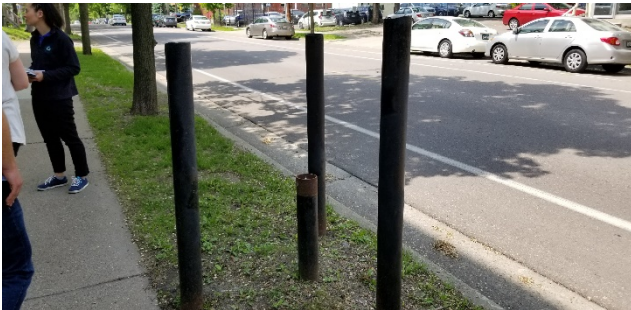
Photo 27- Well outside Varsity apartments. Three bollards and well cap present.

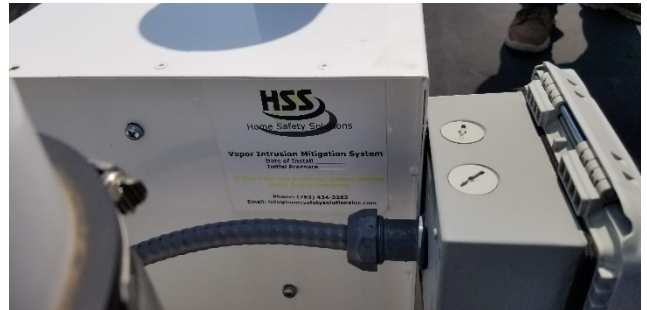
Photo 34- Blower at Varsity Apartments.

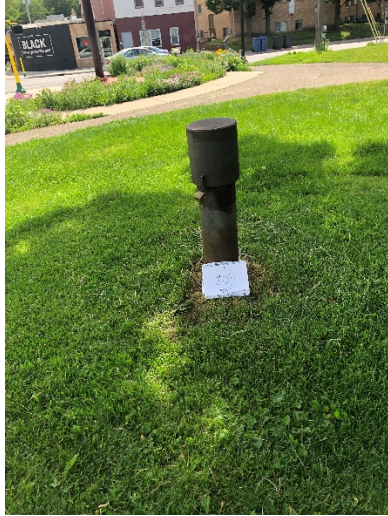
Photo 13 Well 203. 8-10" steel outer casing, Unable to remove lock.
