FIVE-YEAR REVIEW REPORT FOR
ST. LOUIS RIVER SUPERFUND SITE
DULUTH, MINNESOTA

Third Five-Year Review Report 2013
St. Louis River Superfund Site – Duluth, Minnesota

Volume 1.
FIVE-YEAR REVIEW REPORT FOR
US STEEL SUPERFUND SITE
DULUTH, MINNESOTA

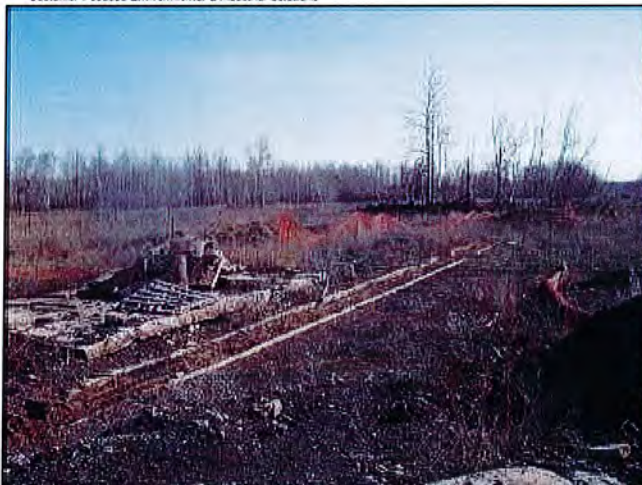
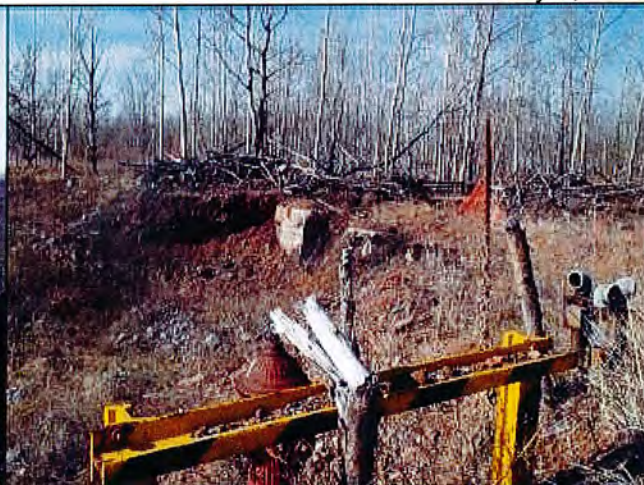
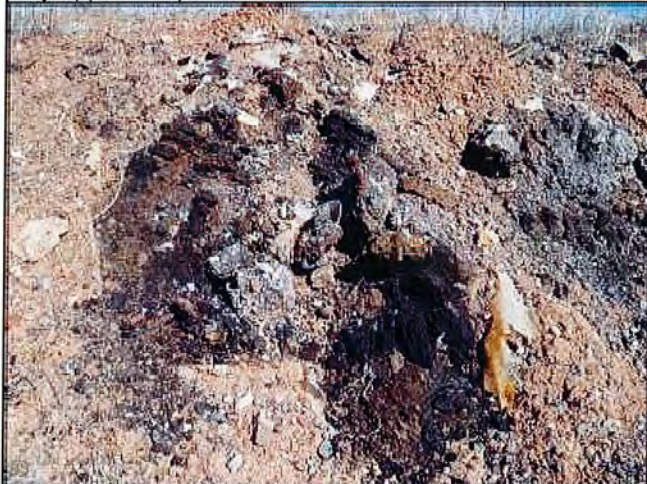
1a: OU-A: Tar soil removal from T-1 through T-4 area; clay applied to prevent erosion.

1b: OU-A: Tar soil removal from T-1 through T-4 area; clay applied to prevent erosion.

1c: OU-A: Tar soil removal from T-1 through T-4 area; clay applied to prevent erosion.

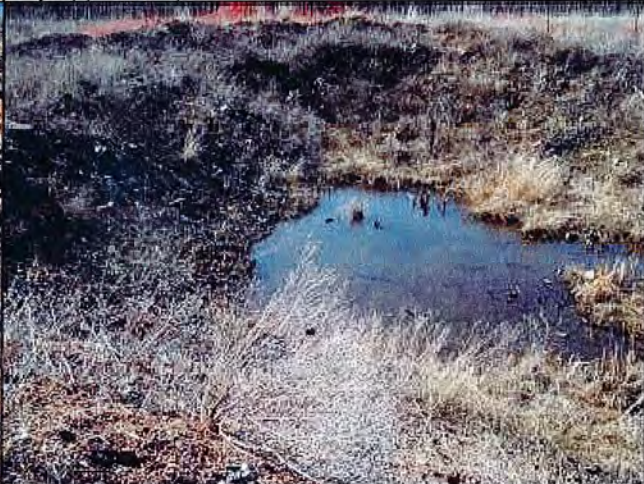
2a: OU-A: Clay wall and bottom of from T-1 through T-4 area.

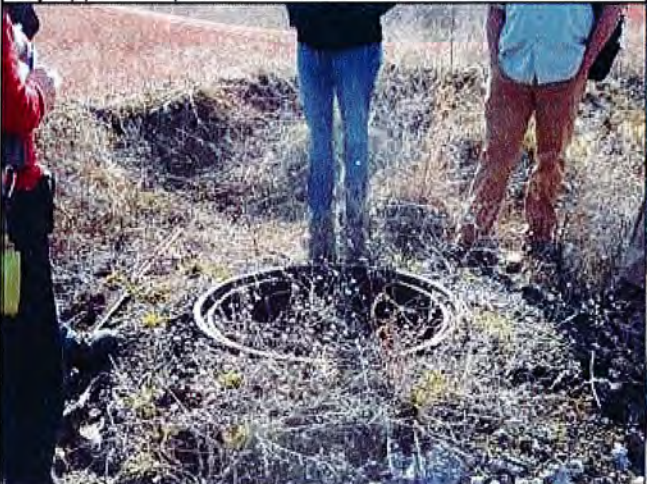
2b: OU-A: Manhole north of T-1 through T-4 area – no lid.

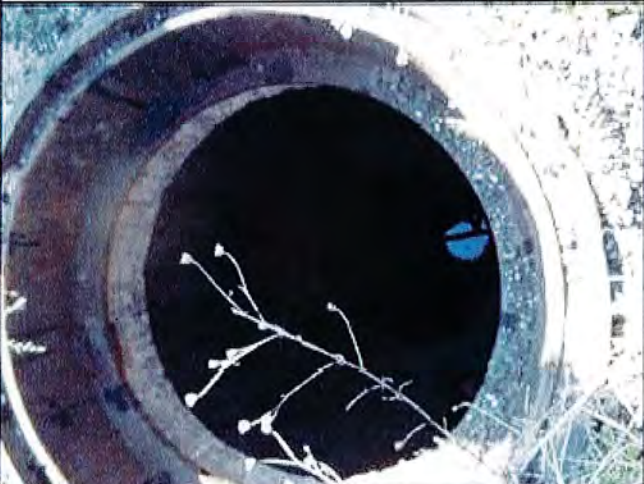
2c: OU-A: Product within manhole with no lid.

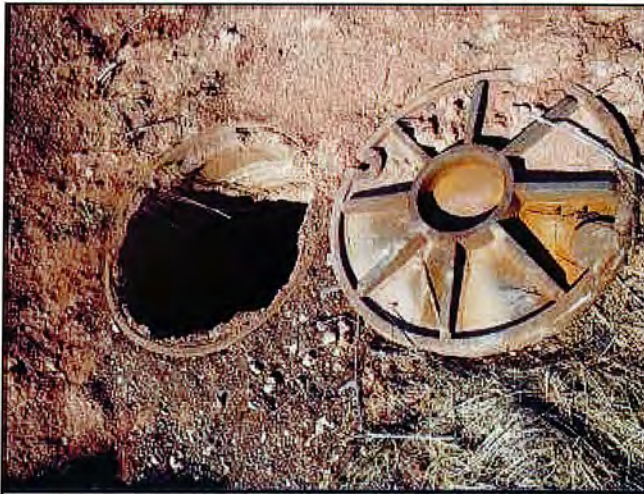
3: Utility Vaults: partially filled and open, another one adjacent.

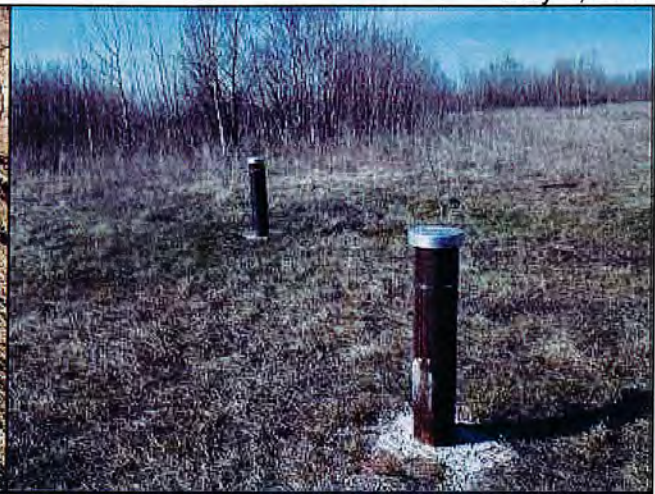
4a: Other AOC: MW-23.

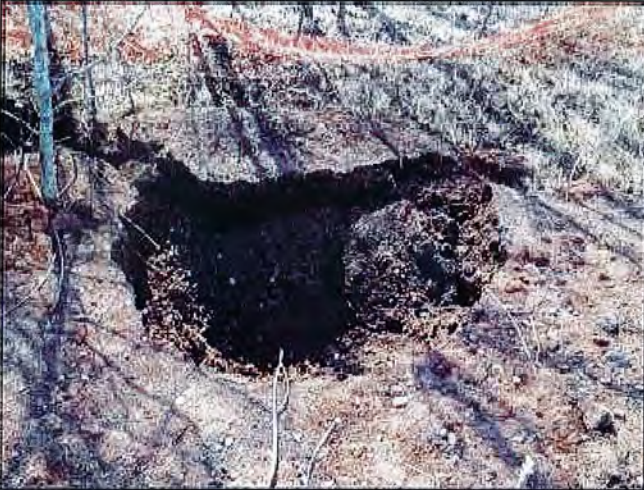
4b: Other AOC: Manhole.

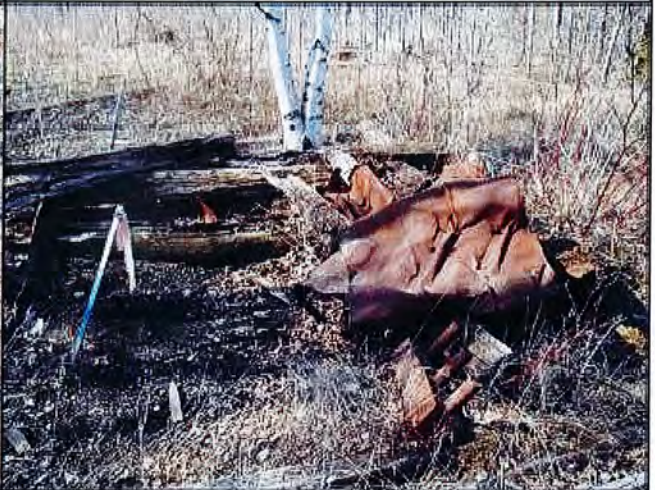
5: OU-A: Lead drums on VIC property.

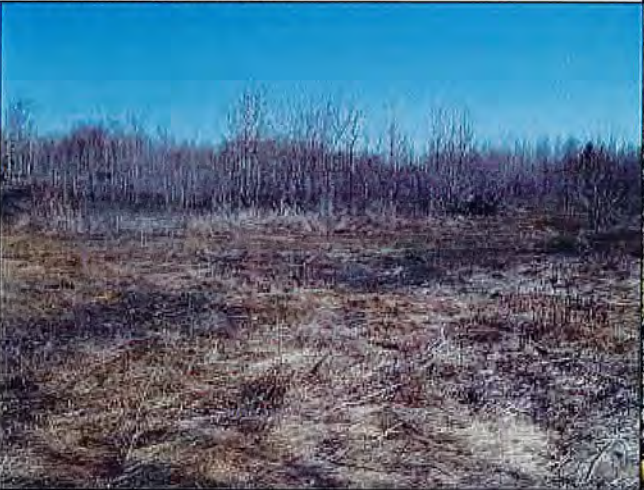
6: OU-A: Lead remediation area on VIC property.

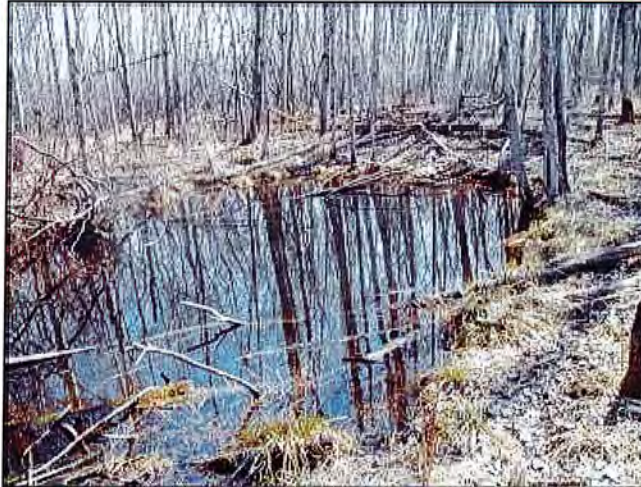
8: Other AOC: Pond feature from LIDAR

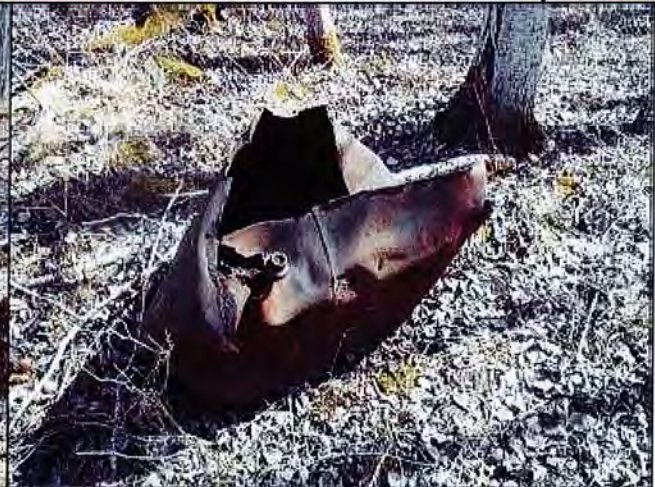
9: DL-2: Tank or process vessel and pipe within DL-2.

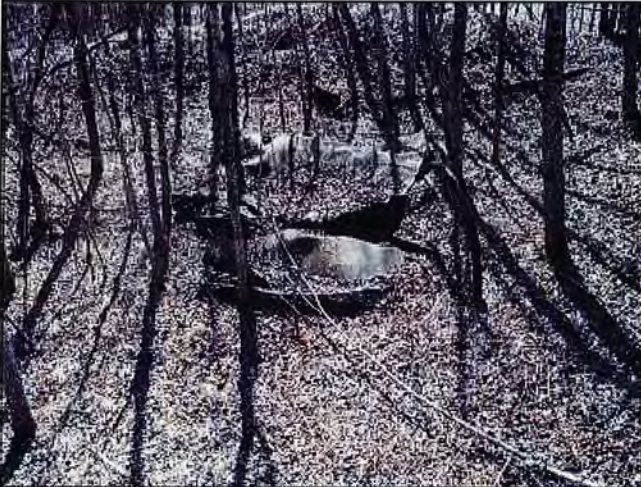
10a: Other AOC: Circle berm process vessel or tank.

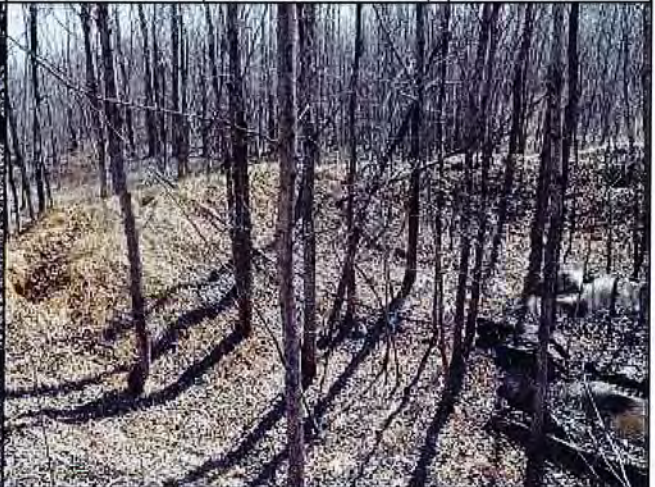
10b: Other AOC: Circle berm feature from LIDAR.

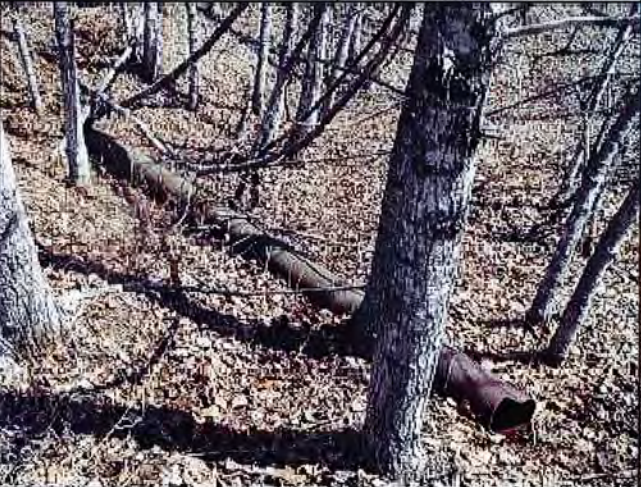
10c: Other AOC: Pipe exiting the circle berm area.

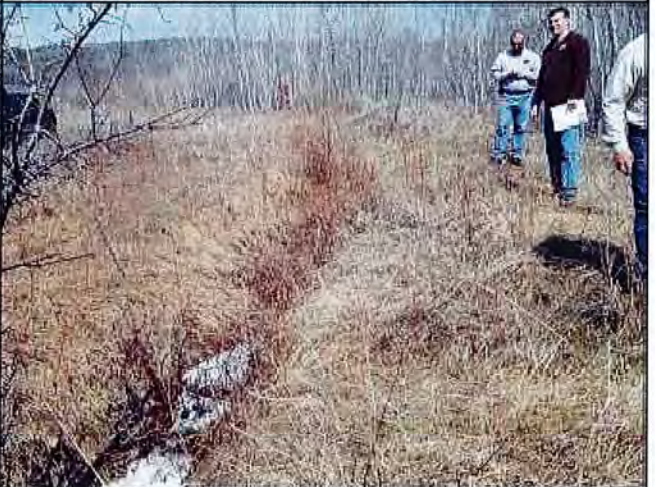
11: Other AOC: Ditch near circle berm

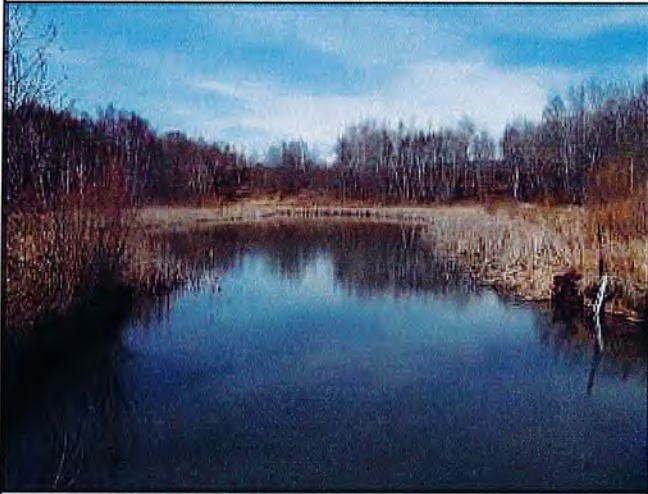
12c: OU-P: Wire Mill Pond

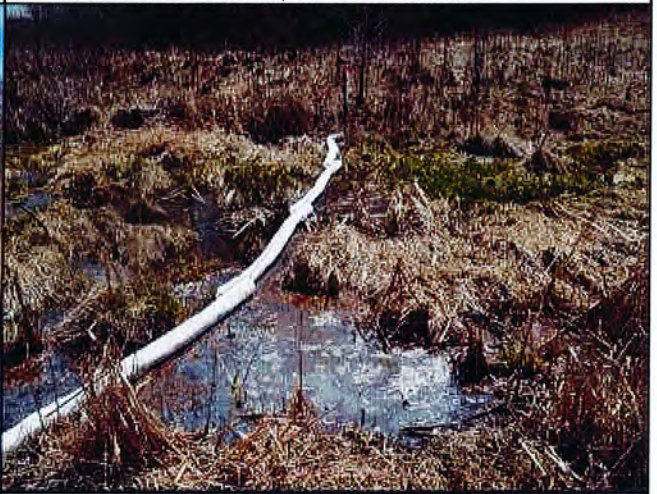
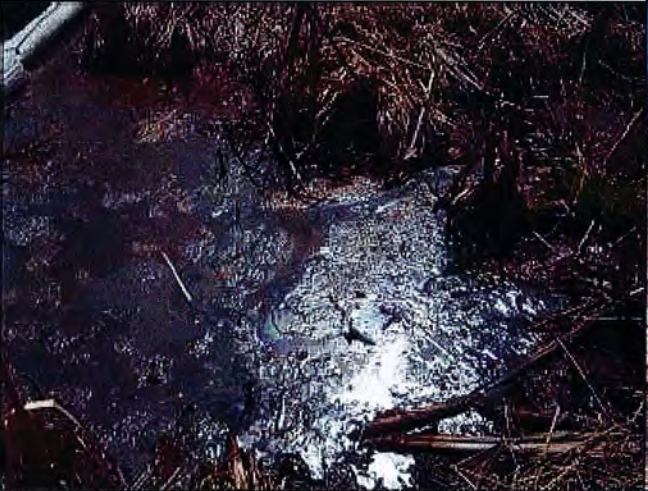
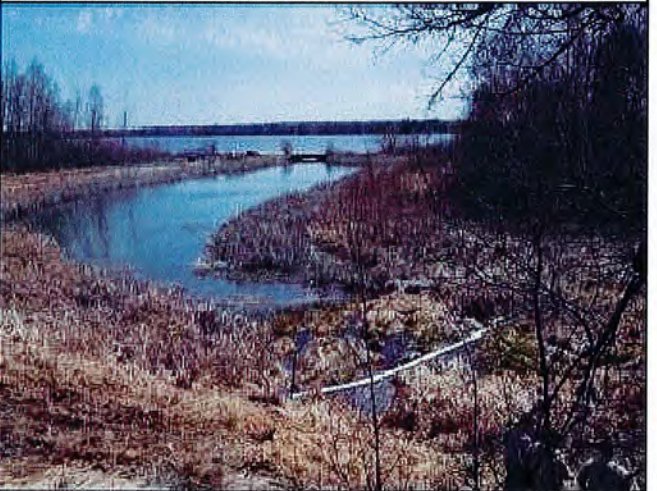
OU-P	Unknown	The OU-P remedy was completed as required but may not be protective of human health and the environment. Sheens were continually observed in the pond. The source of the oil sheens is not known and should be investigated. In order to make a conclusive statement regarding protectiveness, the following actions will need to be completed: identify the source of the oil sheens; an ecological and human health risk-based screening assessment; implementation of RAs; establishment of institutional controls.

Photographs taken during the Site Inspection that highlight these issues are located in **Appendix B**. A map depicting the photograph locations is presented by **Figure 3**. During a later site inspection, oils and sheens were noted throughout the surface of OU-P.

13a: OU-P: Oil sheen, oil and tar bubble at this location.

13b: OU-P: Oil sheen, oil and tar bubble at this location.

13c: OU-P: Oil sheen, oil and tar bubble at this location.

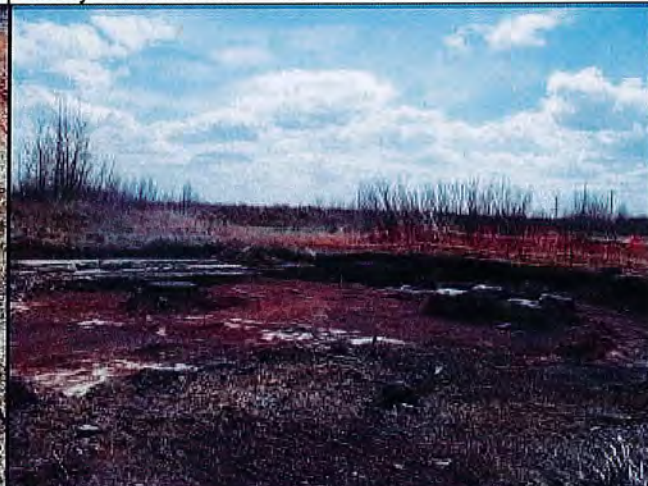
15: PAH Excavation near Coke Over Battery Foundation.

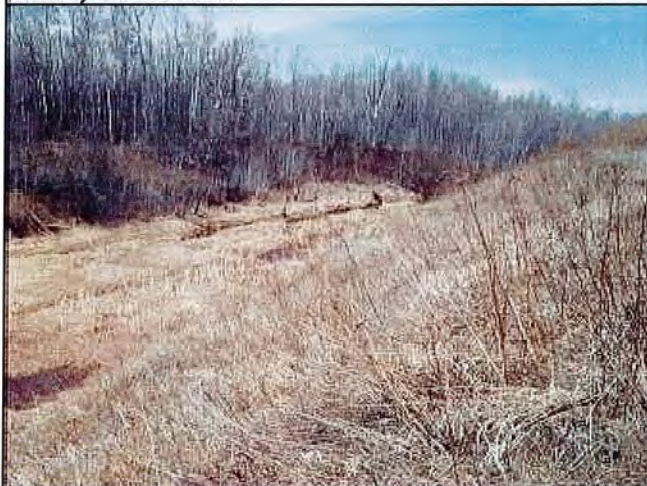
16: Top of OU-J

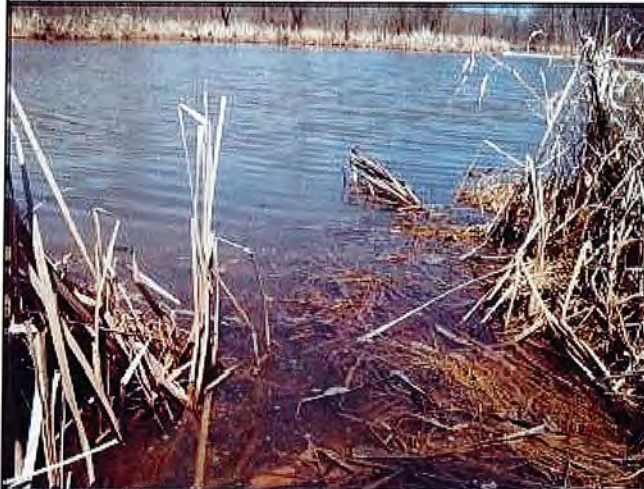
19a: Area between I&J: tar balls and oil bloom

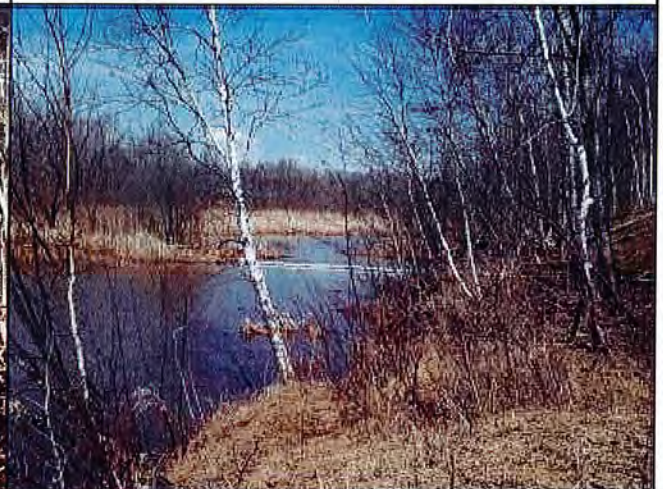
19b: Area between I&J: Sorbent boom prior to OU-I didn't fully extend across stream

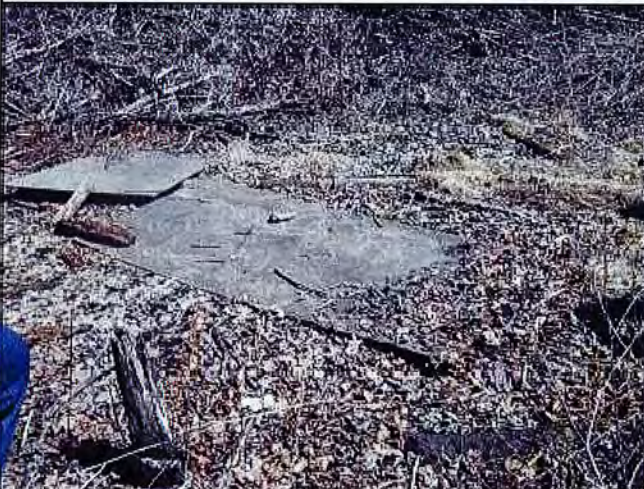
20: OU-A: Tar pit TP-10 covered by sheet of plywood

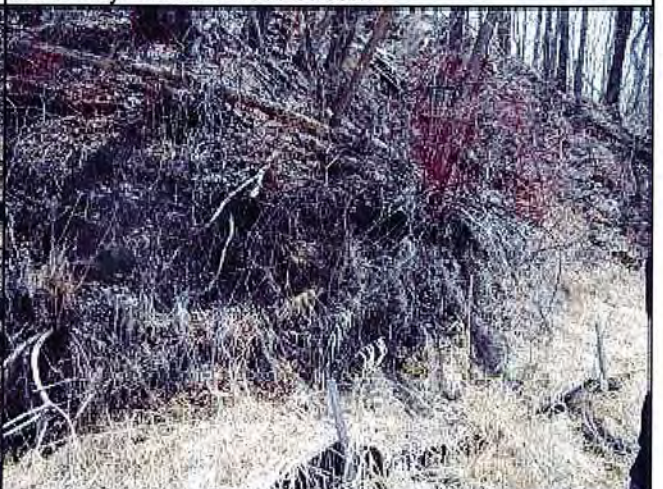
21: Tar pit TP-11, one of 15 tar pits throughout the site.

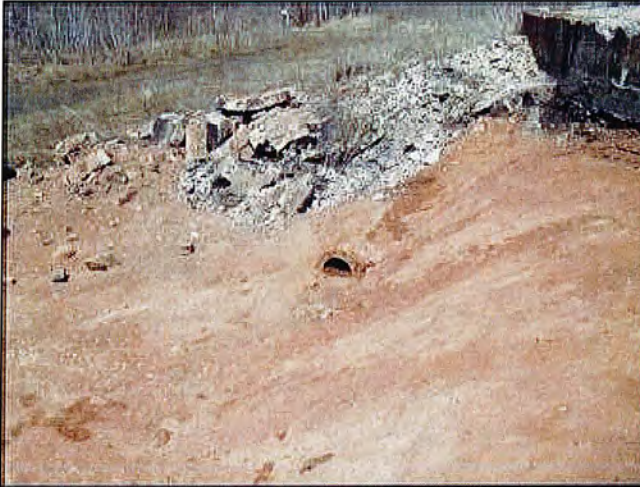
22a: OU-A: T-12 Excavation done, needs fill, pipe unknown.

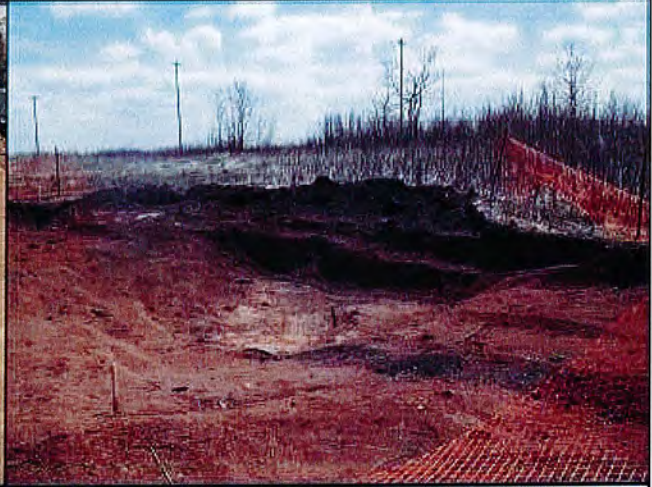
22b: OU-A: T-12 Excavation done, needs fill

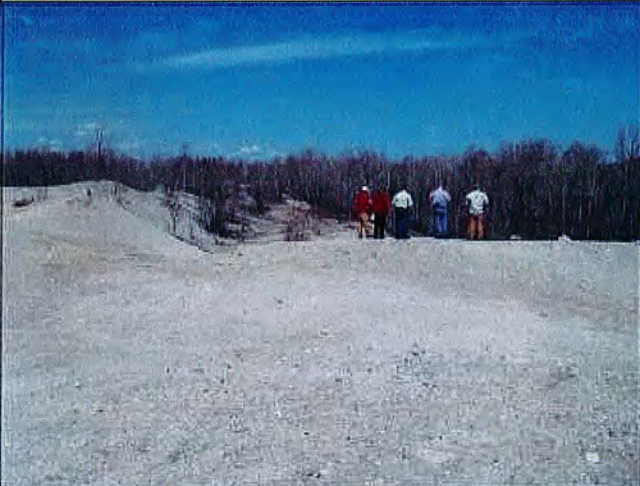
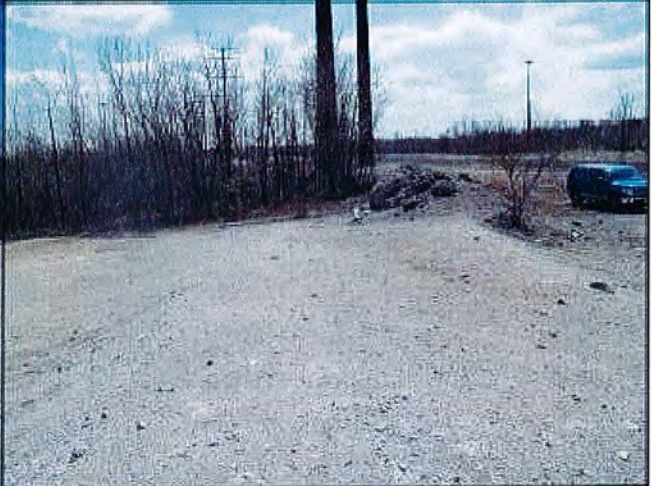
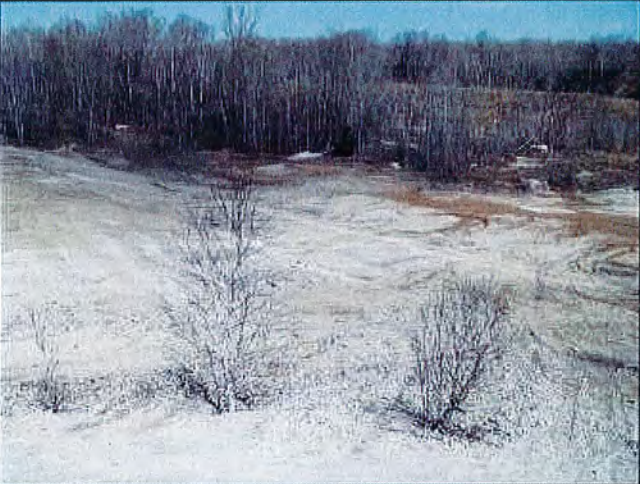
23a: OU-S: No change from last inspection

23b: OU-S: No change from last inspection

23c: OU-S: No change from last inspection

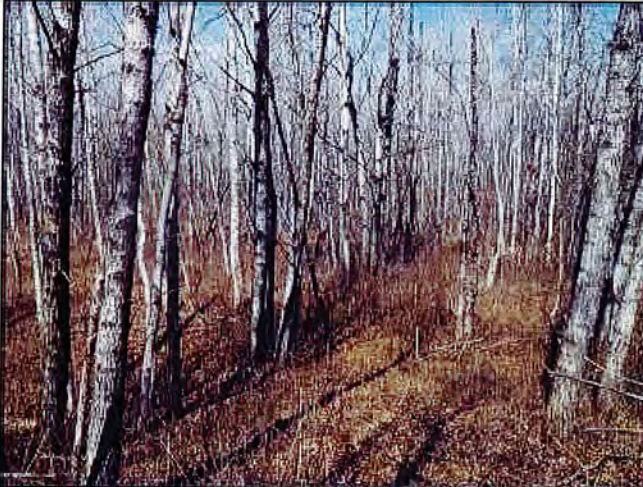
25: Other AOC: LIDAR non-native soils, nothing unusual noted.

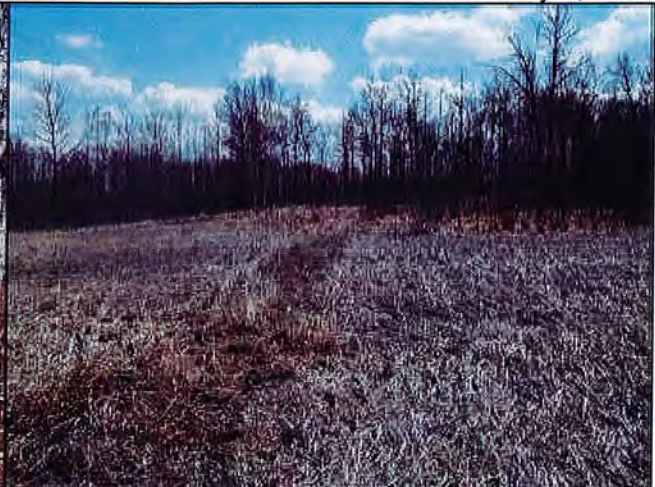
26a: OU-K: Trespassing reduced from last 5-year review.

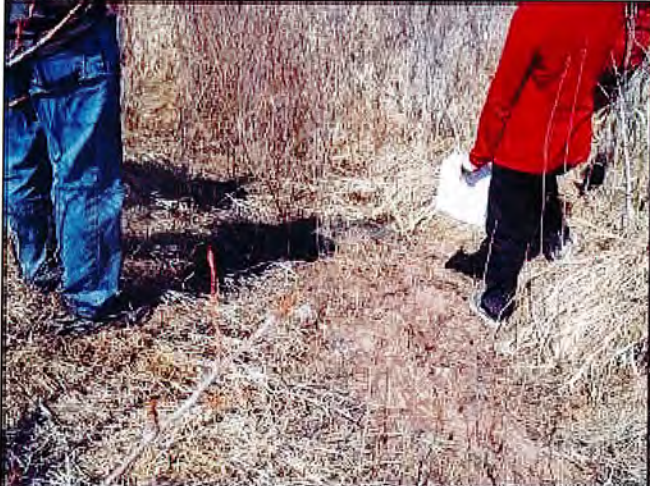
26b: OU-K: Erosion mat visible; trespassing decreased

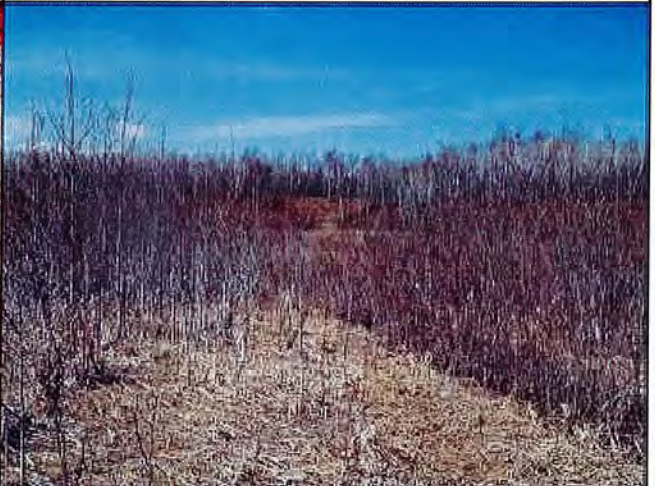
26c: OU-K: Chemical treatment was performed but some live saplings still present.

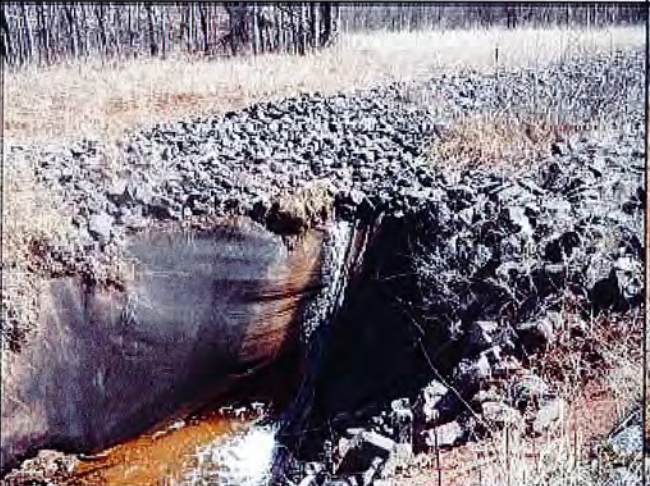
27a: Other AOC: Erosion of stream channel

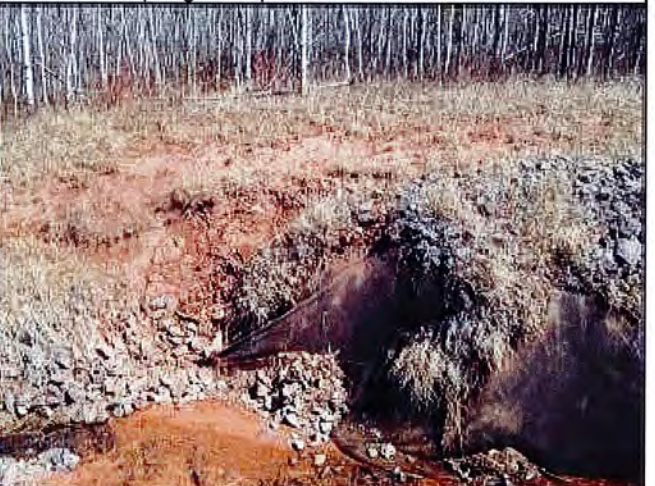
27b: Other AOC: Erosion of stream channel

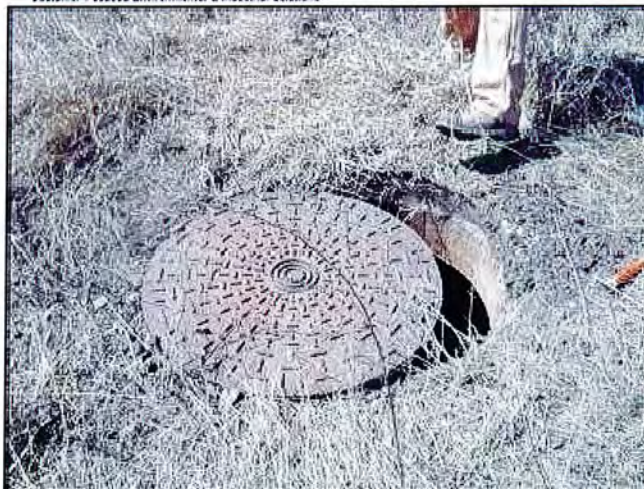
28: Manhole: electrical conduit travels in multiple directions.

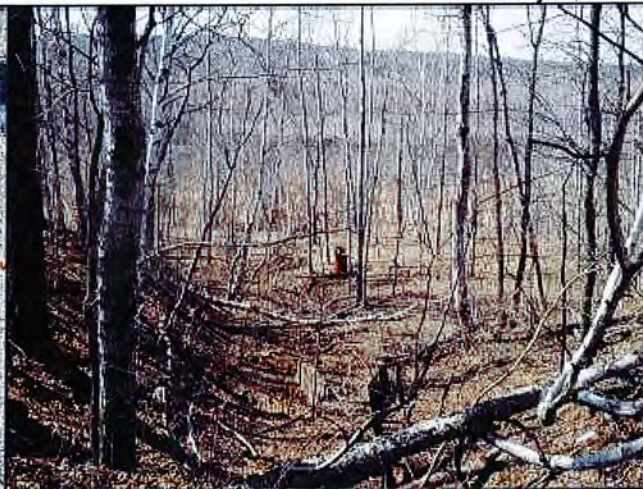
29a: Other AOC: Coke plant settling basin, sewer outfall history unknown, upright clay duct. (Not pictured: trespasser and dog noted in background during inspection)

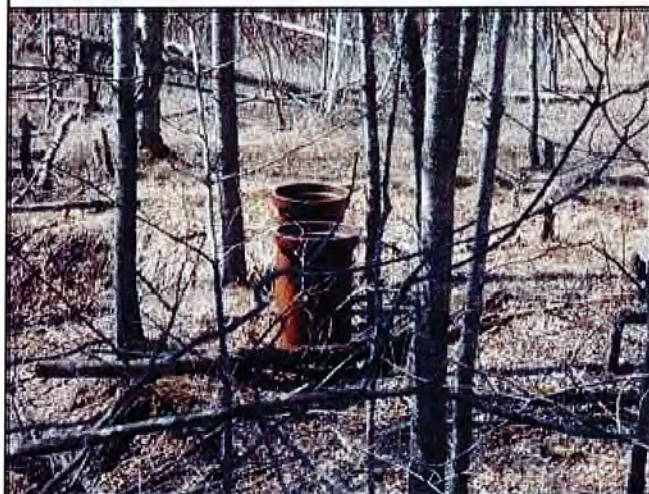
29b: Other AOC: Coke plant settling basin, sewer outfall history unknown, upright clay duct

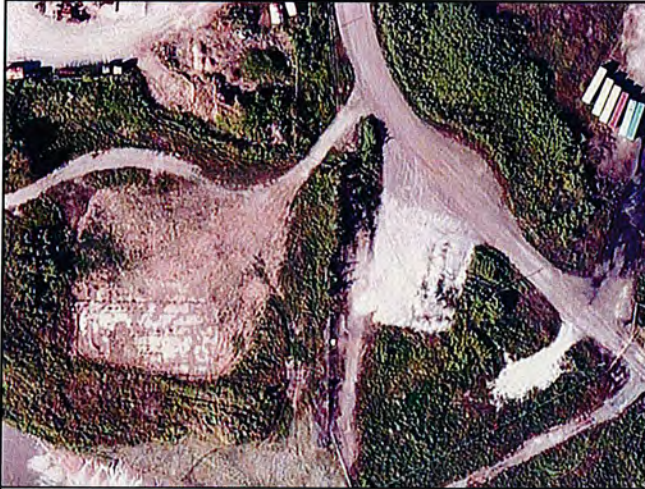
1: Old office Location, site visit start, all structures have been removed. (Bing Aerial WMS)

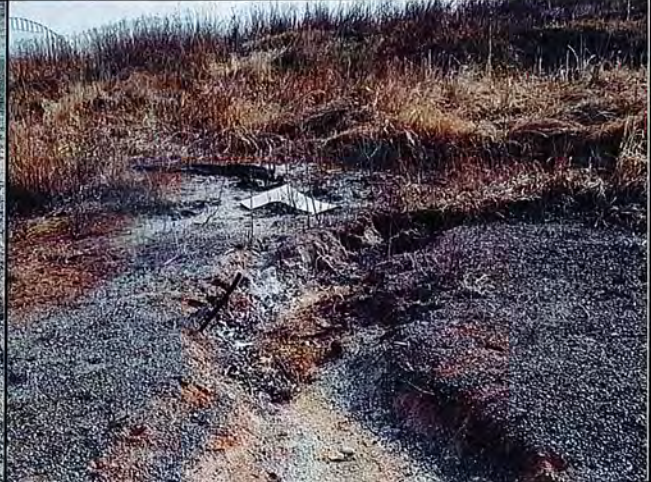
5: SedOU: Erosion of native material near Stryker Bay cap.

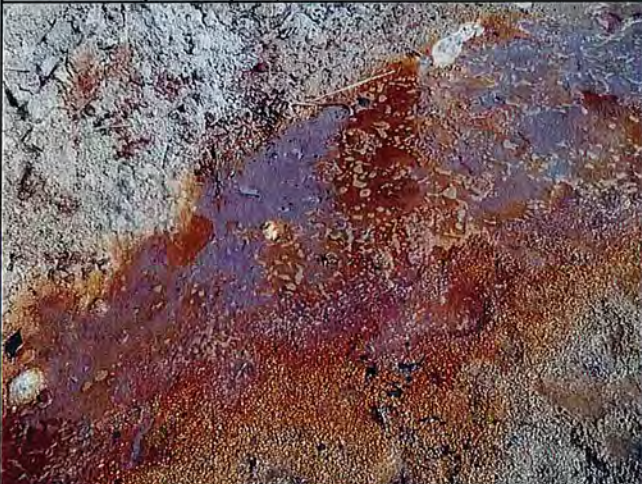
- During the recent site inspection, no oil sheen was identified in this area; however, significant bacterial sheen was noted. The origin of this sheen appears to be identified; no additional work is necessary for this issue.

- The Area E Storm Sewer Outfall, where an oil sheen was previously noted, displayed a significant bacterial sheen. No oil sheens were noted in this area.

6a: SedOU: Iron bacteria sheen in water flowing near northeast corner Stryker Bay cap.

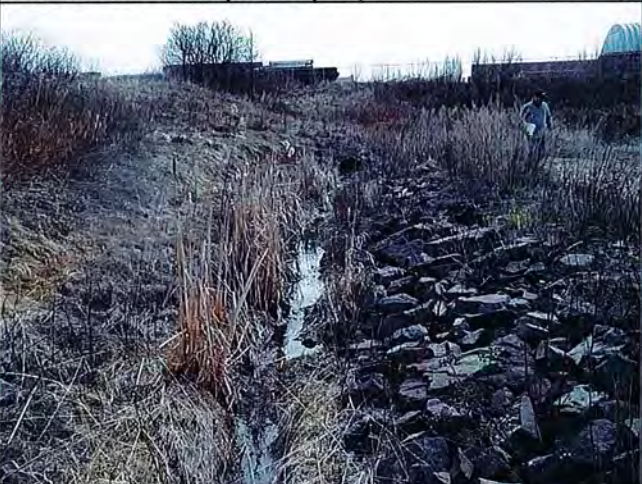
7: SedOU: City storm water diversion channel near NE corner of Stryker Bay cap, good condition.

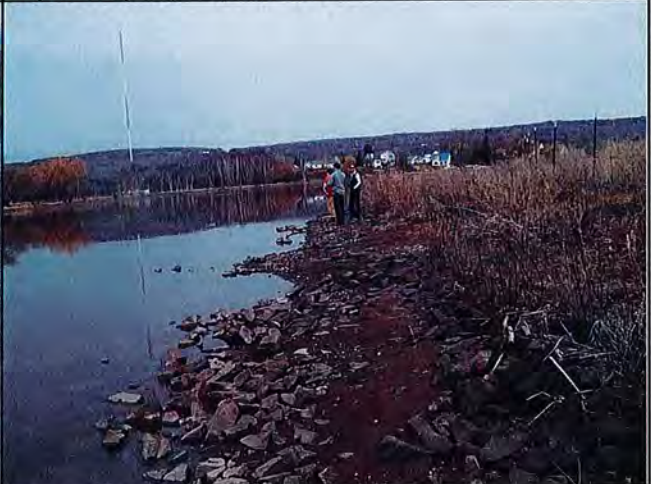
8a: SedOU: Arrowhead Point, good condition.

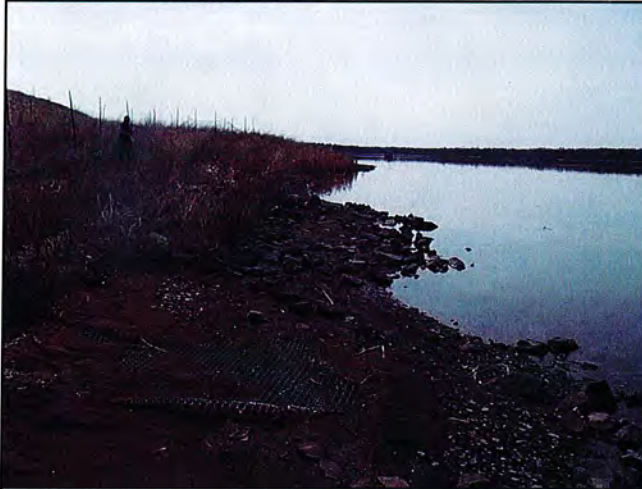
8b: SedOU: Arrowhead Point, good condition.

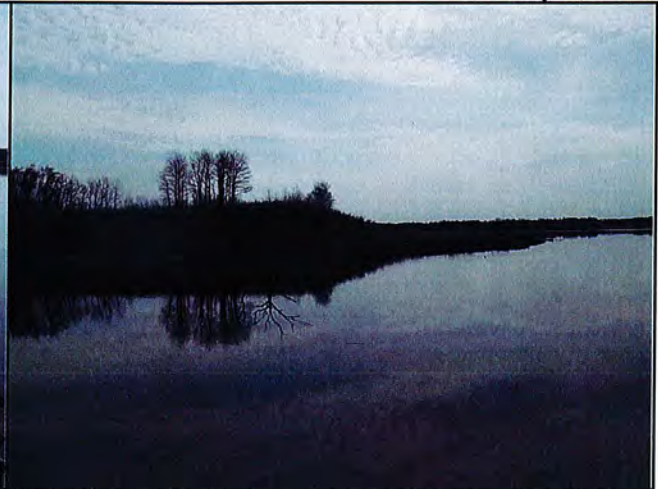
9a: SOU Area C: Looking across Slip 6 at Area C and 54th Ave peninsula, good condition.

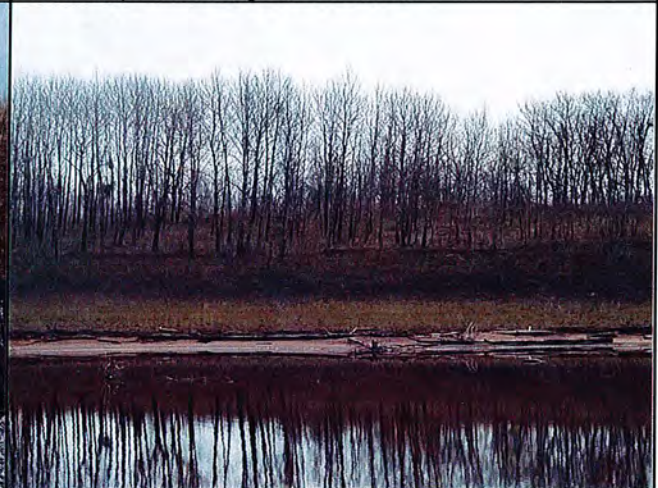
9c: SOU Area C: Looking across Slip 6 at Area C and 54th Ave peninsula, good condition.

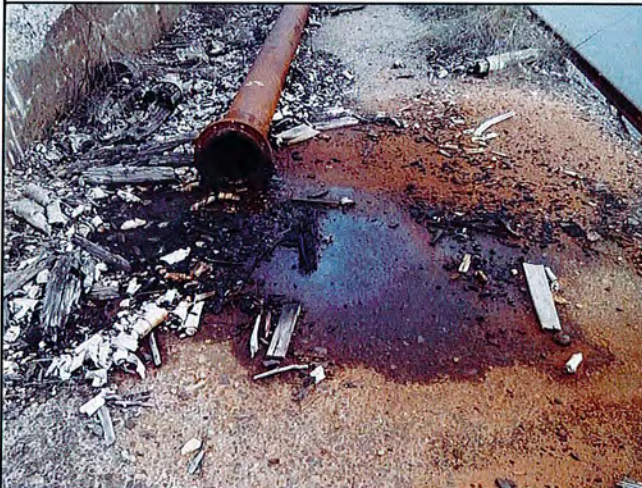
10a: SOU Area D: Pipe on west side of slip 6, oily residue.

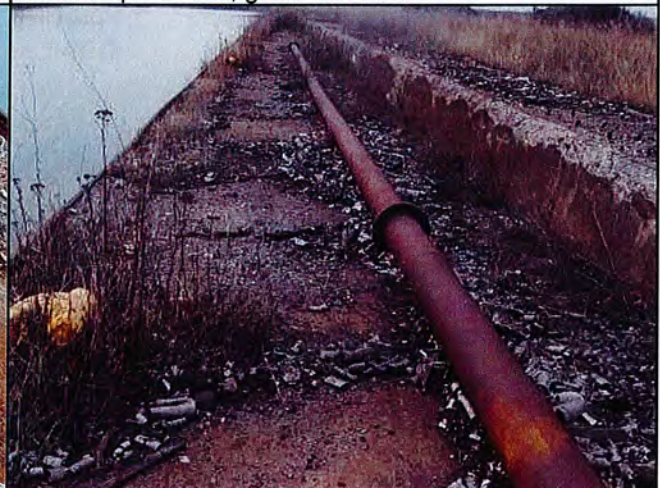
10b: SOU Area D: Pipe on west side of slip 6

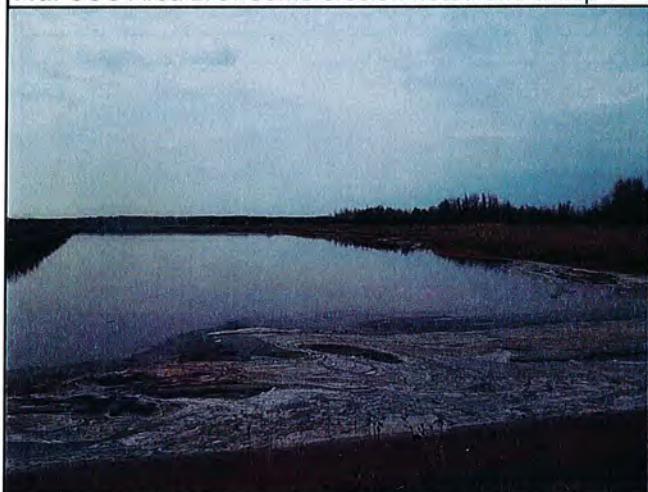
12a: SedOU: Wetland area at end of Slip 7.

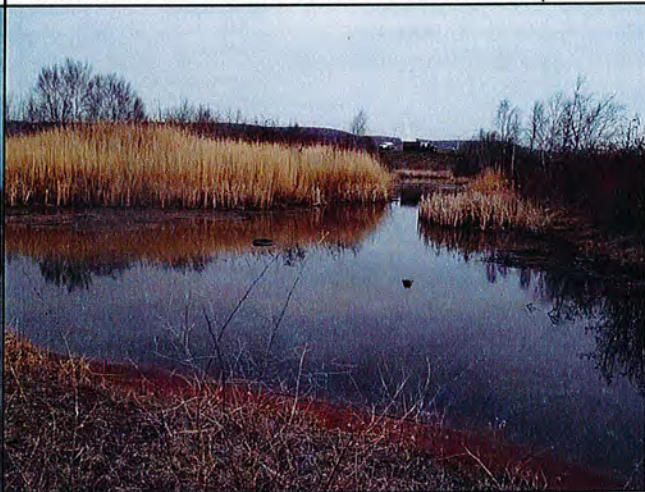
12b: SedOU: Wetland area on Slip 7.

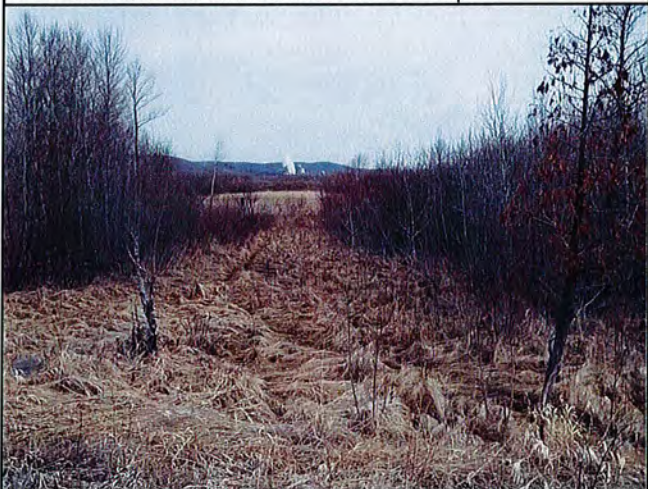
13a: SedOU: Slip 7, wetland area, good condition.

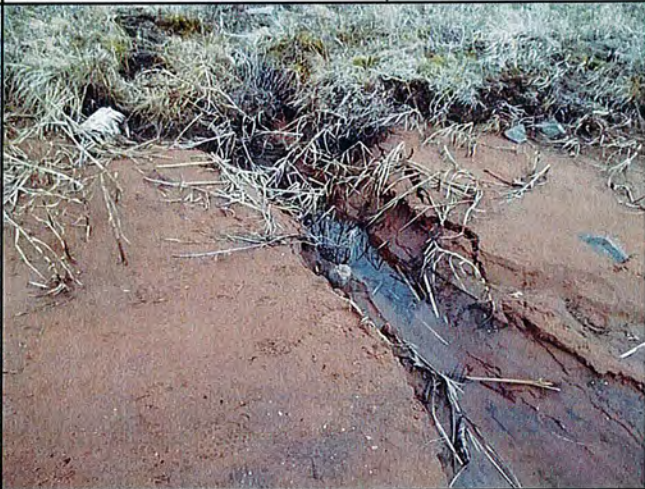
14: Mild erosion noted.

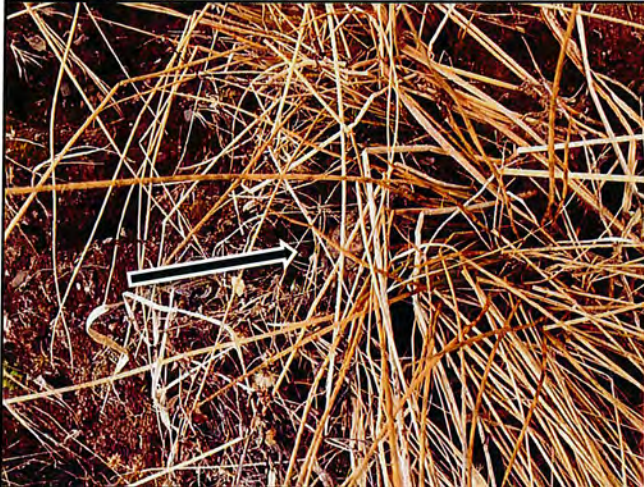
15: SedOU: Wildlife, frog in vegetation along shore of Slip 7.

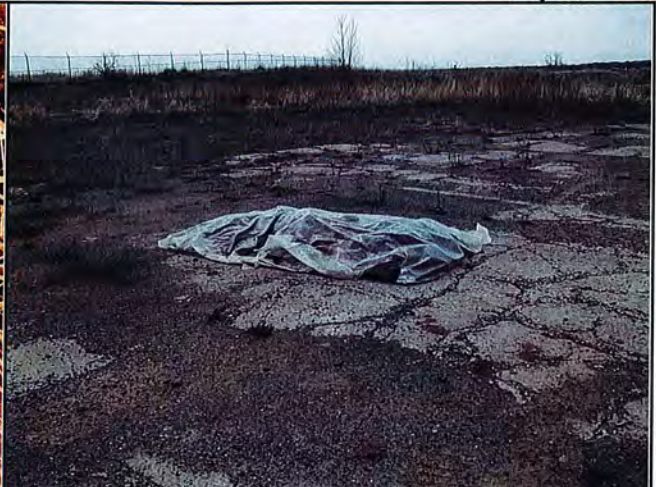
16: SOU Area A: Soil spoils pile, covered by plastic.

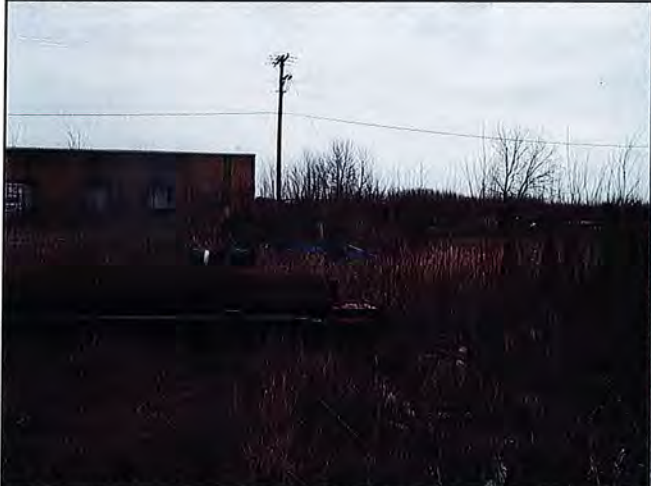
17a: SOU Area E: Terry Andersen encountered coal tar when installing a gas line.

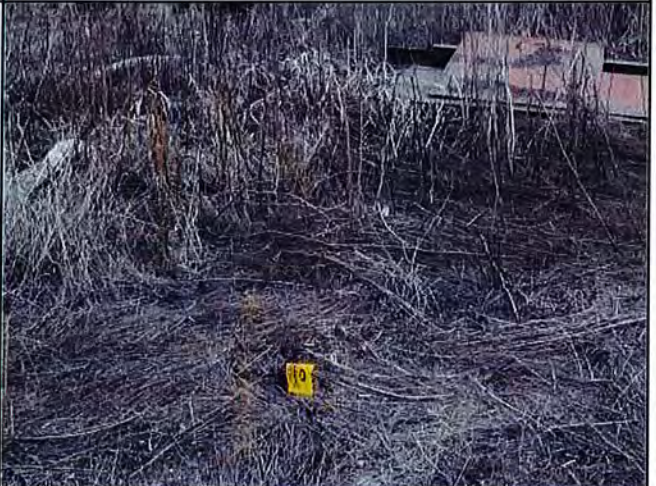
17b: SOU Area E: Coal tar pile on EBI property generated during gas line installation.

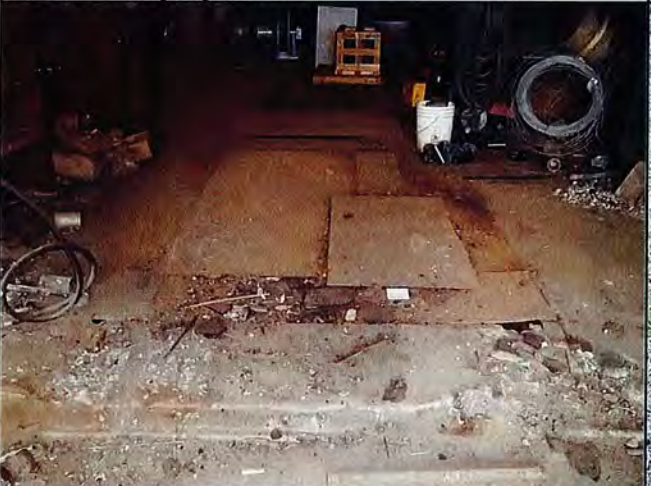
18: SOU Area E: Pit inside Terry Andersen building filled with up to 9' of tar.

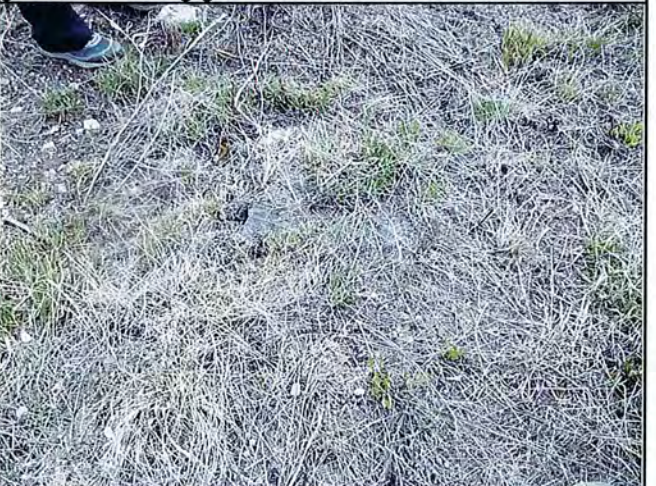
19a: SOU Area E: Tar seep on EBI property.

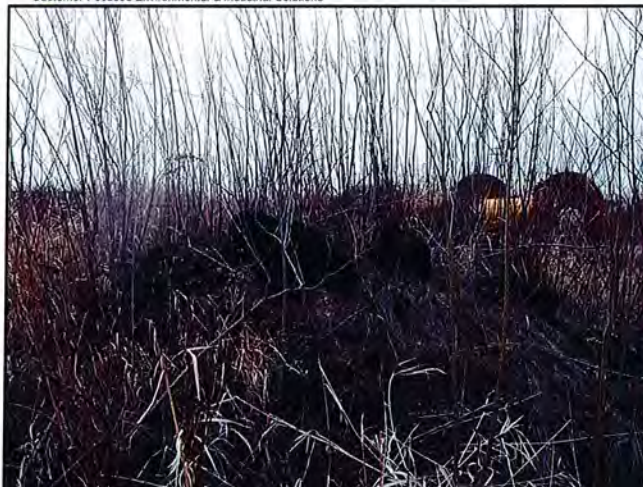
19b: SOU Area E: Coal tar pile on EBI property.

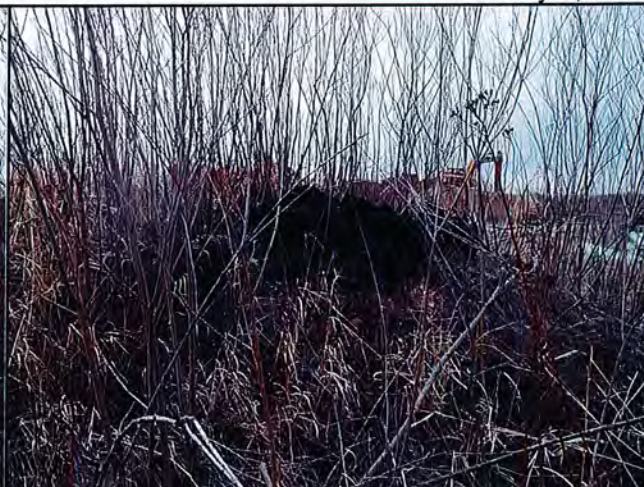
19c : SOU Area E: Coal tar pile on EBI property.

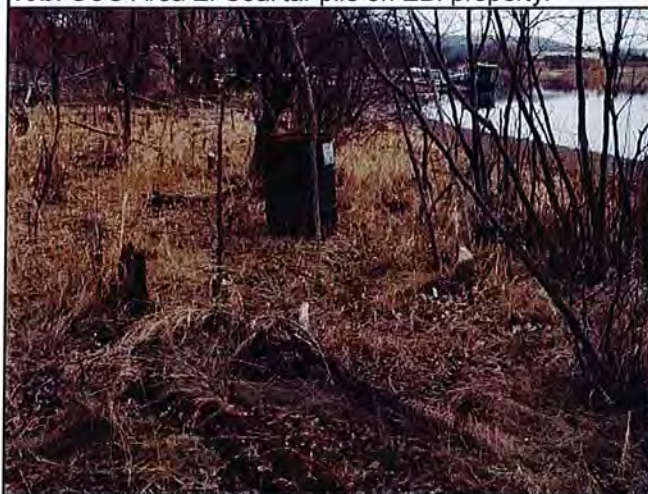
20a: Radio Tower (west side of Stryker Bay): four drums still remain on this property.

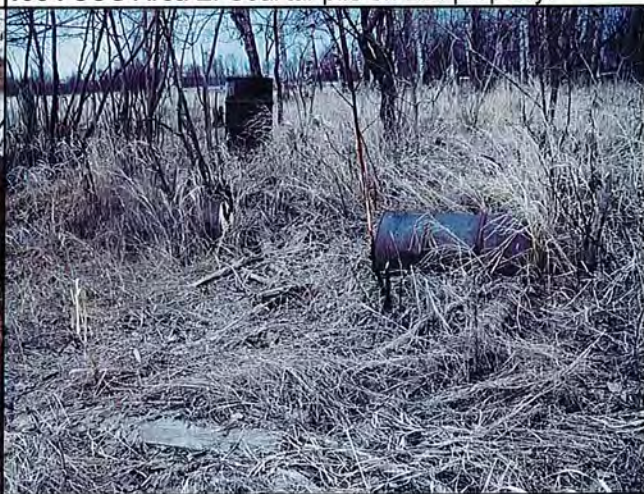
20b: Radio Tower (west side of Stryker Bay): drums.

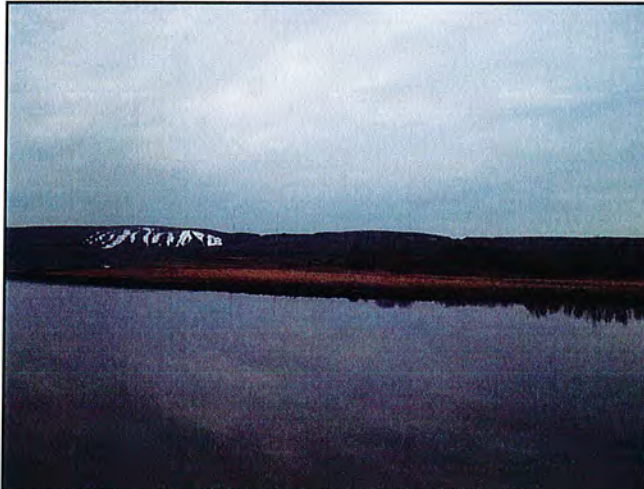
22a: SedOU: East side of slip 7 facing site

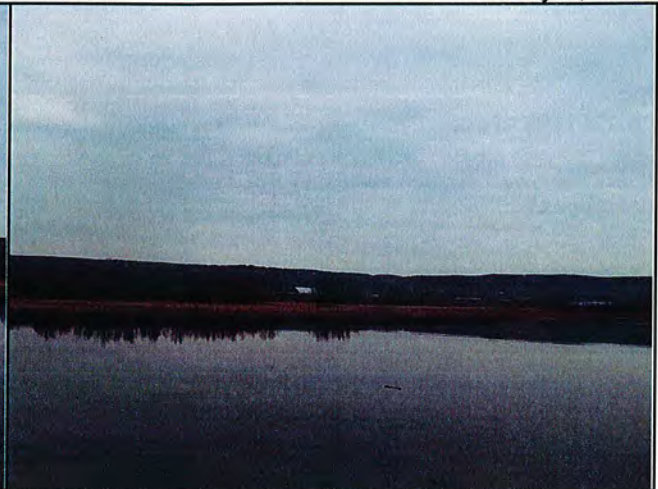
22b: SedOU: East side of slip 7 facing site

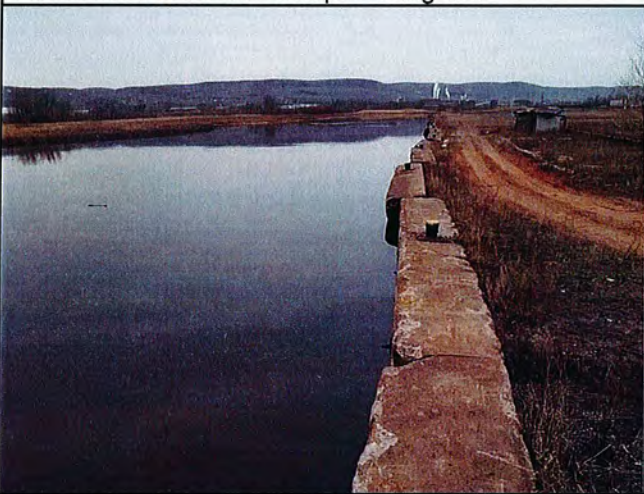
22c: SedOU: Facing north down slip 7.
