FIVE-YEAR REVIEW REPORT FOR
ST. LOUIS RIVER SUPERFUND SITE
DULUTH, MINNESOTA

Third Five-Year Review Report 2013
St. Louis River Superfund Site – Duluth, Minnesota

Volume 1.
FIVE-YEAR REVIEW REPORT FOR
US STEEL SUPERFUND SITE
DULUTH, MINNESOTA

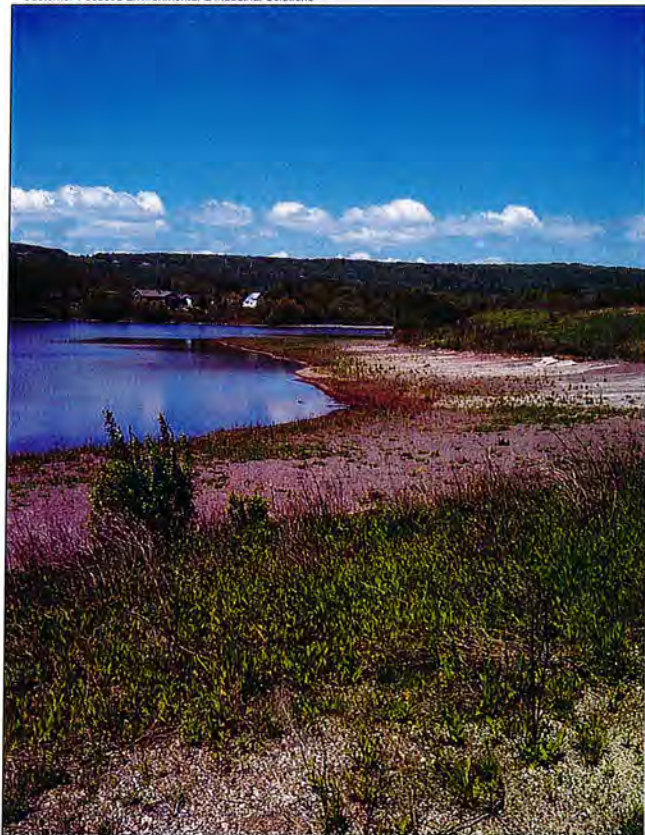
24: Stryker Bay cap, during green inspection.

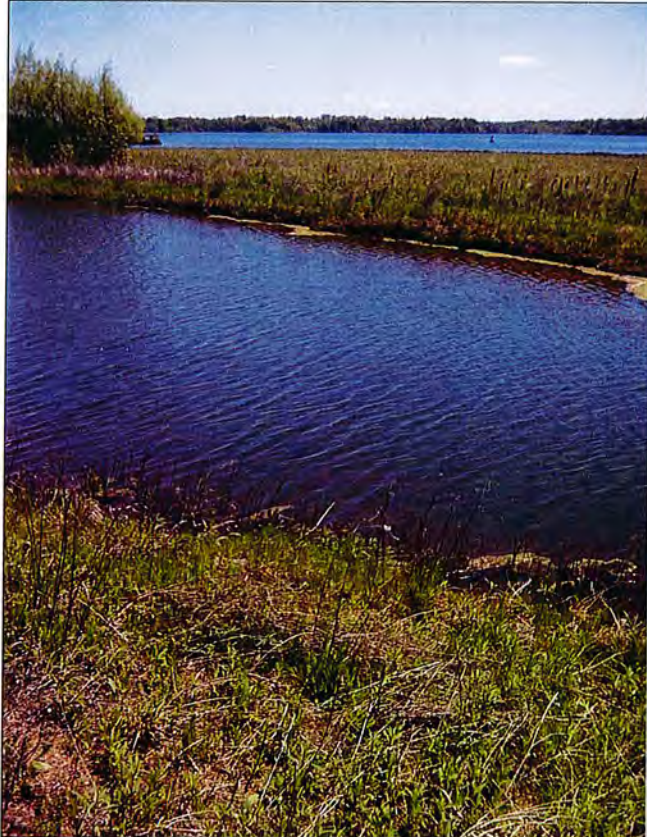
30: Pond in good condition on 54th Ave peninsula
