FOURTH FIVE-YEAR REVIEW REPORT FOR **ST. LOUIS RIVER SUPERFUND SITE** ST. LOUIS COUNTY, DULUTH, MN

MINNESOTA POLLUTION CONTROL AGENCY

Minnesota Pollution Control Agency Site Remediation and Redevelopment Section Duluth, MN

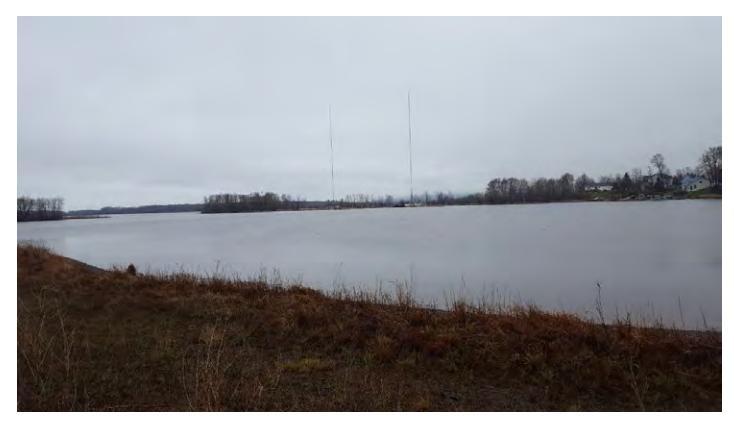
1a: View of Stryker Bay, towards radio tower

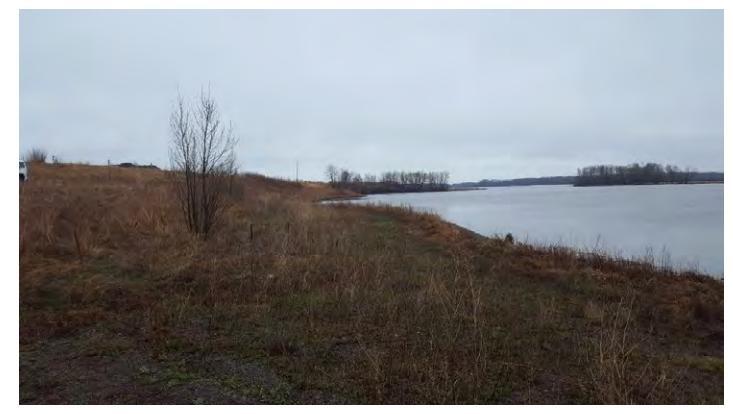
1b: Stryker Bay

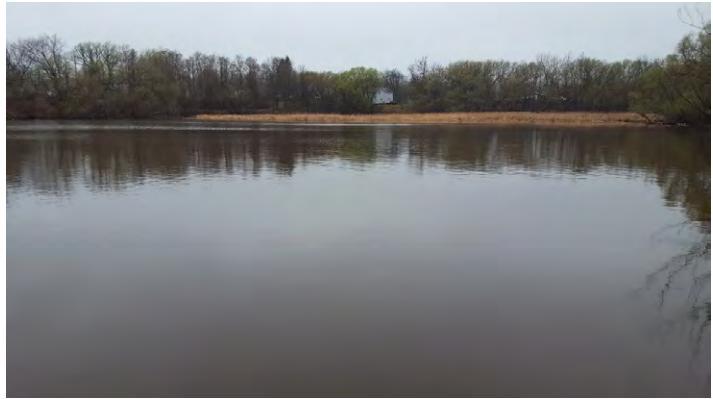
6: Stryker Bay

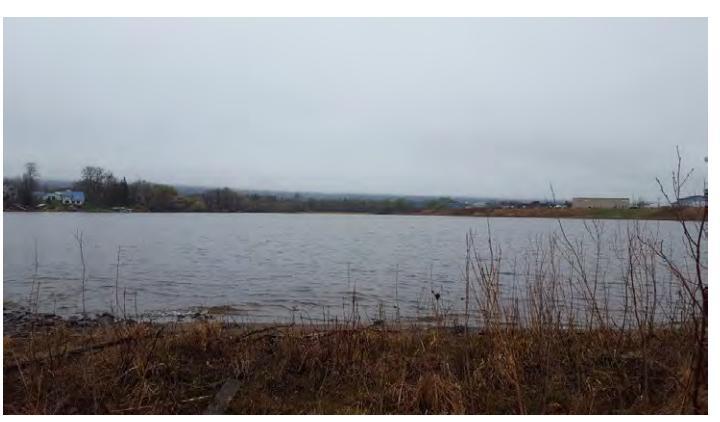
7b: Stryker Bay from Arrowhead Point

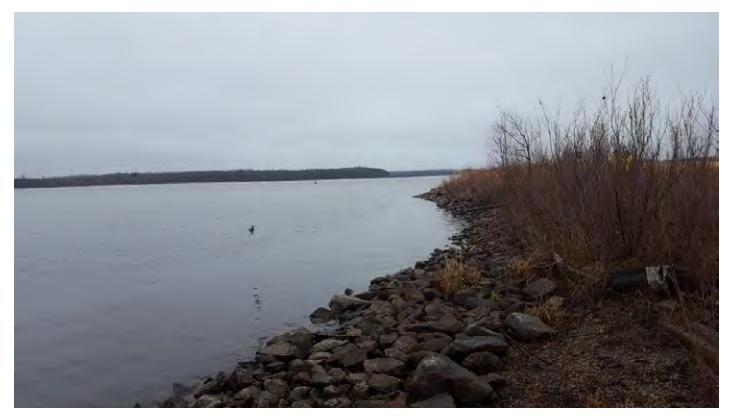
7c: St. Louis River from Arrowhead Point.

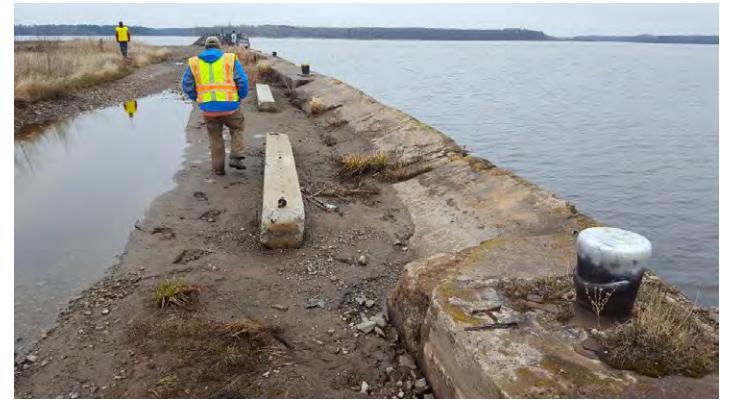
13a: Slip 6 dock wall

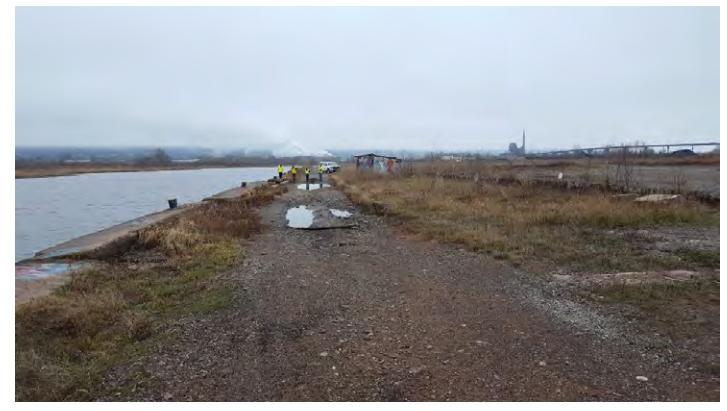
13b: Slip 6 dock wall

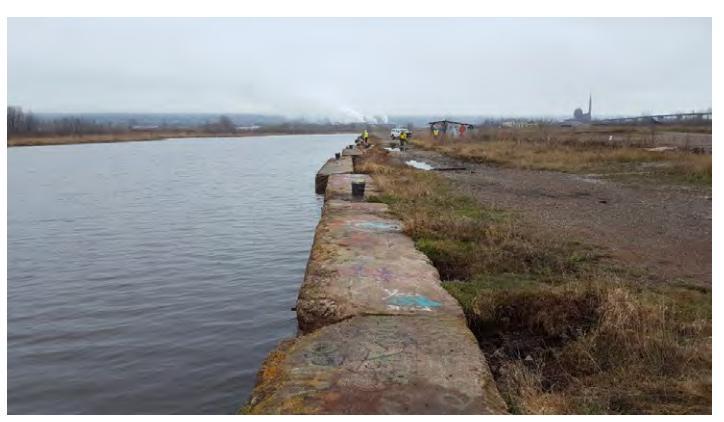
15: Slip 6 dock wall

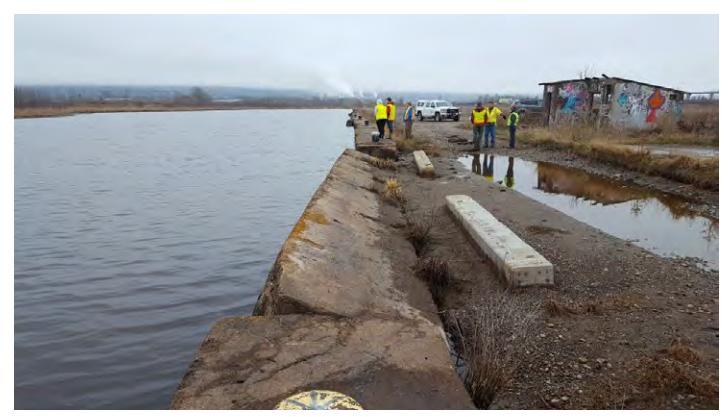
16: Slip 6 dock wall

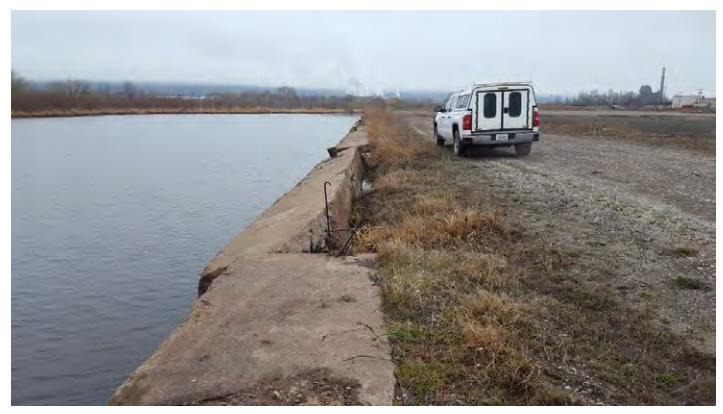
17: Slip 6 dock wall

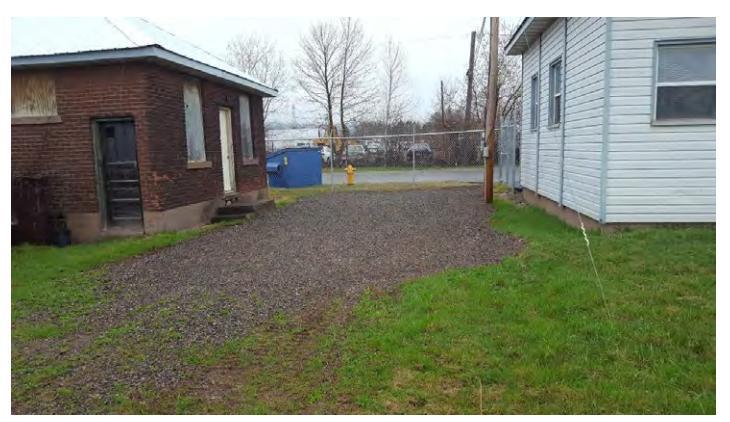
18b: Area E inside Earth Burners fence

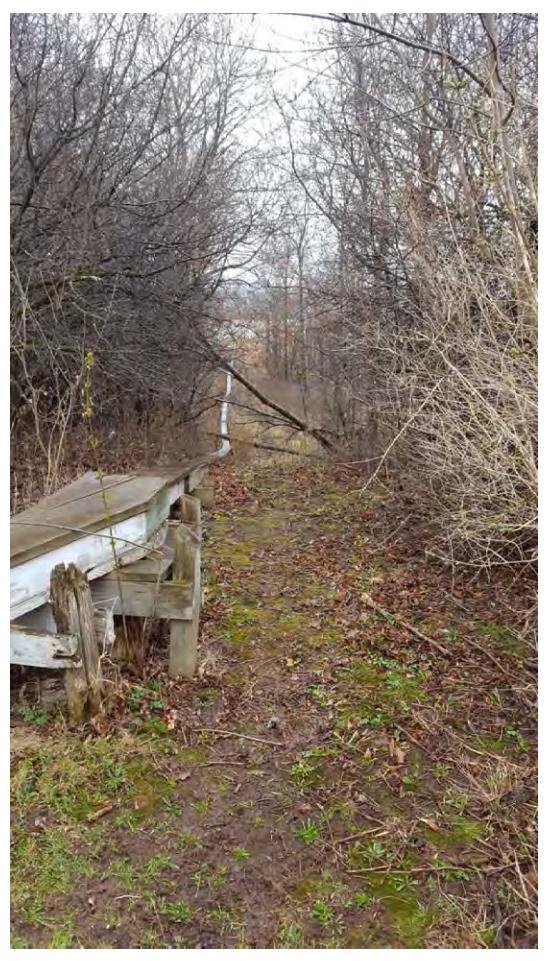
20: View of Radio Tower Bay
